# TECHNICAL NOTES SERIES

## JOWETT JAVELIN – PA, PB, PC, PD & PE JOWETT JUPITER – SA & SC

## – PART XII –

### ENGINE CRANKCASE REPAIR TECHNIQUES

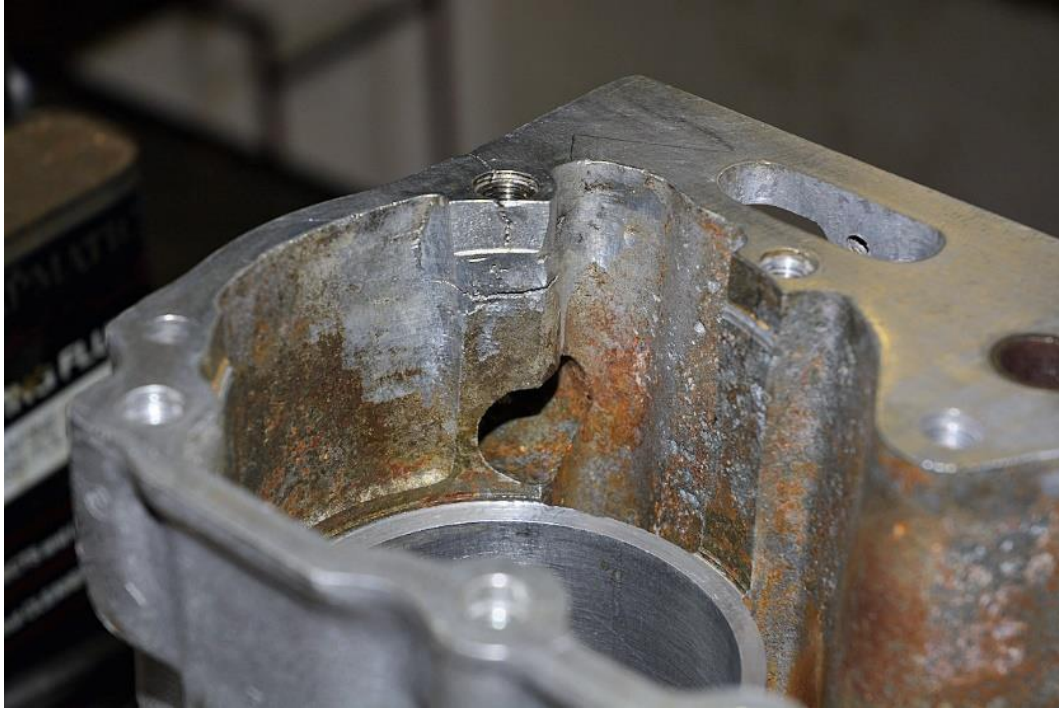
*Above: The part of the right-hand side crankcase-half, which generated the subject of these Technical Notes. In this photo, the horizontal crack was the crack that appeared two days after the cylinder head had been tightened. See Figure 1. The vertical crack aligned with the stud thread reveals a Recoil thread insert, a previous attempt at a thread repair.*

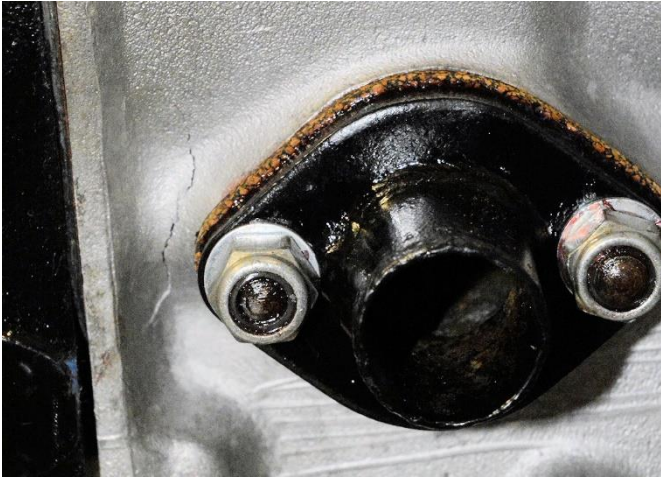
Figure 1.

Shown in *Figure 1*, left above, is the crack at the RHS crankcase half that appeared two days after the cylinder head had been tightened in place. Note that the coolant inlet tube weld assembly had been installed prior to the cylinder head studs' sequence of tightening in three stages. Also, note that the crack has appeared slightly outboard of where such cracks usually appear. At the time, this was mystifying.

First, an attempt was made to carry out a repair, with the cylinder head remaining in place. The crack, as revealed externally, was grooved out and the repair weld gave the impression that the welded area was sound. This was not so, because as soon as coolant water was poured into the radiator, there was a cascade of leaking water at the cylinder head gasket area close to where welding had been carried out.

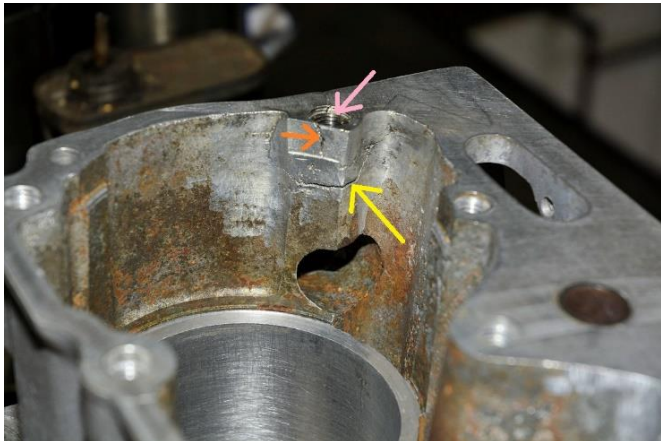
Figure 2.

After the cylinder head was removed, inspection showed that damage due to cracking, was a great deal more than expected. *Figure 2* shows the extent of the crack damage, with the yellow arrow indicating the initially visible crack. The orange arrow indicates a further crack aligned with the threaded stud hole. This crack was through both sides of the threaded hole. The pink arrow shows that a Recoil® thread insert had been fitted at some time. A decision was quickly made to completely dismantle the engine so that appropriate repairs could be effected. It was decided to make an entirely fresh start.

Before any repair work could commence, a set of new cylinder head studs were machined from stainless steel

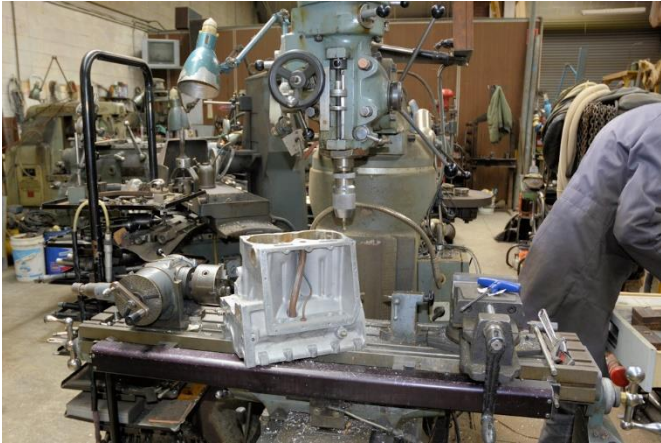
*Figure 5.*

The crankcase half was set up on the table of a large milling machine. Once located in position, *Figure 5*, it was clamped in place so that milling away the cracked metal could commence. A large cutter was fed into the affected area until there was clean, original metal.

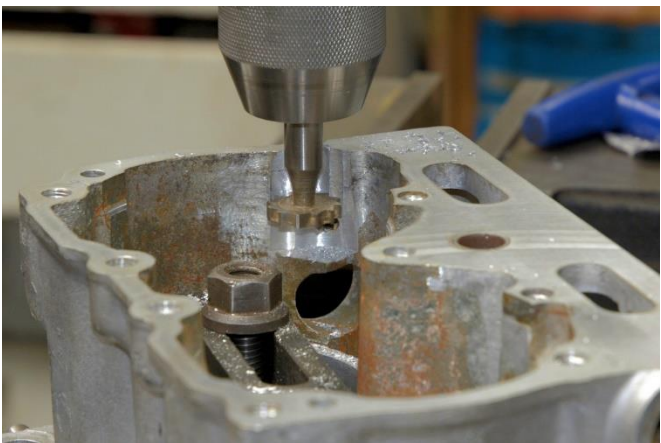
*Figure 6.*

This is where matters became interesting. In a portion where the original crack had one end, there was an enclosed chamber, about the size of a small pea, that most likely resulted from the original pouring of the casting. It was probably a starting point for the crack. The gaseous chamber can be seen, to the right of, and above the mill cutter in *Figure 6*, towards the push rod port.

Parent metal was carefully removed with different shaped mill cutters, until there was only clean metal for the weld repair activity.

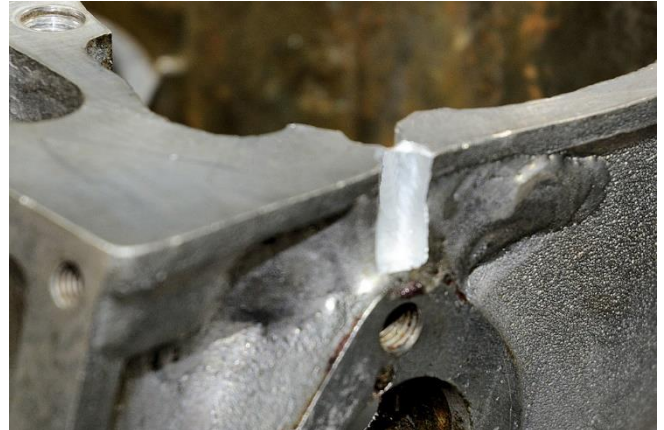
*Figure 7.*

material was cut away from the original, unsuccessful, weld repair along the threaded hole, see *Figure 7*.

Once the weld preparation had been completed, the weld material was laid down larger than was strictly necessary, to allow machining for the cylinder liner and its lip to pass through and into the home position.

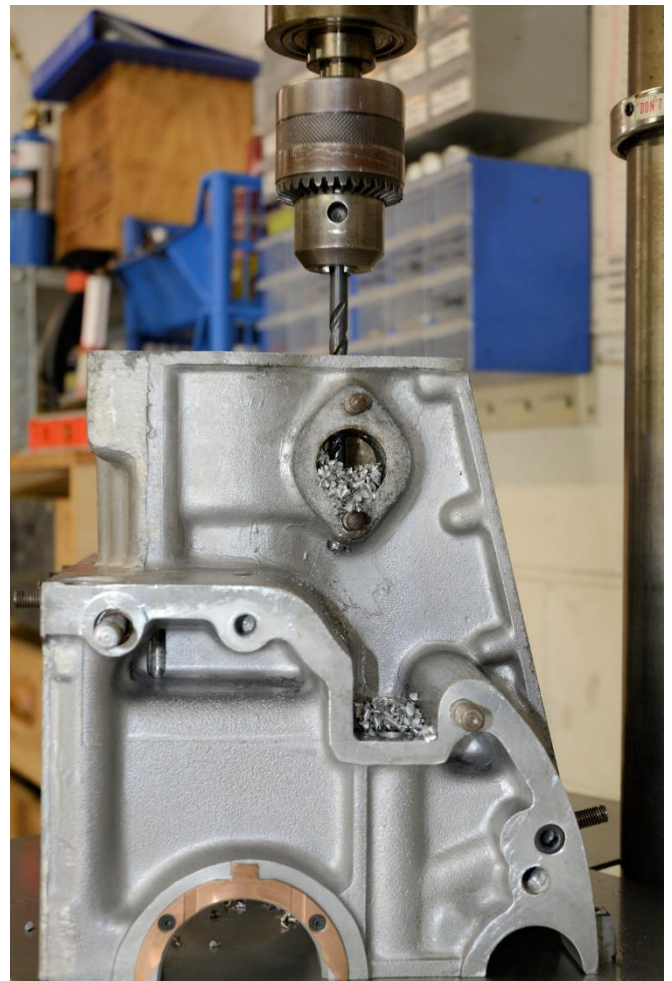
*Figure 9.*

After the 8 mm diameter drill bit breaks through into the coolant inlet port, as shown in *Figure 9*, great care must be taken while feeding the drill into the far side of the port. Very gently apply enough feed pressure to allow the drill bit to establish a round hole in the parent metal.

Once the drill bit is established and is making a clean cut, continue drilling until it breaks through the side of the coolant inlet flange. The reason for allowing the hole to break through, is to permit thorough cleaning away of drill and tap swarf. It also prevents air being compressed as the stud is installed.

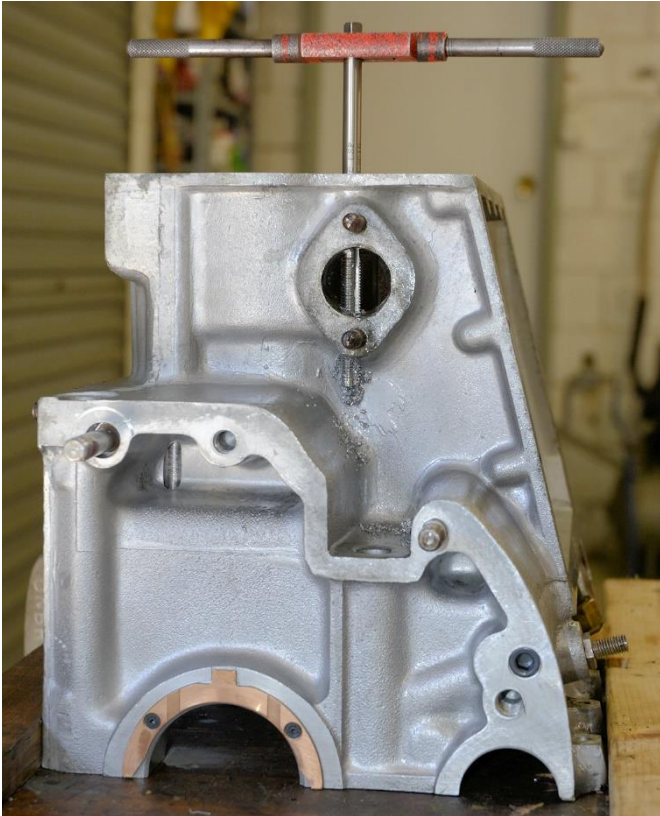
Figure 10.

Figure 10, shows the long series tap being used to cut the  $\frac{3}{8}$ " BSF thread into the far side of the coolant port. Note that the thread of the tap is still engaged with the outer portion of the crankcase, thus forming a continuous thread for the studs to follow into their home position.

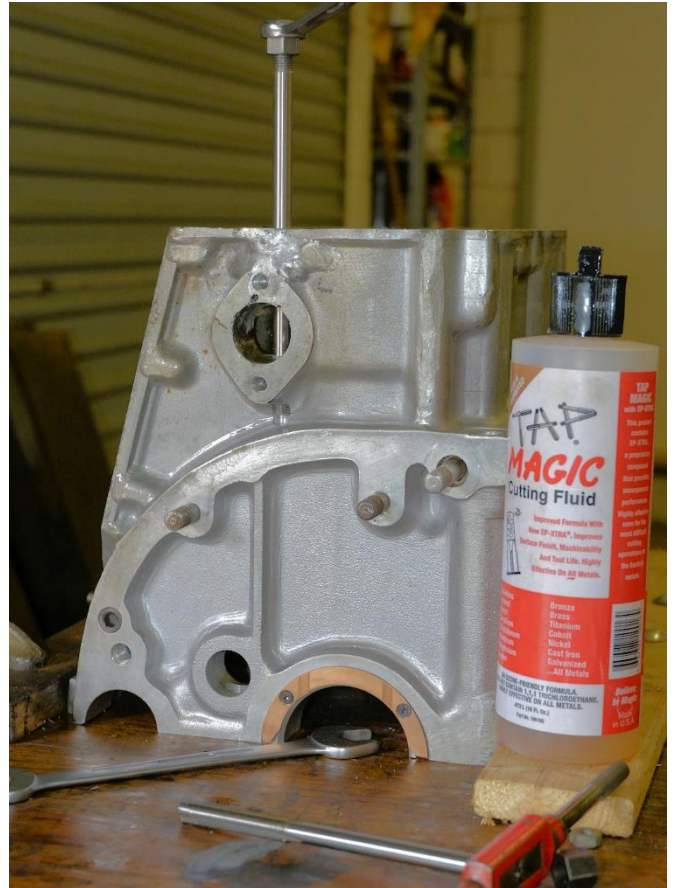
Figure 11.

Figure 11, shows a stud being installed. This was a very satisfying experience.

**Note:** The crankcase half, is shown in Figure 11, placed on a wooden work surface, this is important to help prevent damage to the crankcase joint face and, also note that the crankcase half is located by two pieces of scrap dressed timber clamped to the work bench to prevent the crankcase half from sliding during the thread cutting process.

These extended studs will be final-installed using Loctite 518 as the sealant/retainer to prevent coolant migration. Once the studs are installed, excess Loctite 518 should be wiped away with a rag soaked in methylated spirits, the end of the stud, where it protrudes, can then be sealed with a covering formed from Permatex Cold Weld. The exclusion of air from the area will allow the Loctite 518 to properly cure for perfect sealing and stud retention.
