# TECHNICAL NOTES SERIES

## JOWETT JAVELIN – PA, PB, PC, PD & PE

## JOWETT JUPITER – SA & SC

## PART III – SERVICE BULLETINS – JAVELIN AND JUPITER

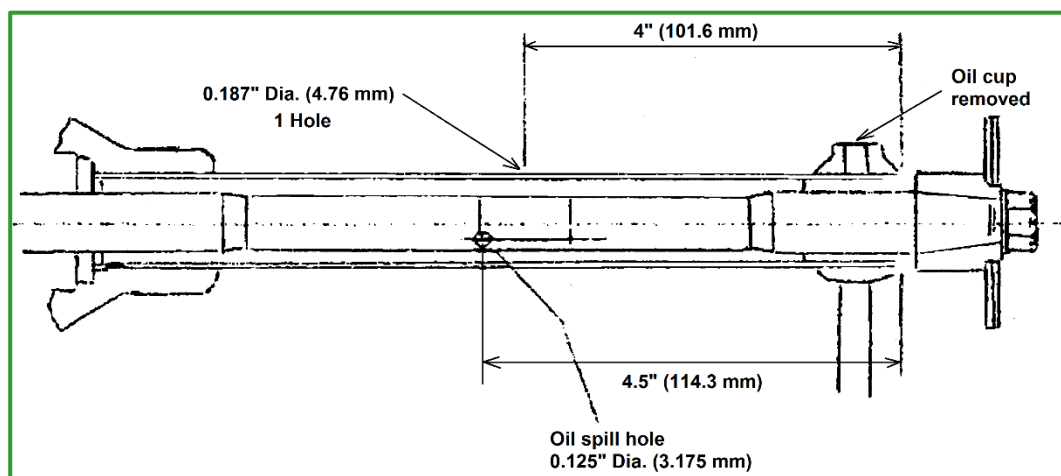
### Item No. 93. Lubrication of Fan Spindle Bearing – Javelin

With the introduction of the radiator mounted oil cooler the fan support tube oil cup, Part Number J54011, was inaccessible and therefore removed. A  $\frac{3}{16}$ -in. (4.7625 mm) hole is now incorporated in the fan support tube for lubrication purposes together with a  $\frac{1}{8}$ -in. (3.175 mm) spill hole to prevent over lubrication.

Figure 1. Dimensions for drilling fan support tube.

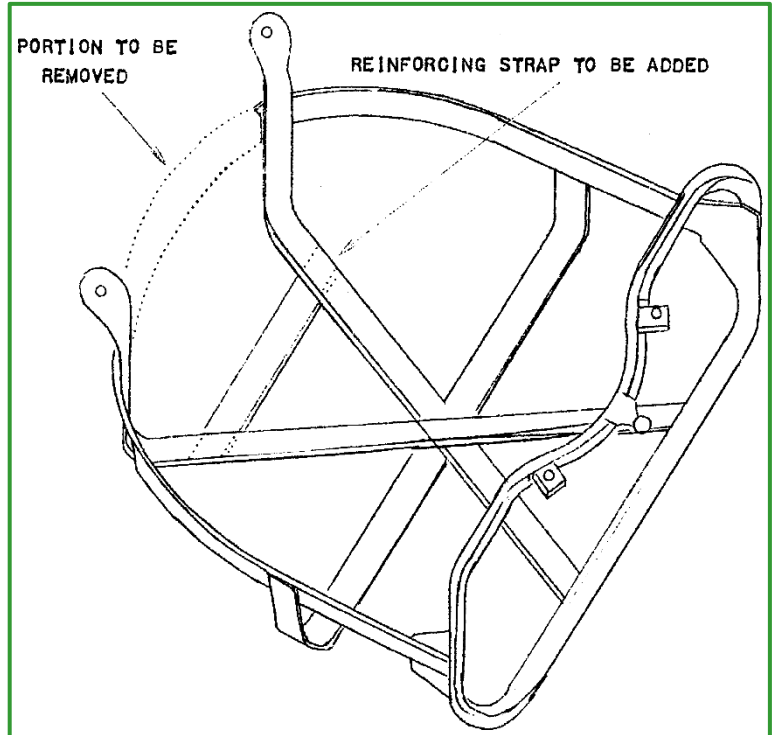
Under certain conditions there is a possibility that the spare wheel carrier will foul the rear brake compensator. From Javelin Serial Number E0 PB 8145 the rear portion has been removed and a reinforcing strap has been substituted.

Should this condition be experienced on cars before E0 PB 8145, the carrier may be modified as shown in the sketch at right:

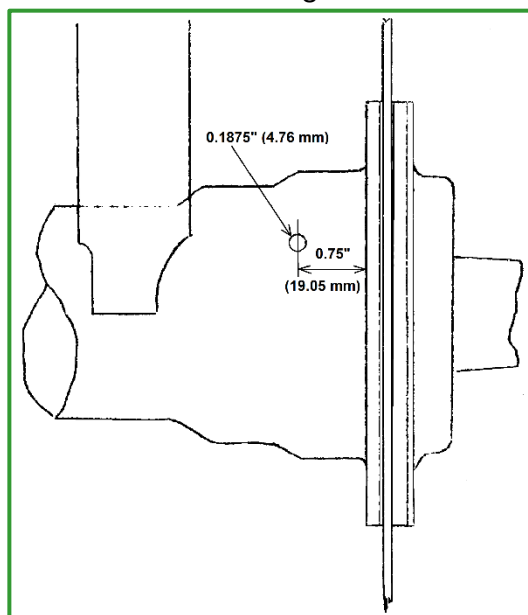
Cases have been reported where an over application of grease to the rear hubs has resulted in brake lining contamination and subsequent brake inefficiency. A  $\frac{3}{16}$ " (4.7625 mm) diameter grease relief hole will shortly be incorporated for all rear hub bearings at the rear and outer (hub) end of the axle casing tubes, as shown in the sketches below:

*Figure 1. Location of grease release hole.*

When greasing rear hubs embodying this feature, hubs should be lubricated until grease just appears from the relief hole.

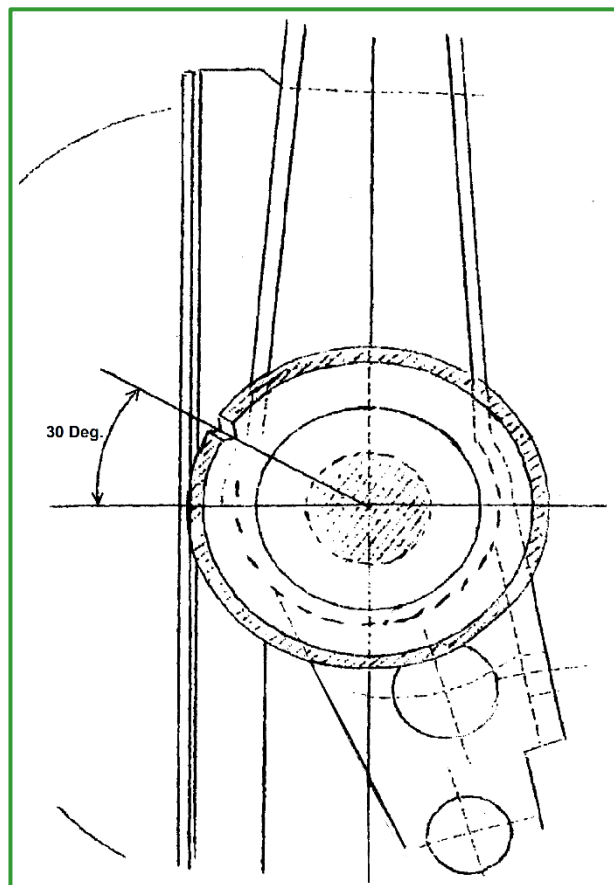
*Right: Figure 2. Section through rear axle tube, showing angle of grease hole.*

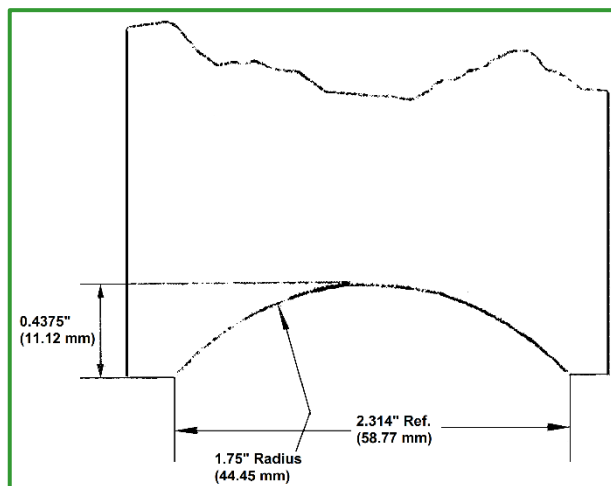
*Right: Figure 1. Detail of clearance cut out at cylinder liner.*

Depth of cut-out in cylinder liner skirt 0·437-in. (11·10 mm)

Width of cut-out at cylinder liner edge 2·314-in. (58·77 mm)

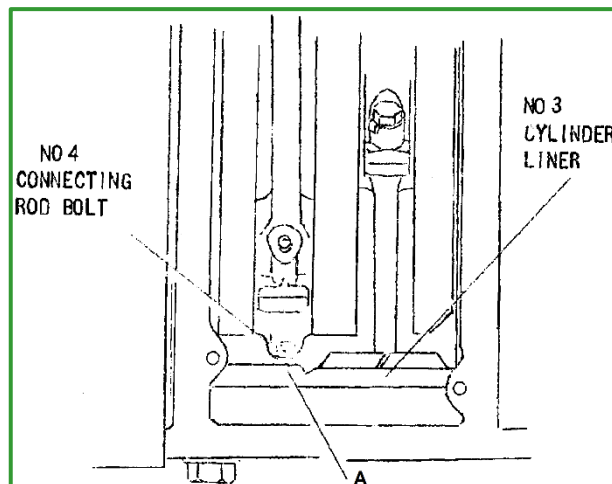
there is adequate clearance between the crankcase boss and number 4 connecting rod bolt. Should any doubt exist, a flat may be filed on the crankcase boss as shown in the illustration on the next page. After carrying out this modification great care should be taken to remove all traces of filings etc., from inside the crankcase.

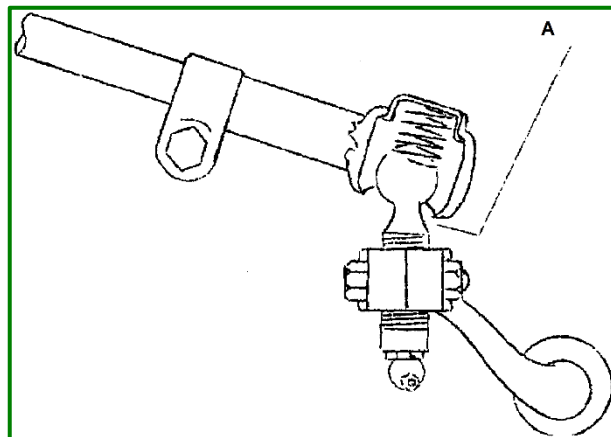
In addition to the above, it is equally important to check that the bottom inner edge of the bore of the steering ball housing does not foul the neck of the steering arm ball with the suspension in the full rebound position. A satisfactory check may be made with the suspension in the full rebound position and by rotating the steering ball housing which should be free to rotate in a backwards and forwards direction.

If the housing is free to rotate, a clearance is indicated between the inner edge of the steering ball housing and the steering ball neck. Please refer to *Figure 1*.

If there is little or no free movement, it is apparent that the inner edge of the steering ball housing and the neck of the steering ball are in contact. In this case, **immediate action must be taken to fit replacement ball joint assemblies as detailed in Bulletin Item Number 30.**

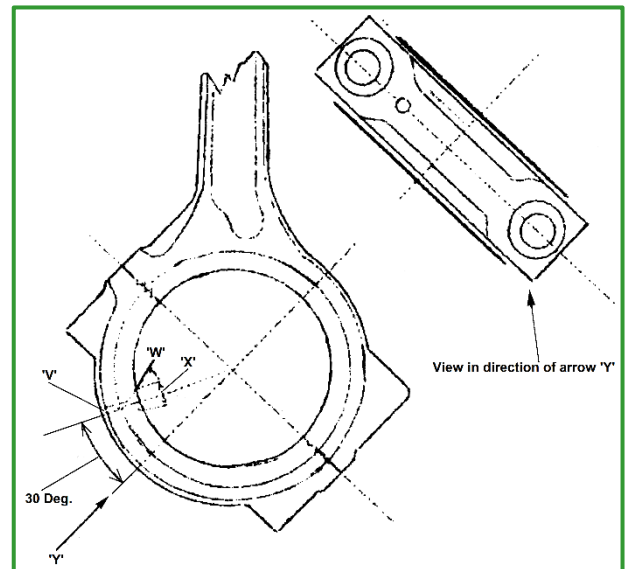
Where: 'V' = Drill  $\frac{1}{16}$ -in. (1.58 mm) dia. hole through big end cap, de-burr at 'V'. 'W' = Countersink at  $45^\circ$  included angle. 'X' = Countersink width  $\frac{5}{32}$ -in. (3.96 mm).

Arrangements are being made for all service replacement connecting rods, Part Number 54024, and connecting rod bearing shells, Part Number 52574, supplied from our Spares Department to incorporate the sludge release hole.

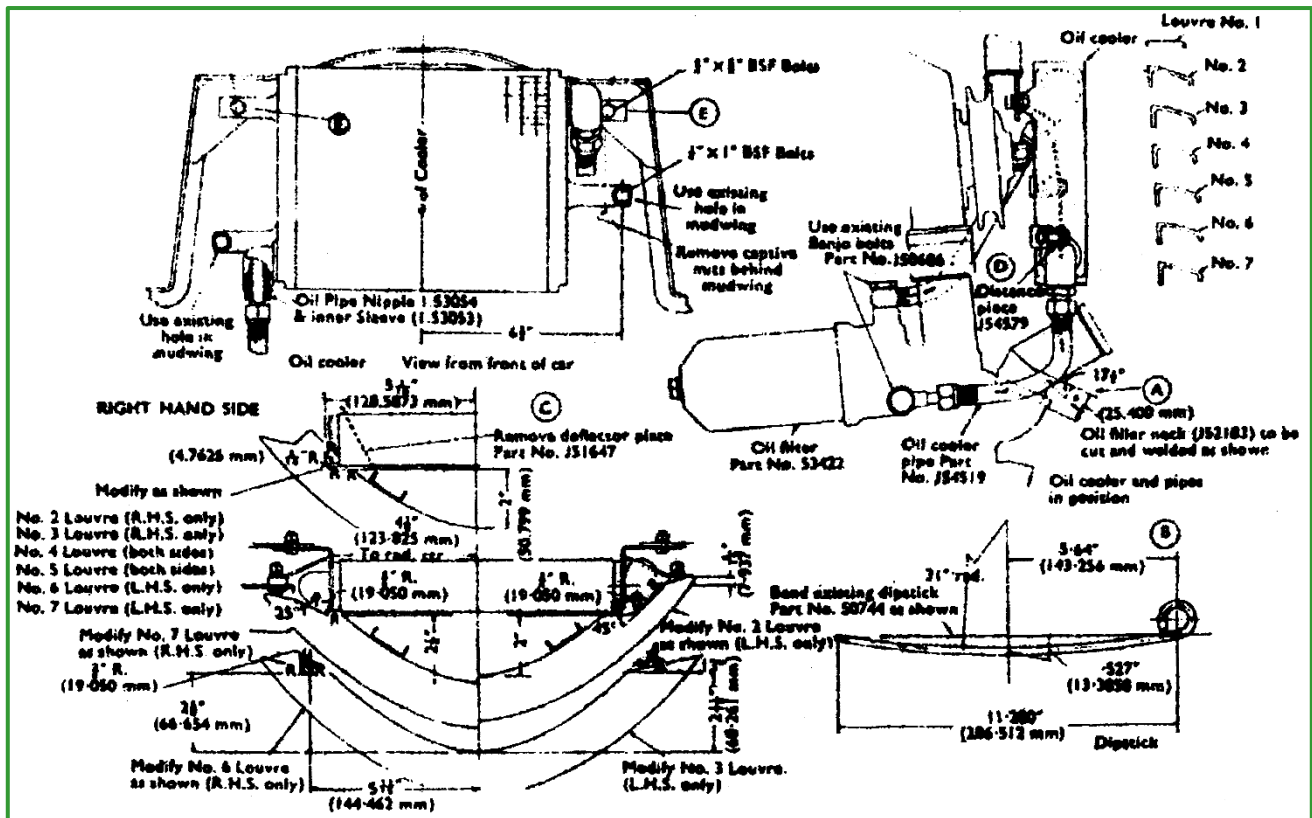
Above: Figure 1. Mounting of competition type oil cooler (with Tecalemit oil filter).

4. To fit the cooler, remove the captive nuts at the rear of the mud-wing and drill the lower cooler brackets to coincide with the existing holes in the mud-wing and secure with two  $\frac{1}{4} \times 1$ -in. BSF bolts and nuts with the distance pieces positioned between the lower cooler brackets and the mud-wing as shown at (D) in Figure 1.

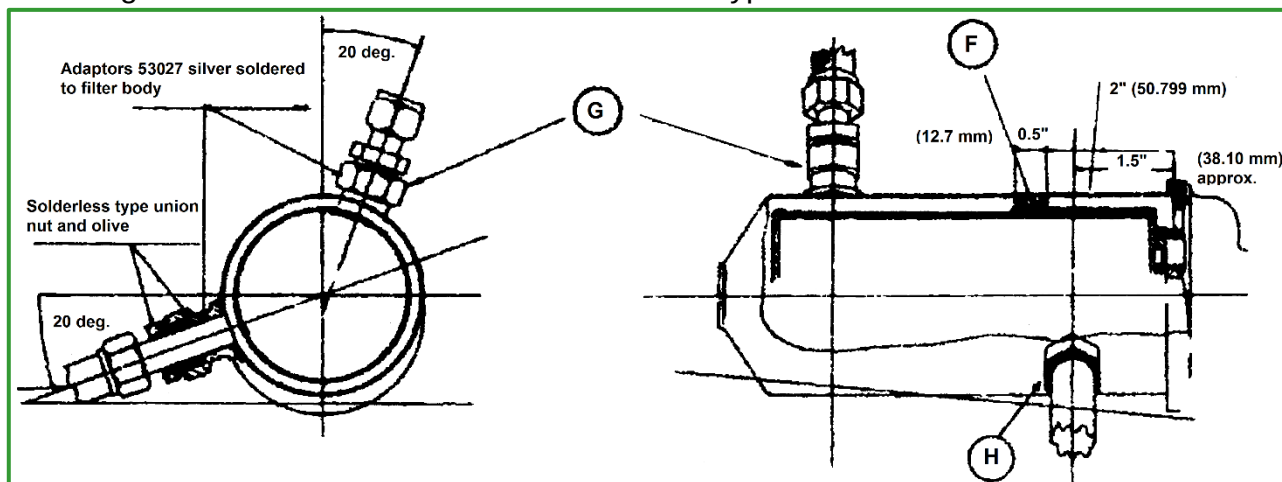
Figure 3a. Vokes oil filter modification.

1. Fit the blanking ring, Part Number 53046, to the oil filter case as shown at (F) *Figure 3a* and secure in position by riveting or sweating, do not weld or braze as this method would tend to cause distortion.
2. Drill two ½-in. (12.70 mm) holes in the filter case in the positions shown at (G) and (H) in *Figure 3a*, and fit the oil cooler pipe adaptors, Part Number 53027. Secure the adaptors to the case with silver solder.
3. Butt solder the shroud, Part Number 53045, as shown at (J) *Figure 3b*, and after removing the three lugs from filter element front plate, sweat the shroud to the front plate in the position shown at (K) *Figure 3b*.

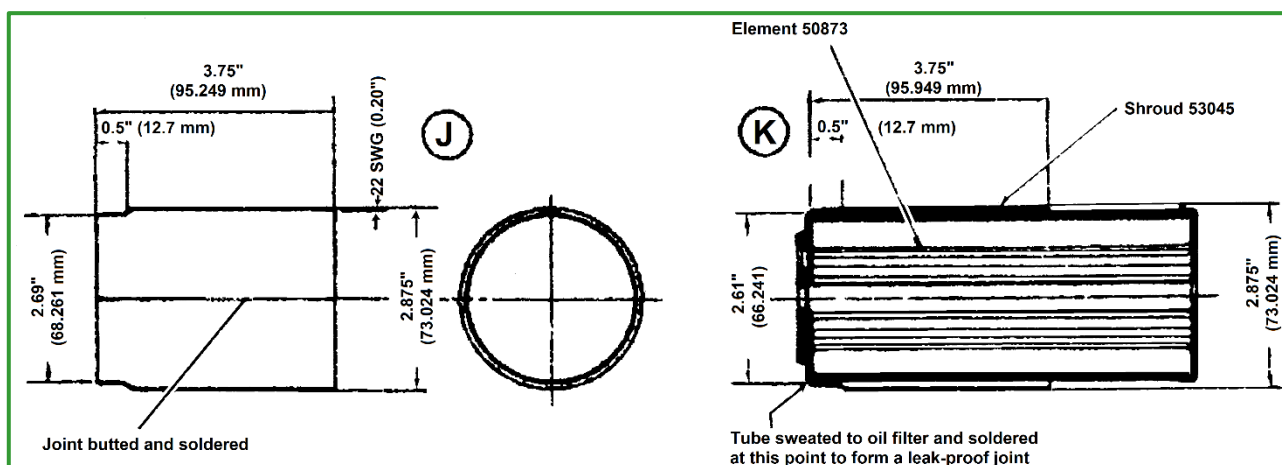
Figure 3b. Vokes oil filter element modification.

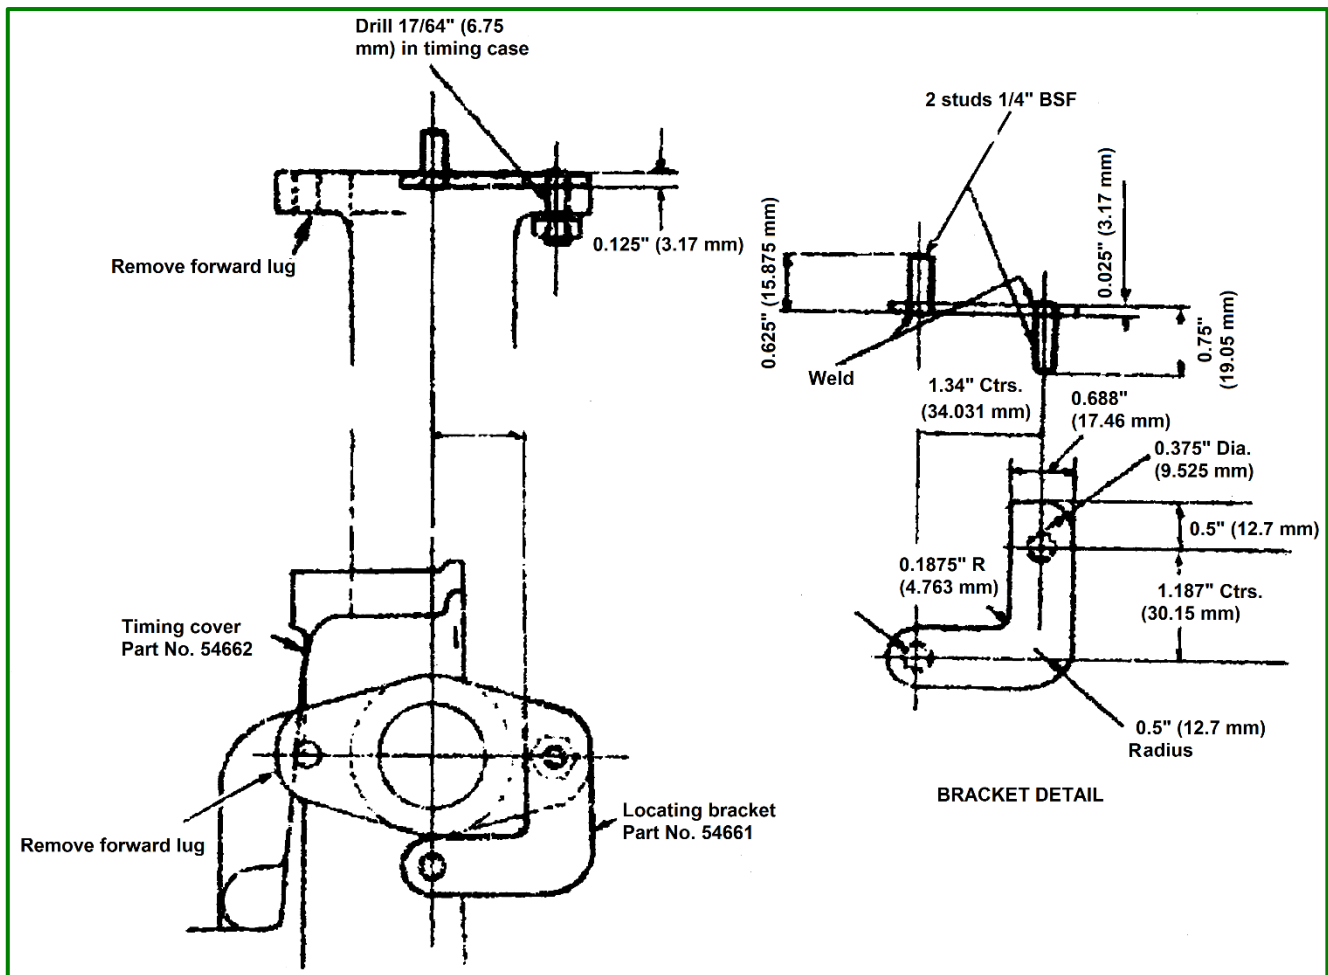
Figure 2. Installing Lucas DKY H4A distributor on later type timing cover.

The old type distributor (DKY H4A) can be fitted to the new type timing cover by removing the forward lug of the timing cover mounting flange and fitting a distributor locating bracket, Part Number 54661, to the rear lug of the timing cover mounting flange as shown in *Figure 2*.

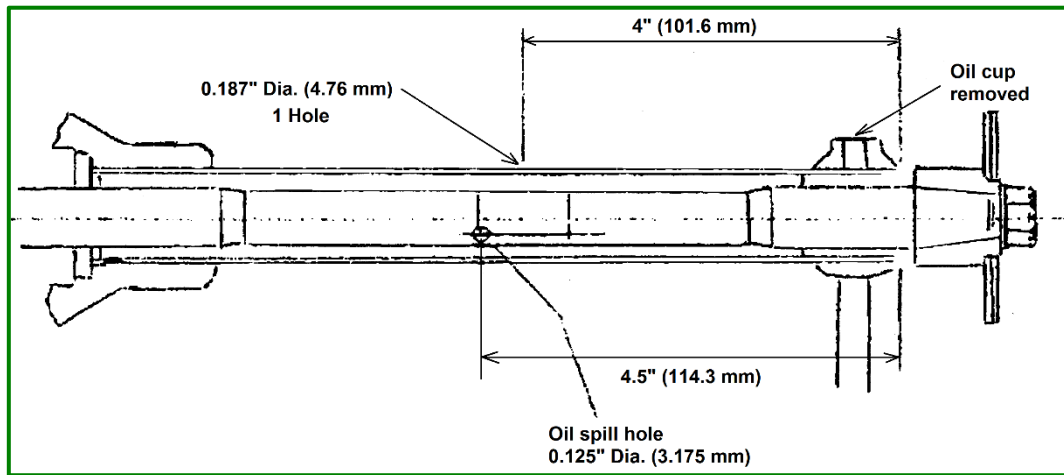
With the introduction of the radiator mounted oil cooler the fan support tube oil cup, Part Number J54011, was inaccessible and therefore removed. A  $\frac{3}{16}$ -in. (4.763 mm) hole is now incorporated in the fan support tube for lubrication purposes together with a  $\frac{1}{8}$ -in. (3.175 mm) spill hole to prevent over lubrication.

Figure 1. Dimensions for drilling fan support tube.

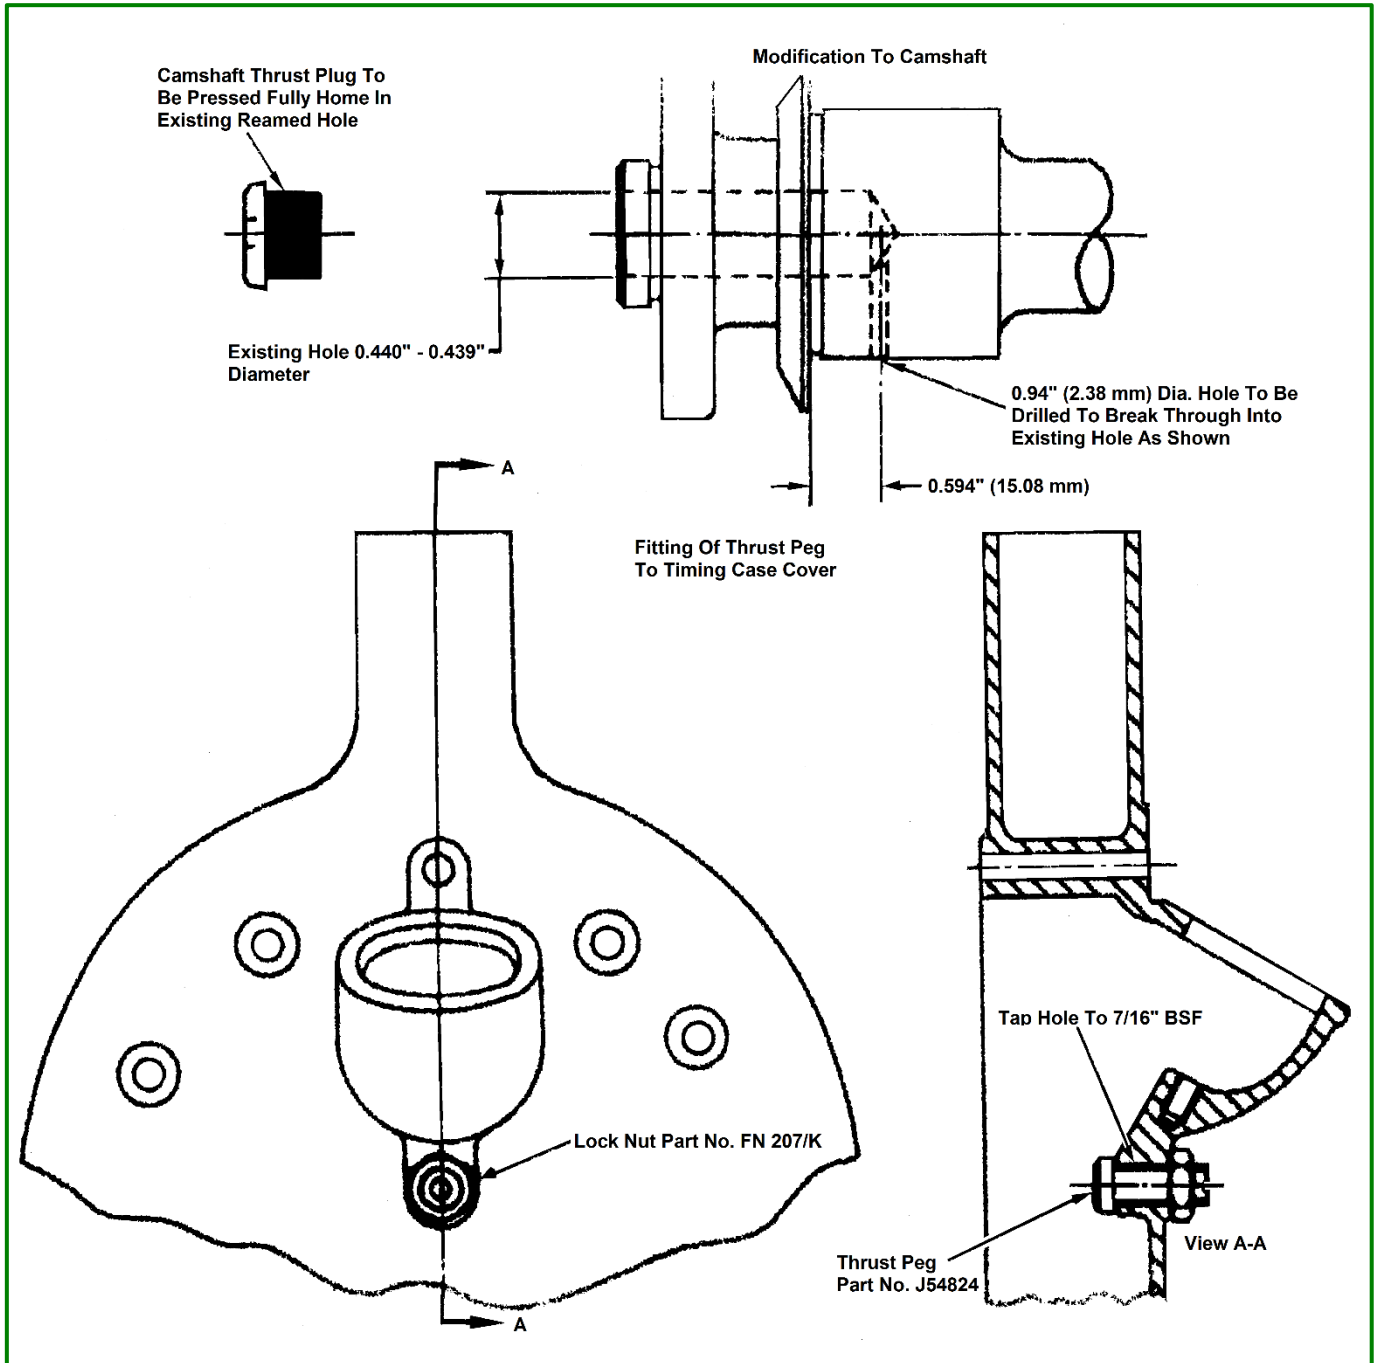
*Above: Figure 2. Modifying early front timing cover, camshaft and Section 'AA'.*

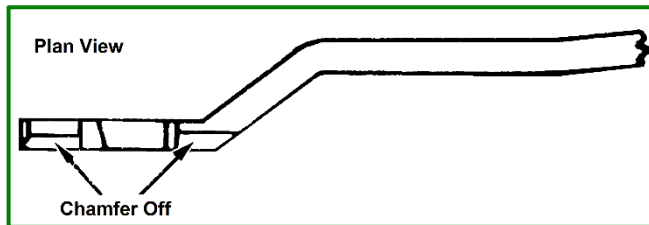
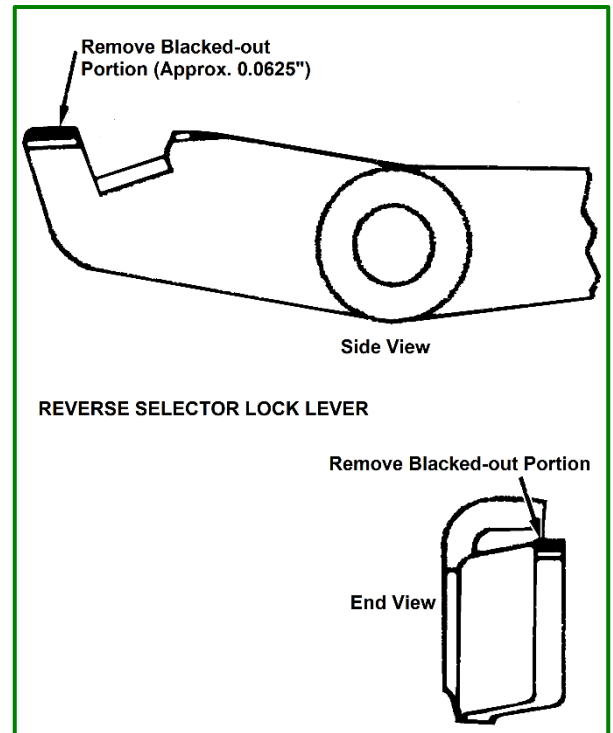
*Figure 1. Modification to reverse selector lock lever.*

To eliminate this fault remove approximately  $\frac{1}{16}$ -in. (1.6 mm) from the reverse selector lock lever and back off as shown in *Figure 1*.

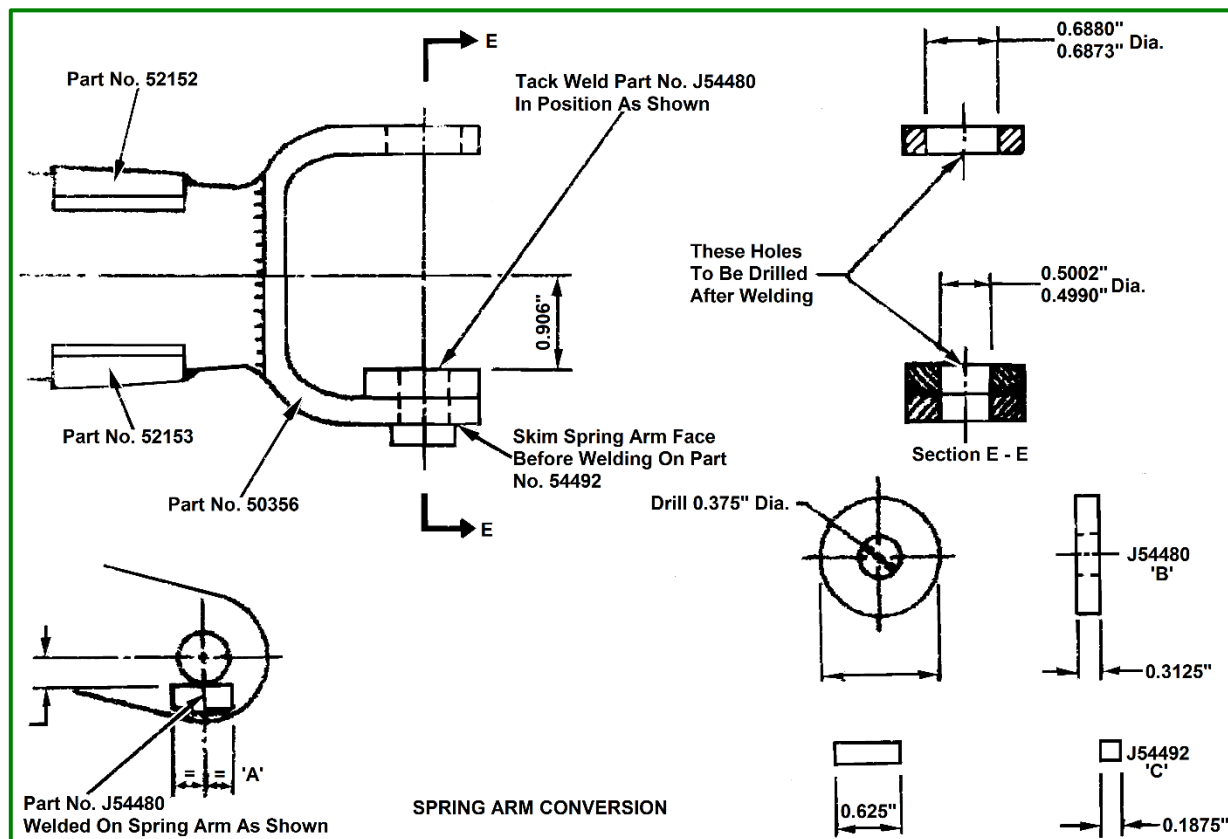
Figure 1, Featuring details 'A', 'B' and 'C'. Front spring arm conversion (RHS shown).

Reference should be made to *Figures 1 'A', 'B' and 'C'* for conversion instructions. *Figure 1 'A'* shows the general arrangement, *Figure 1 'B'* and *Figure 1 'C'* show the parts required to convert the spring arm.

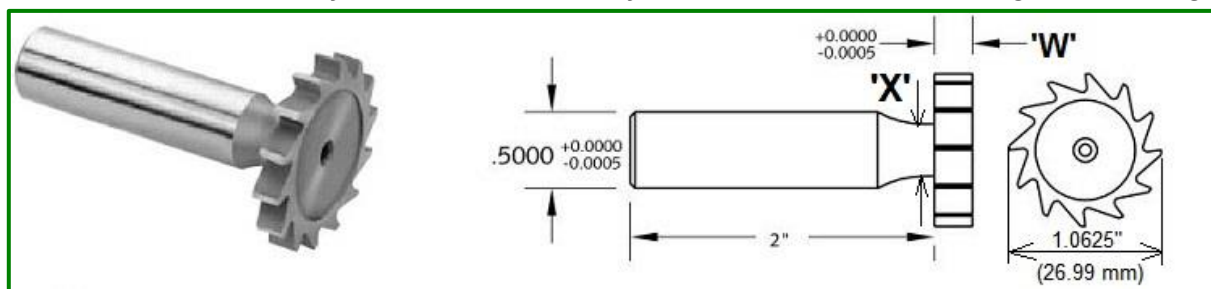
Figure 1. Woodruff keyway cutter for milling the material from the cylinder head.  
Legend: 'W' is 0.25" (6.35 mm), 'X' is waisted area to provide 'reach' for the cutter.

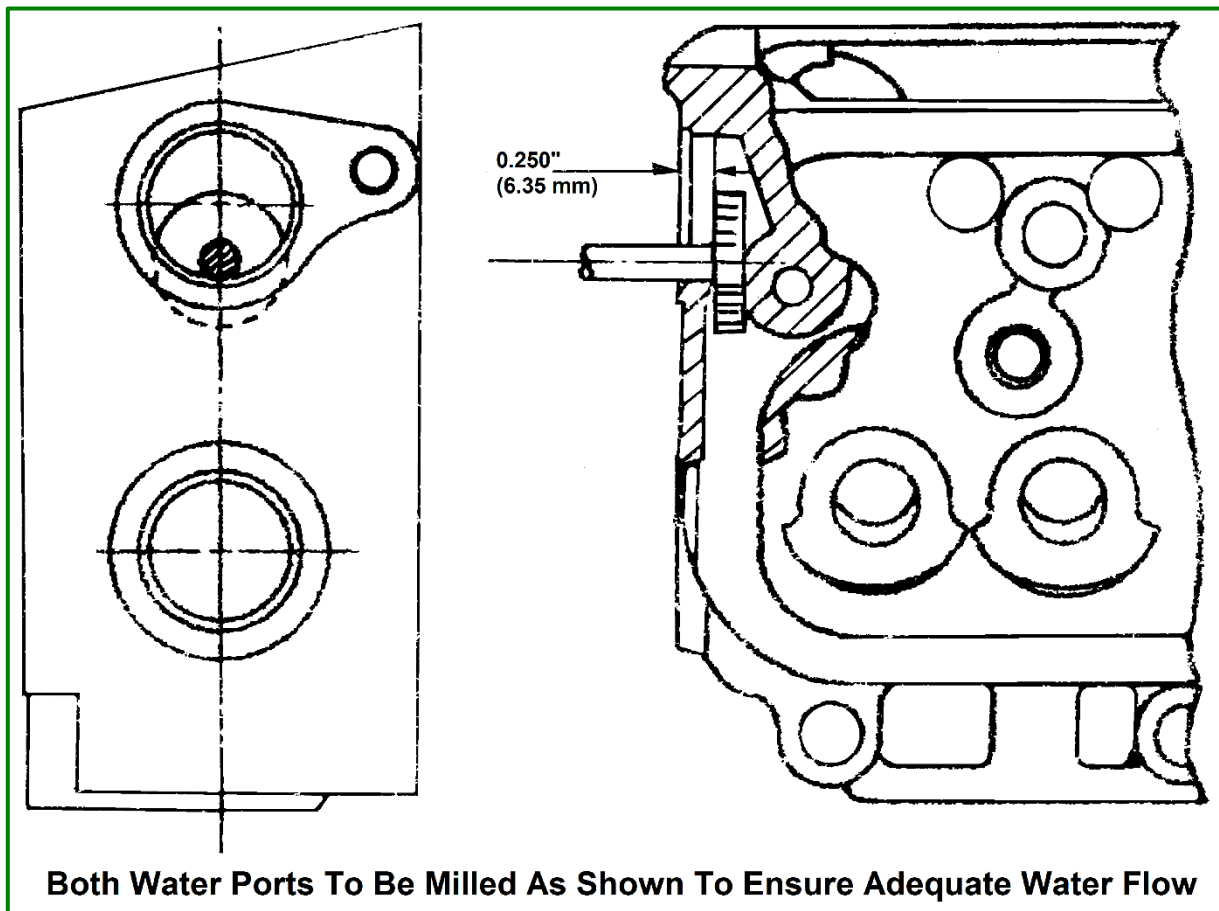
Cases have occurred where engine overheating and pinking has been caused by a restriction between the outer wall of the cylinder head and the cylinder head stud hole casting shown in *Figure 2*.

*Figure 2. Showing where material can be milled from cylinder head.*
