# TECHNICAL NOTES SERIES

## JOWETT JAVELIN – PA, PB, PC, PD & PE JOWETT JUPITER – SA & SC

## – PART XI –

### ENGINE CRANKCASE – CYLINDER HEAD STUD THREAD REPAIR TECHNIQUES

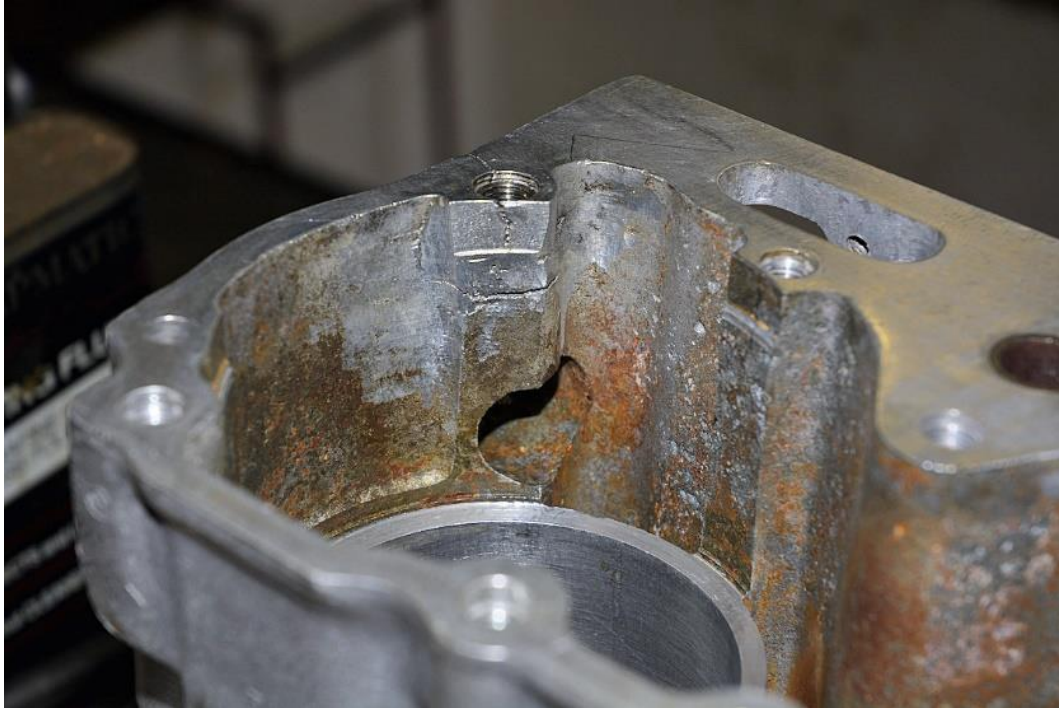
*Above: What we are up against – the part of the right-hand side crankcase-half, which generated the subject of these Technical Notes. In this photo, the horizontal crack was the crack that appeared two days after the cylinder head had been tightened. See Figure 1. The vertical crack aligned with the stud thread reveals a Recoil thread insert, a previous attempt at a thread repair.*

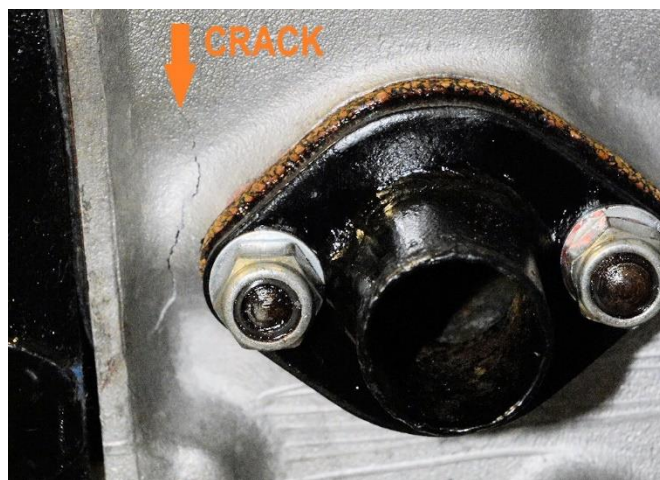
*Right: Figure 1. R.H.S. crankcase cracked. Orange arrow indicates. Engine inverted for dismantling.*

Shown in *Figure 1*, is the crack at the R.H.S. crankcase half that appeared two days after the cylinder head had been tightened in place. The cylinder liner protrusion had been set at 0.008-in. The coolant inlet tube weld assembly had been installed prior to the cylinder head studs' sequence of tightening in three stages. Note that the crack has appeared slightly below of where such cracks usually appear. At the time, this was mystifying.

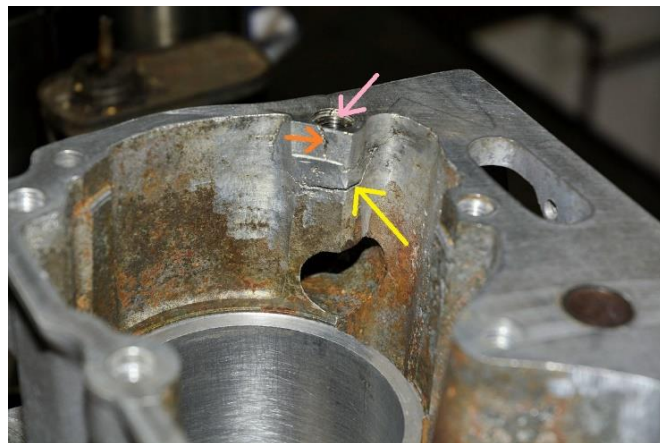
*Right: Figure 2. Coolant jacket detail.*

After the cylinder head was removed, an inspection light showed that damage due to cracking, was a great deal more than expected. *Figure 2* shows the extent of the crack damage, after scale had been cleared, with the yellow arrow indicating the initially visible crack. The orange arrow indicates a further crack aligned with the threaded stud hole. This crack went through both sides of the threaded hole. The pink arrow shows that a Recoil® thread insert had been poorly fitted at some time. A decision was quickly made to completely dismantle the engine so that appropriate repairs could be effected. It was

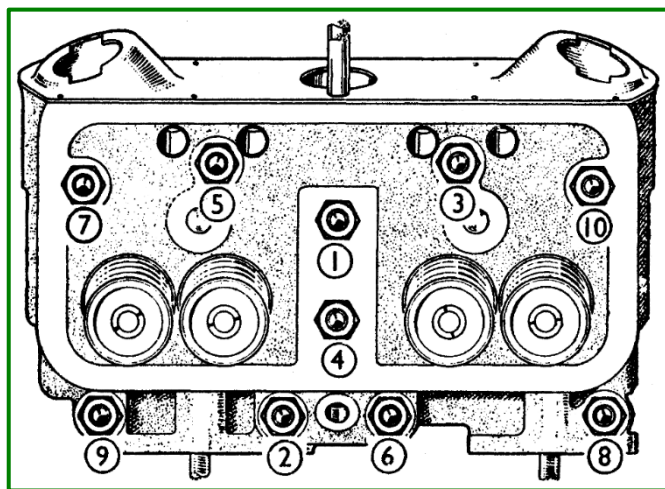
*Right: Figure 3. Cylinder head nut identification.*

The extreme case was where a No. 4 stud finished up well below the outer surface of the nut. In an attempt to resolve this concern, cylinder head stud dimensions were carefully measured and given individual part numbers. The format used was, as per the example: **Part No. 50636-2L** where:

Referring to Figure 3, cylinder head stud Nos. 2, 3, 5, 6, 7, 8, 9 and 10 are the most at risk for concerns should repairs using the Recoil (Helicoil) thread insert method, for the following reasons:

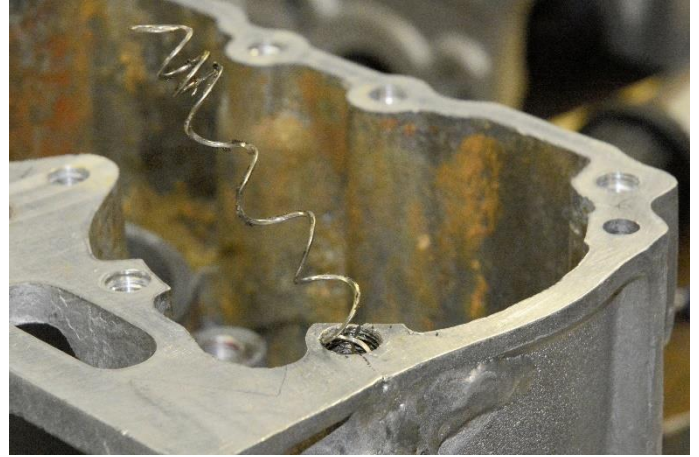
Before taking the R.H.S. crankcase half to a machine shop, the Recoil thread insert had to be removed. This was not at all easy, because there were two Recoil thread inserts, one above the other with the outer insert being out of true position.

*Right: Figure 5. Unwinding a thread insert.*

The stud had been previously installed with Loctite Studloc 263 that had held the stud in place. It was necessary to remove the inserts in case of drama while cutting away the parent metal in preparation for weld build-up. Recoil do make a special tool for insert removal, however, the tool that is suitable for removing a  $\frac{3}{8}$ -in. BSF insert, had to be modified to be able to be used inside the counter-bore in the crankcase which meant that it had to be modified to suit  $\frac{3}{8}$ -in. and lesser sized inserts only. Once modified and a tail end of the insert had been exposed, it was gripped securely with slim pointed self-lock pliers and both were wound out of the crankcase.

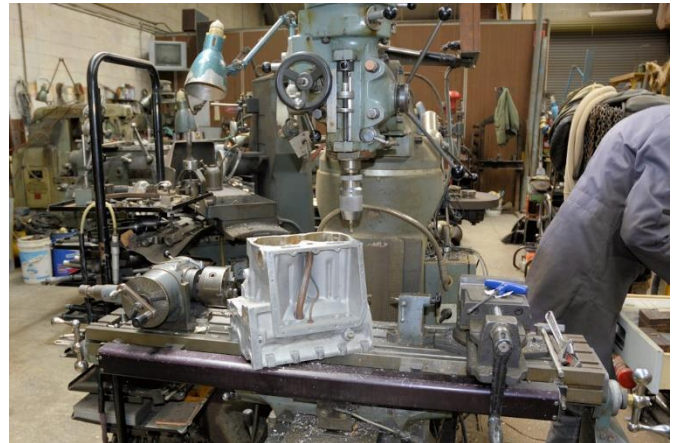
*Right: Figure 6. Setting up the milling machine.*

It was decided that a new boss for the stud should be created with new weld material. The crankcase half was set up on the table of a large milling machine. Once located in position, *Figure 6*, it was clamped in place so that milling away the cracked metal could commence. A large cutter was fed into the affected area until there was clean, original metal.

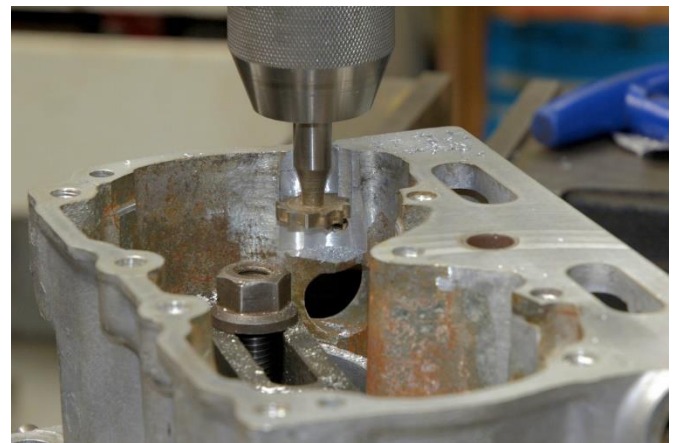
This is where matters became interesting. Located in a portion where the original crack had one end, there was an enclosed chamber, about the size of a small pea, that most likely resulted from the original pouring of the casting. It was probably a starting point for the crack. The gaseous chamber can be seen, to the right of, and above the mill cutter in *Figure 7*, towards the push rod port.

*Right: Figure 7. Cutting away the thread boss.*

As metal was removed, it was observed that the crack (*Figure 1*), had been partially cracked before the external crack appeared. The yellow arrow in *Figure 2*, shows the crack and while machining the area, it was found that there was scale inside the crack with clean aluminium towards the outer part of the crack. The crankcase had been stressed prior to our work commencing on the engine. In addition to this concern, the crankcase set had been extensively weld repaired.

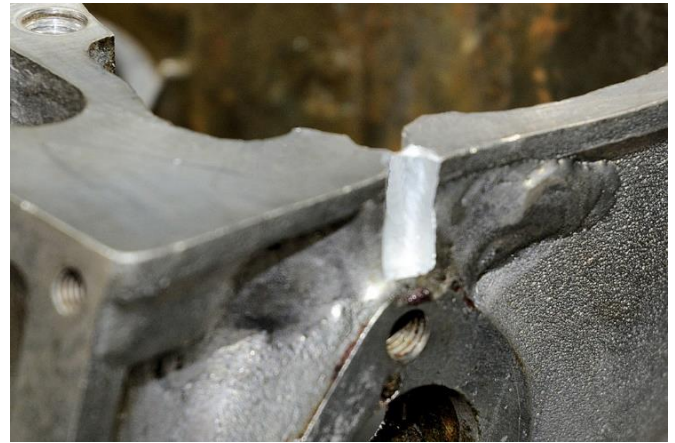
*Right: Figure 8. Unsuccessful weld grooved out.*

After the welding task had been completed, the crank-case half was again set up on the milling machine table and a fly-cutter was used to machine the clearance diameter recess for the outer lip of the cylinder liner. Then the rest of the excess weld material was machined so that the liner could be seated in its bore in the crankcase half. Once this operation was completed, the mill table was positioned so that, after fitting the cylinder head on four studs and tightening down, a drilling jig sleeve could be inserted to guide the tapping size drill.
