# TECHNICAL NOTES SERIES

JOWETT JAVELIN – PA, PB, PC, PD & PE  
JOWETT JUPITER – SA & SC

## – PART XIII – CRANKCASE STUDS CYLINDER LINER INSTALLATION CYLINDER HEAD GASKET INSTALLATION ENGINE COOLANT MAINTENANCE CYLINDER HEAD GASKET EXPERIENCES

*Compiled by Mike Allfrey – 29<sup>th</sup> January, 2006.  
With assistance from Neil Moore, JCC (NZ).  
Revised – February, 2024.*

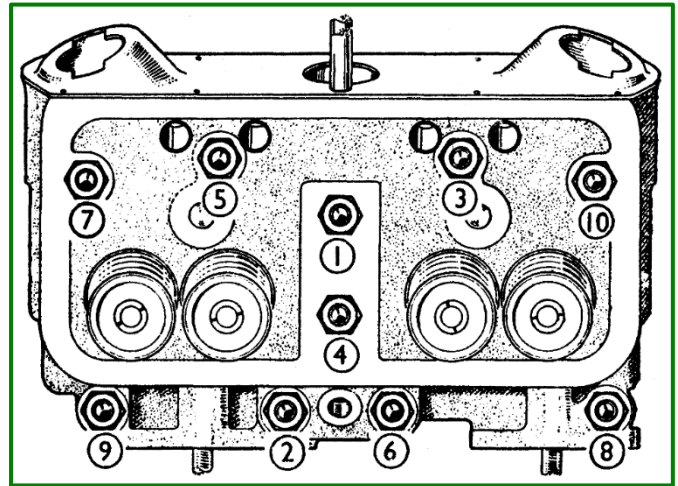
*Right: Figure 1. Cylinder head stud identification.*

All but one of the cylinder head studs (for each head) tighten against their thread shoulder and do not bottom in the crankcase threaded holes. The one exception where a cylinder head stud is not threaded fully into the crankcase is the stud, described as No. 1 in the cylinder head tightening sequence, which carries lubricating oil to the rocker shaft assembly. This stud has been designed to bottom in the threaded hole and form a seal at the flared copper oil delivery pipe, against counter bores in the crankcase set. Typically, this stud does not screw very far into the crankcase, which raises a concern.

In the Maintenance Manual there is no mention of caution where this stud is concerned. During the installation of the cylinder head, use a packing spacer on the oil feed stud, to achieve even clamping of the gasket, but do not tighten No. 1 stud nut further than 25 lb. ft. – prior to installing the rocker shaft banjo nut with an open ended spanner. This stud has been drilled and relieved along its shank to provide oil passage, it is also not threaded very far into the crankcase, and for these reasons, the specified 35 – 37 lb. ft. torque should not be applied to this stud.

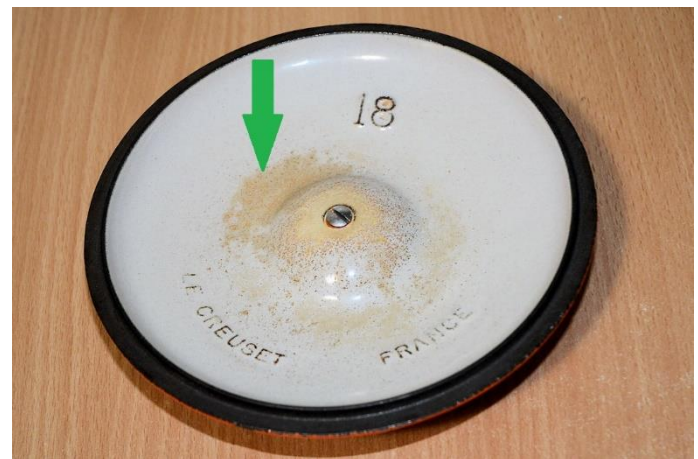
When the cars were built, no one considered that, in over sixty years time, the cars would be preserved and still in use. Hence no mention of the importance of using soft water and a corrosion inhibitor to protect against cavitation erosion and electrolytic corrosion, due to the use of dissimilar metals to make up the cooling system – i.e. cast iron, steel, aluminium, brass, copper and solder (lead and tin). Water, depending on its chemical make-up, when in contact with these different metals, can be the instigator of electrolytic corrosion, particularly when cast iron and aluminium are in close proximity to each other.

*Right: Figure 2. The green arrow indicates the area where cavitation erosion has occurred on the inside surface of a cast iron enamelled saucepan lid. This is an example of what is happening inside an engine, if unprotected.*

There is a very simple solution to this problem. It is a maintenance programme which ensures that the engine cooling system is filled, and maintained, with a good quality corrosion inhibitor such as Tectaloy *Xtra Cool Gold*. One litre of this product will make-up fifteen litres of coolant. It is suitable for three years use in the cooling system. Another approach is to use coolant made-up from 10% Ford R1-3B corrosion inhibitor and 90% soft water or, use a brand of inhibitor that meets AS 2108-1977 and contains 18% ethylene glycol. If antifreeze is required the make-up should be 50% Castrol Antifreeze/Anti-boil Concentrate (Ethylene Glycol 95% mass, to AS 2108-84) and 50% **soft** water.

The cooling system **must** be drained, flushed and filled with a fresh mix of corrosion inhibitor or antifreeze at two or three year intervals. Top-up coolant must be pre-mixed as indicated above. Use corrosion inhibitor when temperature does not drop below 0 °C. Remember the 'cold night chill factor' when making a decision.

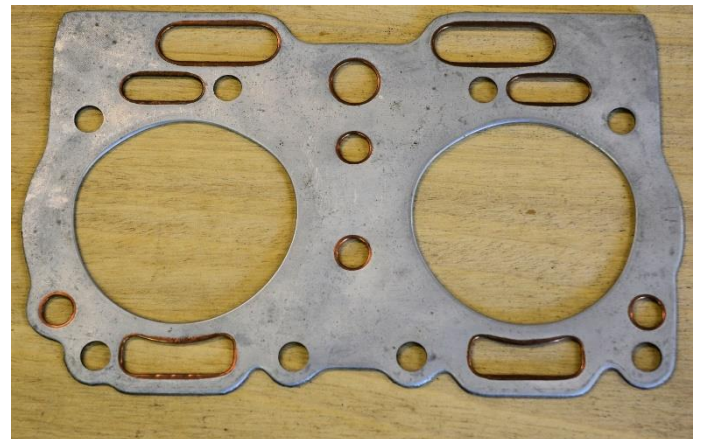
*Right: Figure 7. The steel face of the UK sourced cylinder head gasket, from Bill Lock (UK).*

Referring to *Figure 7*. Again there is uniform swage-over at both liner lip clamp areas. *Figures*

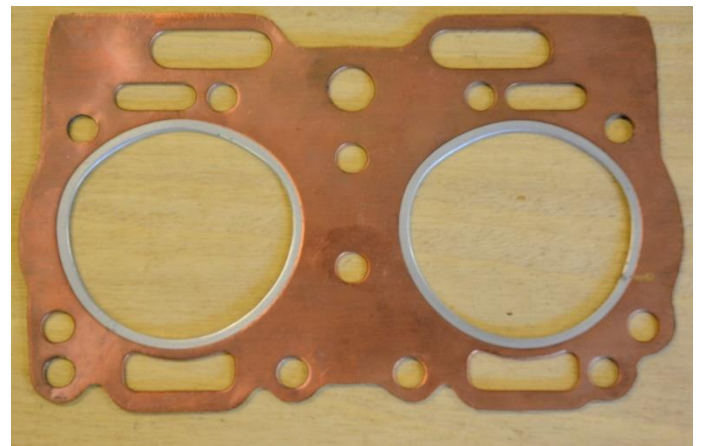
Referring to *Figure 8*. This gasket does look impressive with even swage-overs at the cylinder liner clamp areas.

*Right: Figure 8. The copper sheet face of the gasket in Figure 7.*

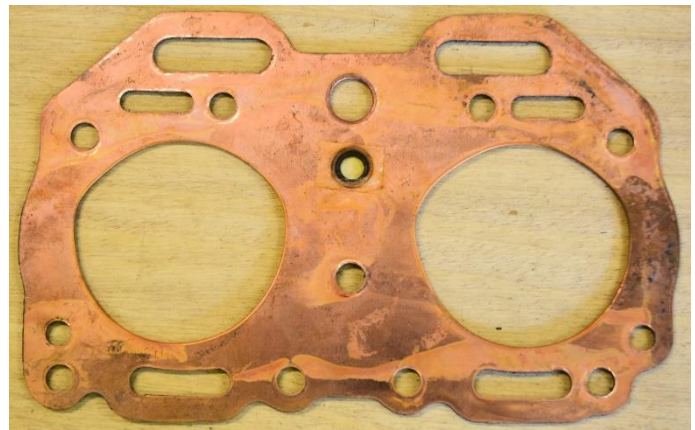
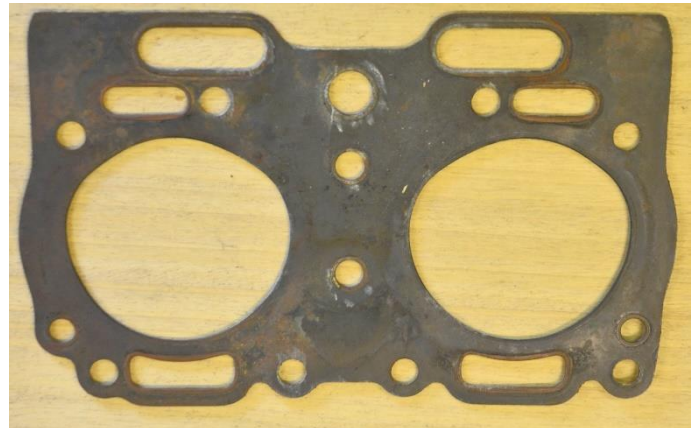
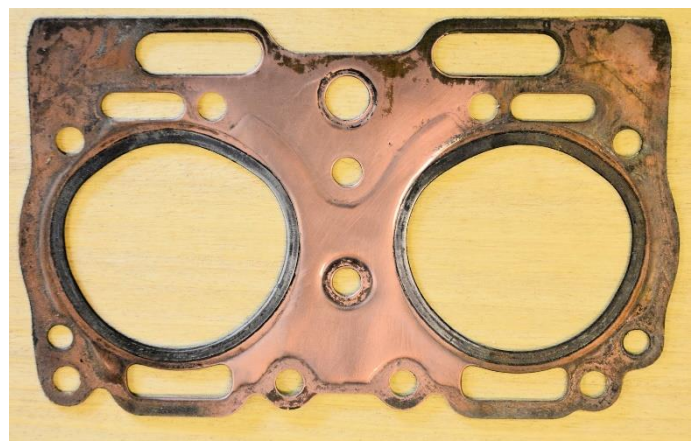
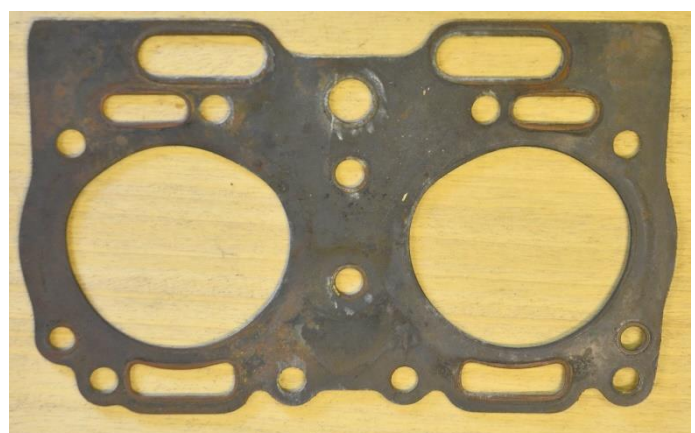
9 and 10 show a gasket that has, in the past, proved itself to be reliable. This is the New Zealand made gasket, its construction shows that the cylinder head contact surface is 'open', meaning that the compressible material does not form the middle of a sandwich construction. One aspect that is a bit surprising, is the yellow sticker, that secures a supplied 'O' ring at stud No. 1, in nearly every case, the action of peeling the sticker away from the fibrous material has removed a small amount of that material. This concern does not seem to affect the sealing ability of the gasket.

*Right: Figure 9. The crankcase face of gasket shown in Figure 10.*

Note how the cylinder liner lip has left its mark out-board of the steel sheet swage-overs. There is also evidence of the head gasket support having done its job, and the crankcase having evenly nipped around the periphery of this gasket. It is possible that this gasket has been kept for a long time, in which case, the steel portion has survived remarkably well.

*Right: Figure 12. The steel sheet face of the gasket shown in Figure 11.*

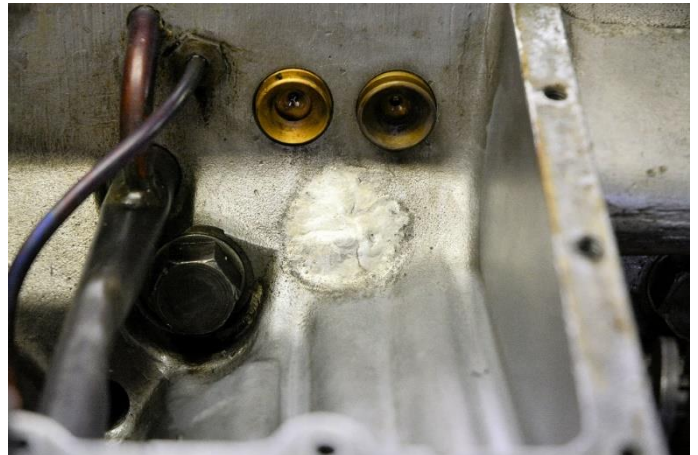
The tappet chest cover was removed to check for possible cracks through to the coolant area. None were obvious, however, it did appear to us that cracking is present at the two weld repairs inside the tappet chest. This became noticeable after cleansing the areas with degreasing fluid prior to photographs being taken.

*Right: Figure 13. The weld repair after the No. 3 connecting rod broke. There was similar welding adjacent to No. 1 cylinder.*

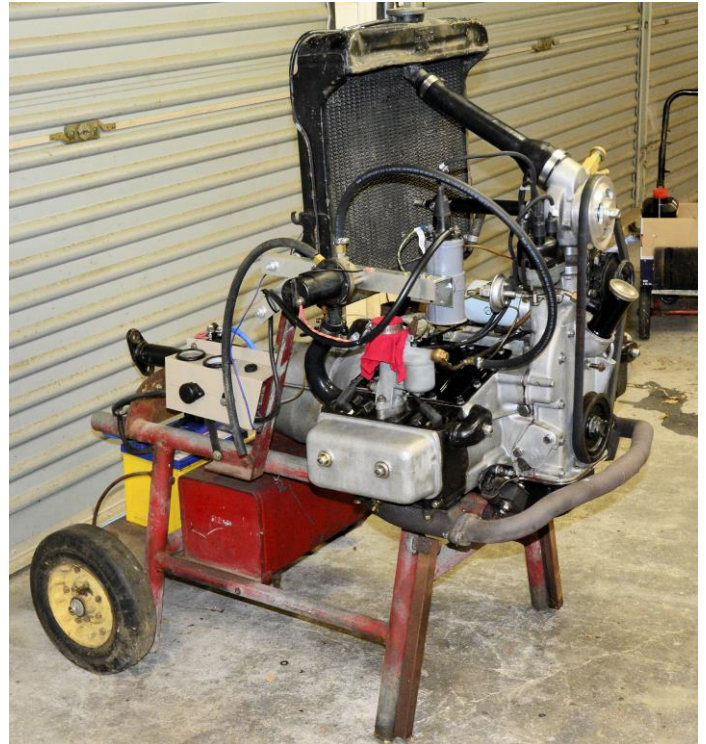
*Right: Figure 16. The Javelin engine on the club's test rig.*

The tappet chest was fitted with a new gasket and the valve clearances were adjusted. The engine was filled with coolant, started and run at a brisk idle till warmed through. Then it was switched off and allowed to normalise for twenty minutes, before checking the cylinder head nuts again. No. 7 nut felt good and solid which means that our repair could well be successful.
