TECHNICAL NOTES SERIES

JOWETT JAVELIN – PA, PB, PC, PD & PE JOWETT JUPITER – SA & SC

– PART XII –

ENGINE CRANKCASE REPAIR TECHNIQUES

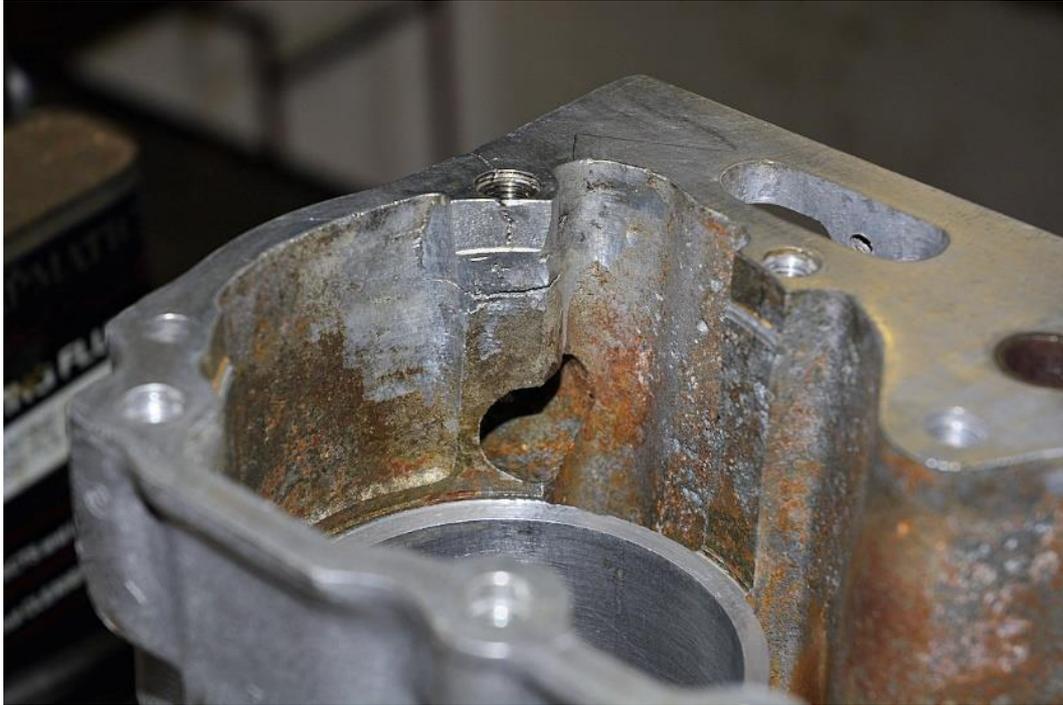
Above: The part of the right-hand side crankcase-half, which generated the subject of these Technical Notes. In this photo, the horizontal crack was the crack that appeared two days after the cylinder head had been tightened. See Figure 1. The vertical crack aligned with the stud thread reveals a Recoil thread insert, a previous attempt at a thread repair.

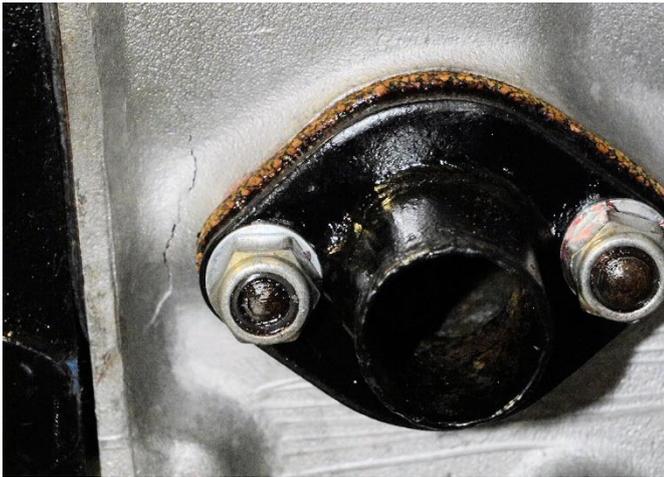
Figure 1.

Shown in *Figure 1*, left above, is the crack at the RHS crankcase half that appeared two days after the cylinder head had been tightened in place. Note that the coolant inlet tube weld assembly had been installed prior to the cylinder head studs' sequence of tightening in three stages. Also, note that the crack has appeared slightly outboard of where such cracks usually appear. At the time, this was mystifying.

First, an attempt was made to carry out a repair, with the cylinder head remaining in place. The crack, as revealed externally, was grooved out and the repair weld gave the impression that the welded area was sound. This was not so, because as soon as coolant water was poured into the radiator, there was a cascade of leaking water at the cylinder head gasket area close to where welding had been carried out.

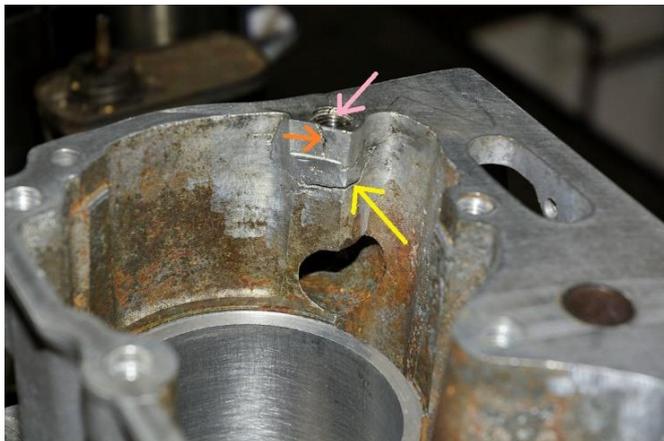
Figure 2.

After the cylinder head was removed, inspection showed that damage due to cracking, was a great deal more than expected. *Figure 2* shows the extent of the crack damage, with the yellow arrow indicating the initially visible crack. The orange arrow indicates a further crack aligned with the threaded stud hole. This crack was through both sides of the threaded hole. The pink arrow shows that a Recoil® thread insert had been fitted at some time. A decision was quickly made to completely dismantle the engine so that appropriate repairs could be effected. It was decided to make an entirely fresh start.

Before any repair work could commence, a set of new cylinder head studs were machined from stainless steel

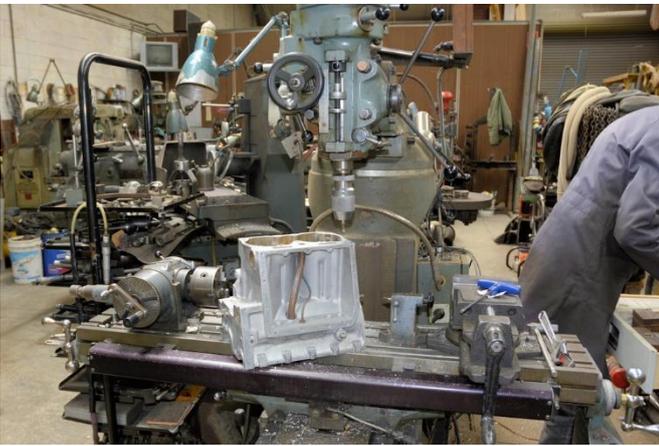
Figure 5.

The crankcase half was set up on the table of a large milling machine. Once located in position, *Figure 5*, it was clamped in place so that milling away the cracked metal could commence. A large cutter was fed into the affected area until there was clean, original metal.

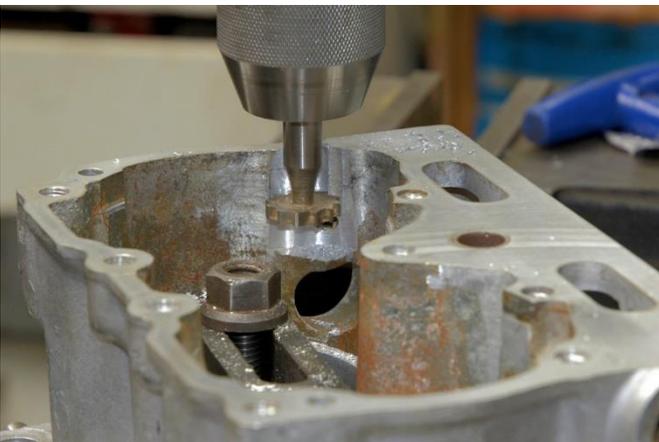
Figure 6.

This is where matters became interesting. In a portion where the original crack had one end, there was an enclosed chamber, about the size of a small pea, that most likely resulted from the original pouring of the casting. It was probably a starting point for the crack. The gaseous chamber can be seen, to the right of, and above the mill cutter in *Figure 6*, towards the push rod port.

Parent metal was carefully removed with different shaped mill cutters, until there was only clean metal for the weld repair activity.

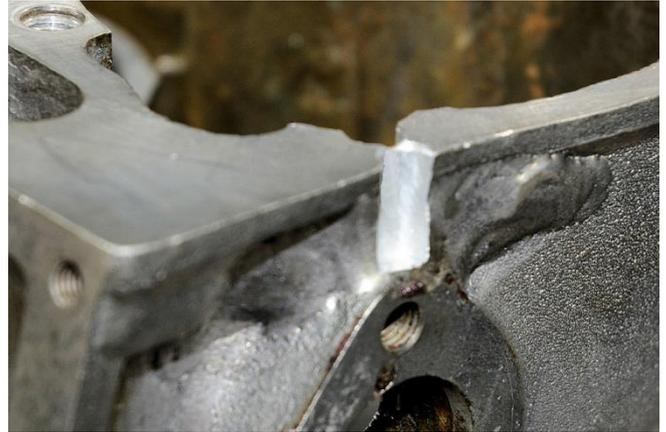
Figure 7.

Once the inside of the coolant jacket wall had been cleaned up, attention was concentrated on the crack where it was revealed at the outside the crankcase. The material was cut away from the original, unsuccessful, weld repair along the threaded hole, see *Figure 7*.

Once the weld preparation had been completed, the weld material was laid down larger than was strictly necessary, to allow machining for the cylinder liner and its lip to pass through and into the home position.

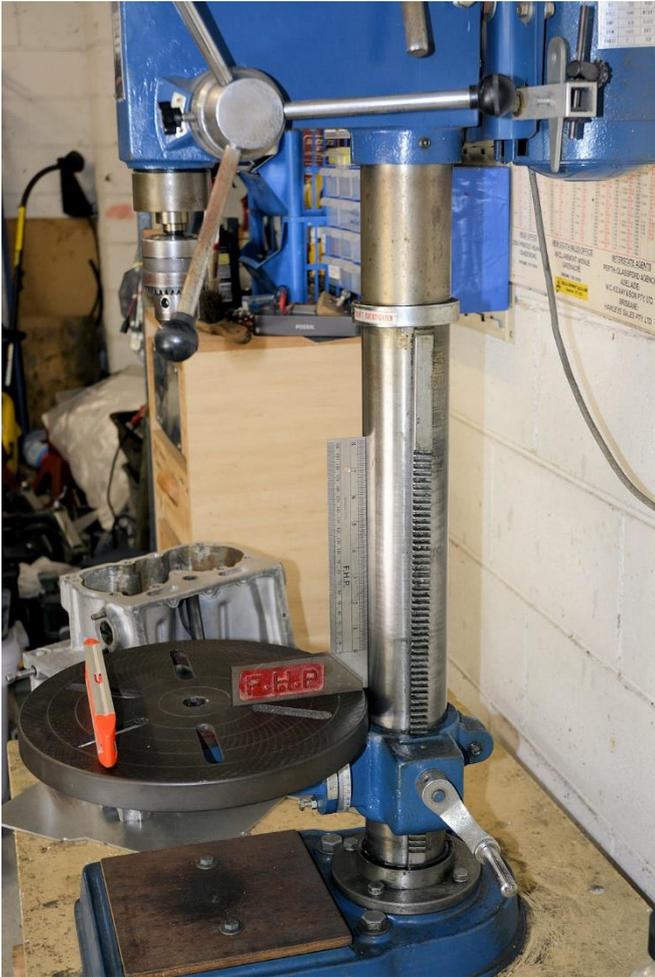
Figure 8.

The plan, initially, was to carry out the modification in the home workshop. This required a degree of patient work for preparing for the deep drilling operation. First of all, the bench drill had to be accurately set up so that the table was in a level plane and at right angles to the drilling machine's post. The table face required a degree of adjustment. The arm assembly for the table features an adjustable $\frac{1}{2}$ " locking bolt so that the level can be set. In the lower face of the arm there is a $\frac{1}{4}$ " adjustable setscrew that facilitates the adjustment for true square, i.e. a try square sitting on the table and positioned on the table, so the drill's pedestal pillar is at exact right angles to the table – in both planes. See *Figure 8*. The set-up

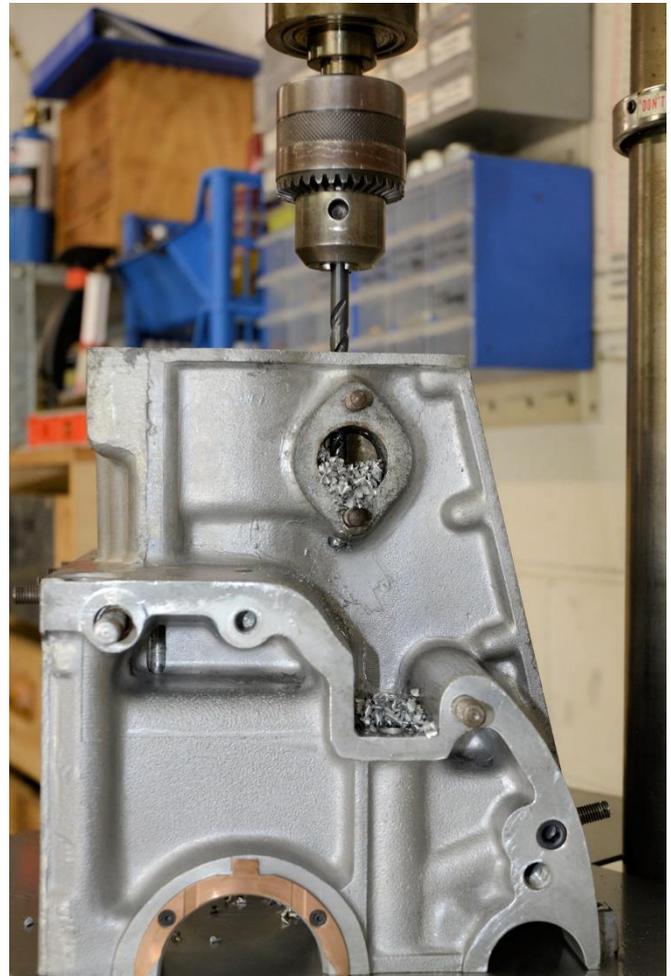
Figure 9.

After the 8 mm diameter drill bit breaks through into the coolant inlet port, as shown in *Figure 9*, great care must be taken while feeding the drill into the far side of the port. Very gently apply enough feed pressure to allow the drill bit to establish a round hole in the parent metal. Once the drill bit is established and is making a clean cut, continue drilling until it breaks through the side of the coolant inlet flange. The reason for allowing the hole to break through, is to permit thorough cleaning away of

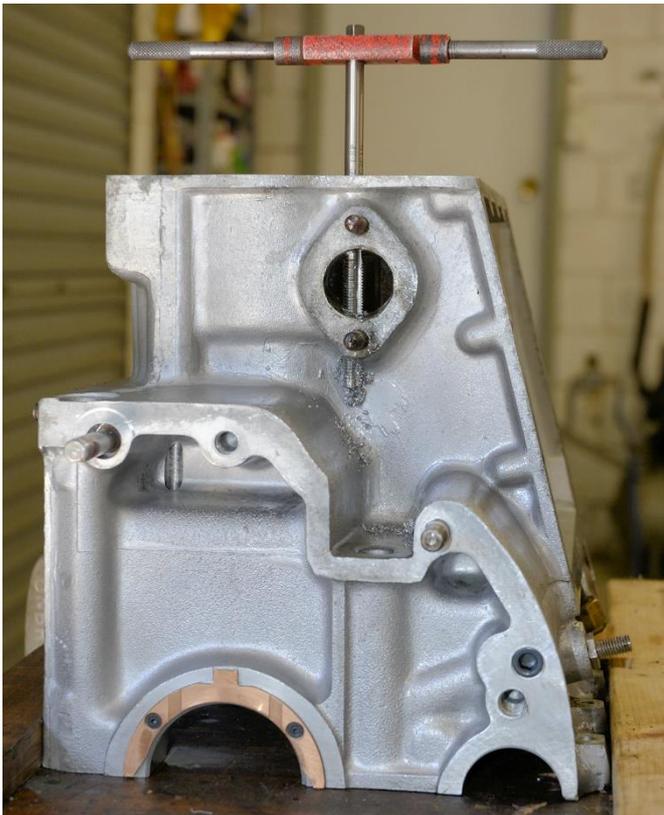
Figure 10.

Figure 10, shows the long series tap being used to cut the $\frac{3}{8}$ " BSF thread into the far side of the coolant port. Note that the thread of the tap is still engaged with the outer portion of the crankcase, thus forming a continuous thread for the studs to follow into their home position.

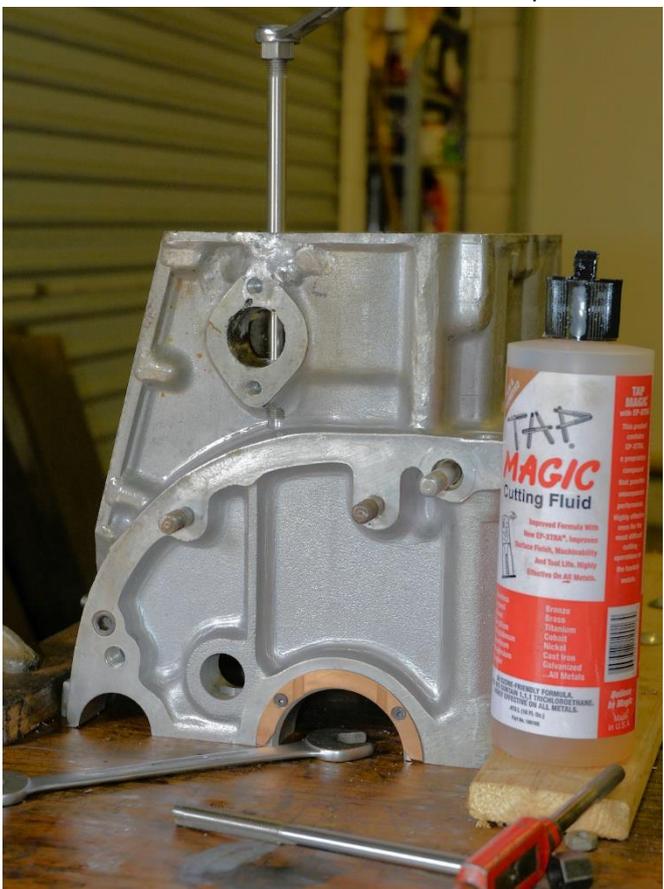
Figure 11.

Figure 11, shows a stud being installed. This was a very satisfying experience.

These extended studs will be final-installed using Loctite 518 as the sealant/retainer to prevent coolant migration. Once the studs are installed, excess Loctite 518 should be wiped away with a rag soaked in methylated spirits, the end of the stud, where it protrudes, can then be sealed with a covering formed from Permatex Cold Weld. The exclusion of air from the area will allow the Loctite 518 to properly cure for perfect sealing and stud retention.
