# TECHNICAL NOTES SERIES

## JOWETT JAVELIN – PA, PB, PC, PD & PE JOWETT JUPITER – SA & SC

## PART XXVIII – GEARBOX OIL LEAKS

*Compiled by Mike Allfrey – January, 2007.*

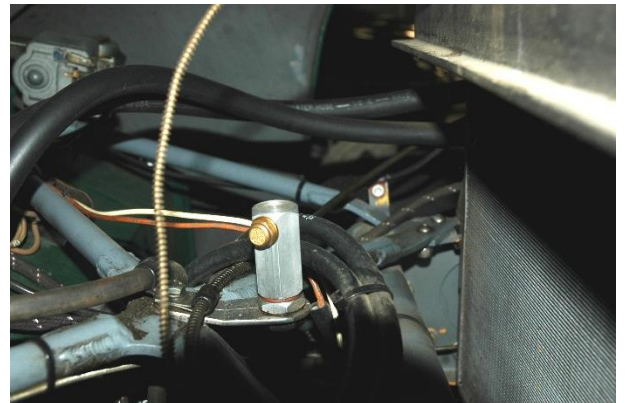
This system, due to the frequency of filling, works well and the breather filter is washed and dried once a year, to ensure there is no blockage due to oil vapour attracting dust. *The breather is shown at right, located in tall filler cap.*

The Jowett designed gearbox breathing system is rather tortuous and, if a home made gasket is installed, can easily be blocked-off completely. With old age having crept up on me, it was decided to install a remote oil filler. This took the form of a hose barb being inserted in the drilled and tapped original filler cap, a hose with an 8 mm bore was attached and routed up to the St Andrew's cross firewall to chassis brace in the centre. A capped fitting was machined from aluminium hexagon bar, with a brass barb for the oil bottle tube so that mess-free oil filling could take place. Into the side of the fitting, a hydraulic breather filter was screwed in. The cap is sealed to the fitting with a fibre washer.

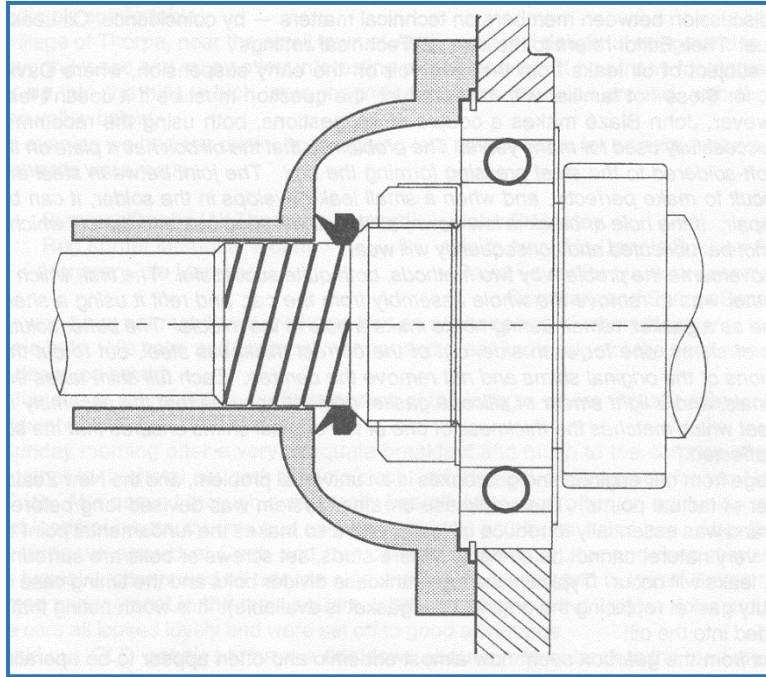
Figure 2. Drawing of Forsheda type seal installation.  
NOT TO SCALE

Some time ago, I read about John Blazé's modification to the clutch shaft (first motion shaft), using a flexible face lip seal of the Forsheda type. See Figure 2, Page 7. The modification involved machining of the brass clutch shaft cover, Part Number 50007 or J50007, inside the bell for the seal lip to run on. The depth of the machining was calculated to provide 2 mm 'crush' at the seal lip. This amount of crush was determined in discussion with the seal supplier. The machining data was as follows:

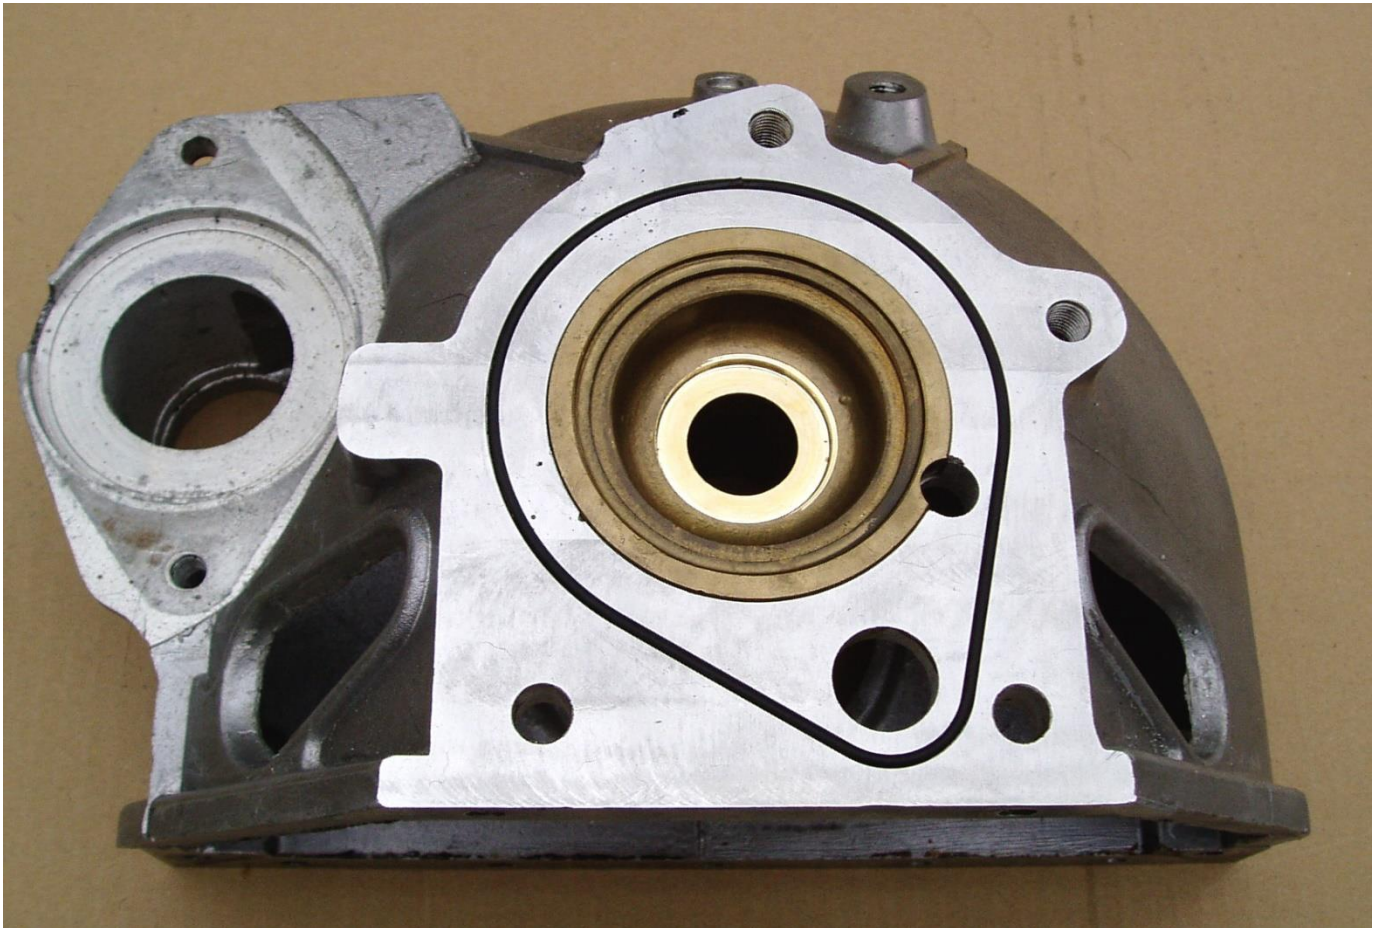
Figure 3. Showing filled breather tract, filled clutch lever pivot hole and 'O' ring cord.  
Also illustrates the machined surface for the Forsheda type seal.

8. Machine into the joint surface an 'O' ring groove. The width of the groove is 0.110" (2.90 mm) wide and is 0.090" (2.20 mm) deep to accept an 'O' ring formed from 2.5 mm diameter 'O' ring cord. The groove will be pear shaped to encompass the clutch shaft cover recess, the RHS throw-out bearing lever pivot and the gearbox layshaft spigot opening. See accompanying photograph, Figure 3 on Page 7. Total length of the groove is free, because of the use of 2.50 mm 'O' ring cord.

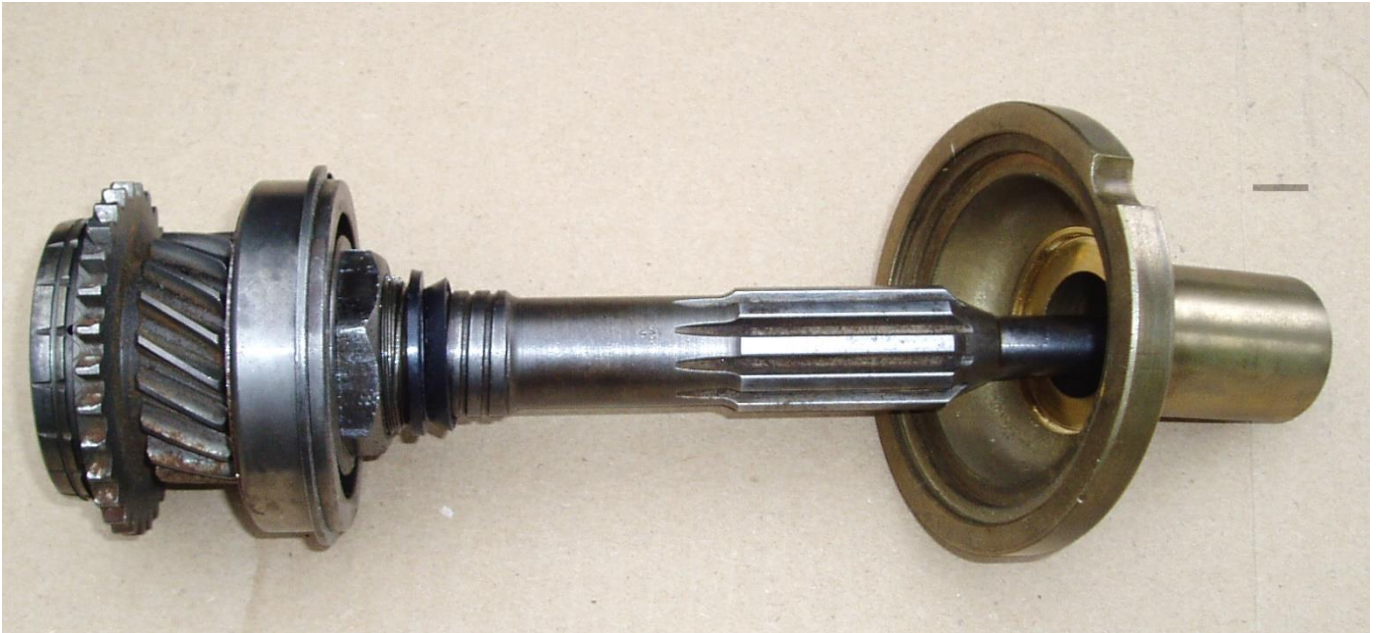
*Figure 4. Illustrates the installation of the Forsheda type seal on the first motion shaft.*

11. After making sure that the clutch shaft bearing securing nut is absolutely tight, install the Forsheda seal with a bead of Loctite Blue RTV (Part Number 34248) to fill the oil scroll groove in the shaft.

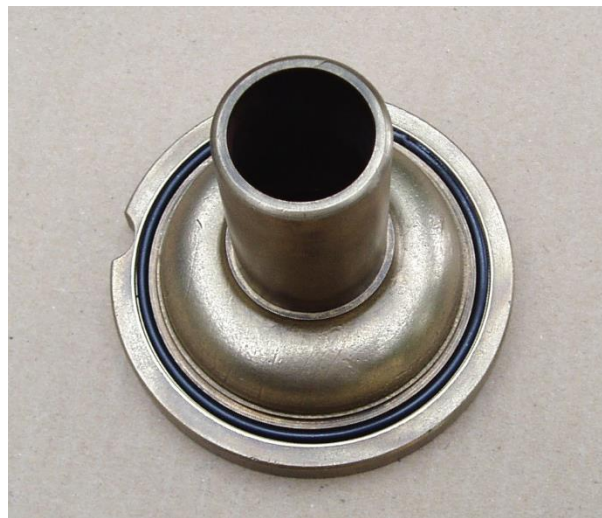
*Figure 5. Illustrates the 'O' ring installed in groove.*

10. The 'O' ring cord should be cut squarely to length so that, when installed in the grooves, it will not fall out during the assembly process. Butt join the ends of the cord using Loctite 406 Instant Adhesive. After adhesive has fully cured, carefully shave off with a sharp blade, excess adhesive residue. The prepared joint must be seamless, so that when the 'O' ring is compressed, an oil tight joint is formed.
