# TECHNICAL NOTES SERIES

## JOWETT JAVELIN – PA, PB, PC, PD & PE JOWETT JUPITER – SA & SC

## PART VIII – THE CRANKCASE SET

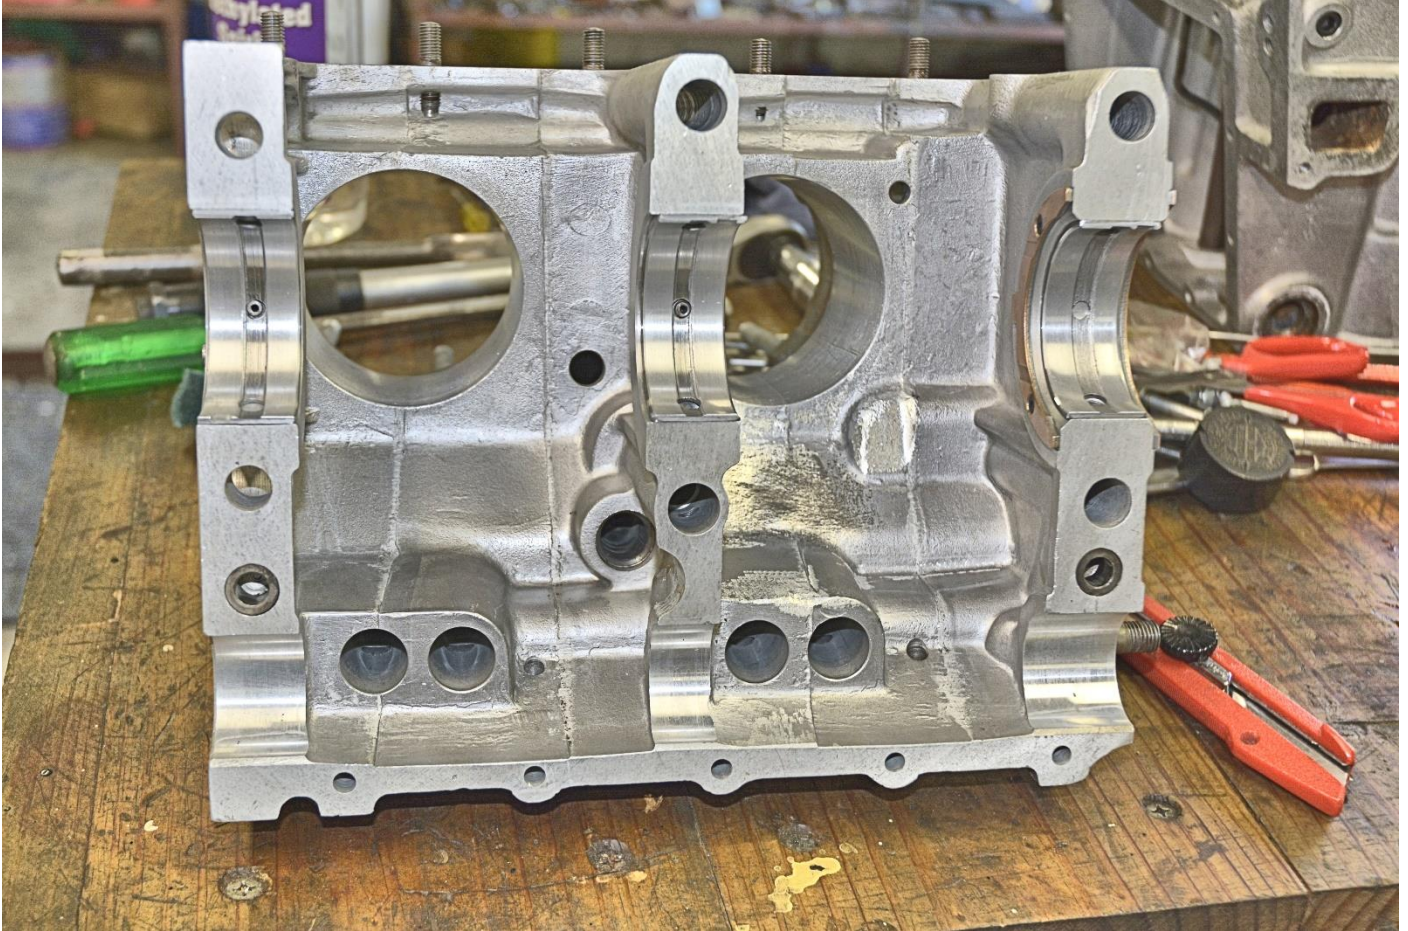
*A L.H.S. crankcase half showing use of Perkins bearing shells and separate thrust bearings.*

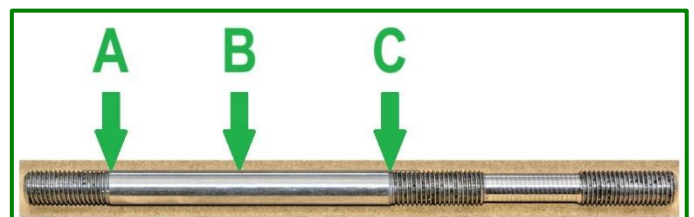
It has to be understood that all studs that are threaded into the crankcase, and other components, have a purpose designed length of thread that can be screwed into position during engine assembly. As an example, refer to *Figure 1*, the cylinder head studs have a longer threaded portion for extra strength when they are tightened into the aluminium crankcase. Any repair of a stripped crankcase thread needs to take this point firmly into consideration. When the crankcase was designed, the depth of useable thread was carefully calculated to ensure that the stud tightened against its shank, **B** *Figure 4*, not at the inner end of the thread in the crankcase. In other words, the stud must not 'bottom' in the threaded hole. In this installation, the stud shank must seat in the counterbore provided. All of this requires due consideration prior to repairing a stripped thread.

*Right: Figure 1. Showing a cylinder head stud where: 'A' = End of thread for cylinder head nut; 'B' = Stud shank; 'C' = Point where stud shank is seated in crankcase counterbore after tightening.*

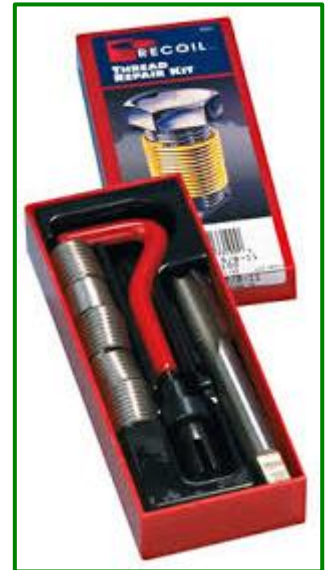
*Right: Figure 2. Example of Recoil thread repair kit.*

Stripped threads in the aluminium crankcase can be repaired by using Recoil kits specially designed to suit BSF threads. Extra thread inserts can be purchased separately. There are two lengths of insert coils available over the counter. It is possible that the Jowett Car Club of Australia can negotiate with the company to have thread insert coils manufactured to suit the length of the original threads in the crankcase. The Recoil kits are available from CBC Australia, or an engineer's supplier store.

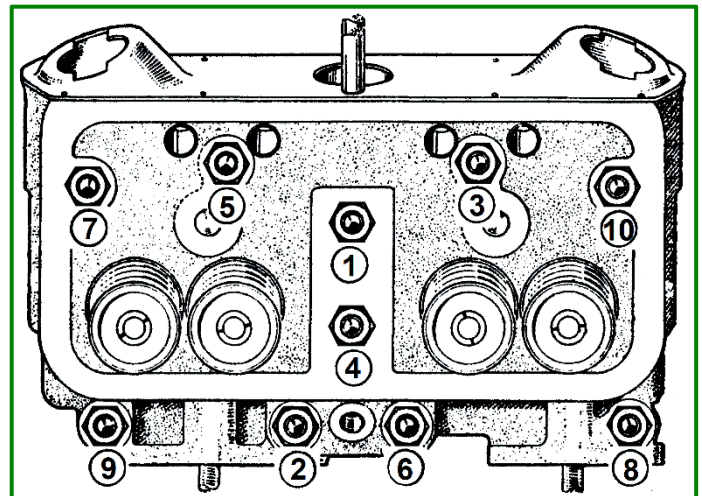
*Right: Figure 3. Cylinder head nut sequence.*

2. Some kits contain a drill bit to drill out any remaining thread in the hole. This the required tap size and should just reach the bottom of the original drilling. It should be noted that at stud numbers 3, 5, 7 (front L.H.S.) and 10 (front R.H.S.) the drilled depth is very close to breaking into the tappet chest. Refer to Figure 3, for cylinder head stud identification.
