# TECHNICAL NOTES SERIES

**JOWETT JAVELIN – PA, PB, PC, PD & PE  
JOWETT JUPITER – SA & SC**

## **PART XV – REAR TIMING COVER GASKET**

*Compiled by Mike Allfrey – January, 2006.  
Revised – February, 2024.*

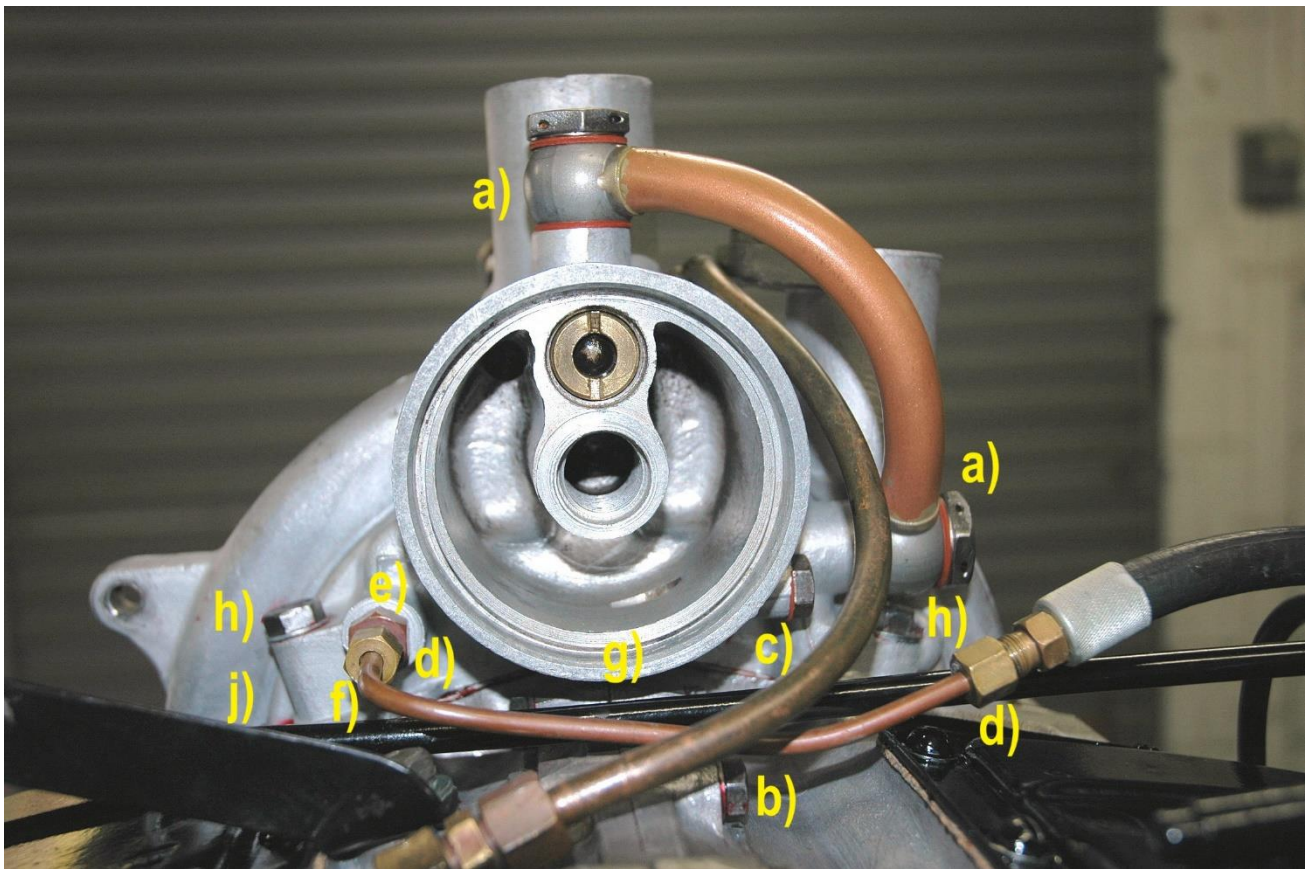
The engine for Javelin and Jupiter motor cars has an unfair reputation for leaking oil from the gasket between the rear timing case cover (also known as the oil filter housing) and the crankcase. There can be cases where oil may not be leaking from this gasket. Before taking any action, check the following potential oil leakage areas, refer to *Figure 1*:

- a) With respect to later series engines, the banjo fittings for the oil cooler hoses (or side transfer pipe) could leak at their fibre washers. It is best to cure leaks here by using 16 mm Dowty hydraulic type sealing washers. These washers have a flexible seal bonded to their inner diameter.
- b) The five ¼-in. BSF bolts along the top of the crankcase joint can leak oil. Often, one half of the crankcase set has the bolt holes breaking through the bottom of the face joint. Hot oil can migrate from here along the bolt and out through the split in the spring washer. An effective repair is to use close tolerance flat washers at both sides in conjunction with Loctite 518 Master Gasket and Nyloc nuts.
- c) The oil filter drain bolt fibre washer could be leaking. This washer tends to be neglected, and should be replaced with an 8 mm Dowty hydraulic washer.

*Above: Figure 1. Potential oil leaks other than the rear timing case cover gasket.*

- d) The oil pressure gauge hose connector can leak at the thread in the housing. This can be repaired by cleaning the threads with Loctite 7471 Cleaner/Activator fluid and applying a drop of Loctite 569 Thread Sealant before assembling the connector.

- e) Check that the oil pressure pipe boss has not been split. Due to over-tightening the union.
- f) At the copper pipe olive at the pipe union. In bad cases, the pipe should be renewed.

- g) The oil filter's canister sealing ring. This source of leakage can be fixed by installing a 'spin-on' oil filter conversion kit.
- h) The two  $\frac{5}{16}$ -in. BSF bolts that clamp the rear timing cover to the crankcase. These bolts should not be tightened further in an attempt to cure a leak. They should be removed, cleaned and installed using flat washers in place of the spring washers. Use a smear of Loctite 518 Master Gasket under the washers and on the bolt shanks.

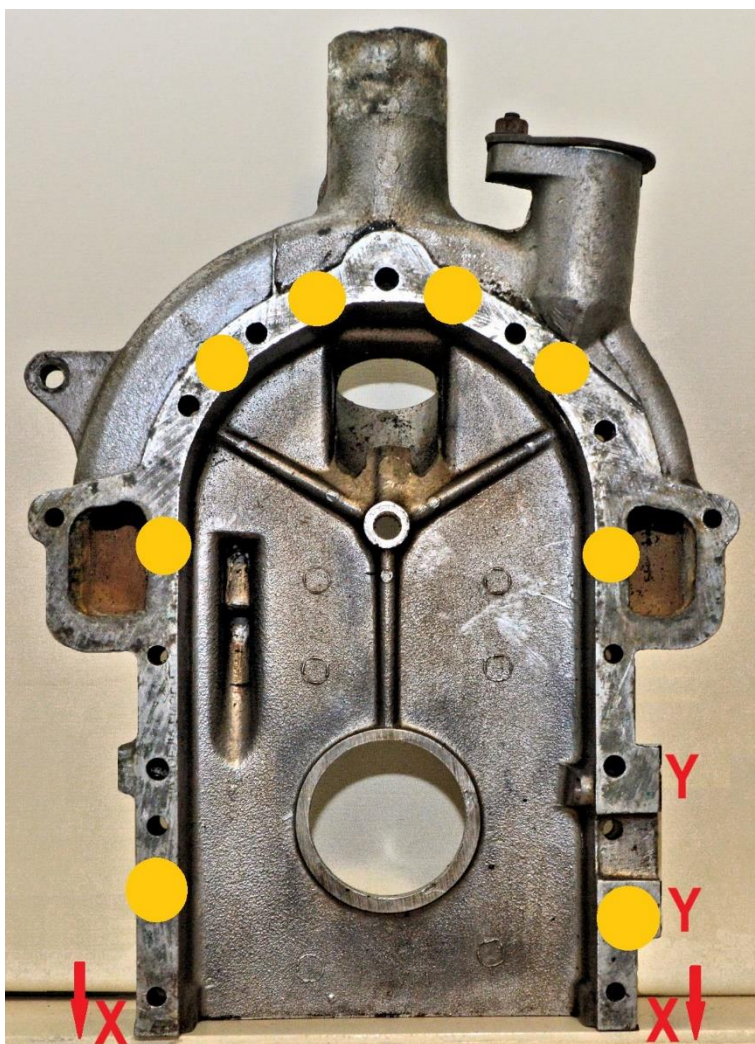
*Right: Figure 2. A suitably scungy front timing cover, viewed from the rear. The gold dots represent pieces of brass shim stock. Ensure that the shims at the second row down do not interfere with the gasket to be fitted. Red 'X' and arrow are where front timing cover gasket sticks out towards the sump gasket. Red 'Y' shows where the front timing cover gasket sticks out towards the petrol pump gasket.*

2. Remove the oil filter canister.
3. The front timing cover, less its gasket, should then be bolted to the crankcase – with 0.005-in. (0.127 mm) shim stock pieces placed between the front cover and the crankcase face to provide a gap for the

rear timing cover gasket to protrude, tighten the bolts. The shim stock can be temporarily adhered with a smear of light grease.

An alternative is to use eight off 0.005-in. (0.127 mm) thick  $\frac{1}{4}$ -in. shim washers at the timing cover bolts. After use, place the shims in safe storage for future use.

The purpose of the shim stock (washers) is to hold the front timing cover 0.005-in. forward of the crankcase face. This ensures that the gasket's front edge protrudes by the correct amount.

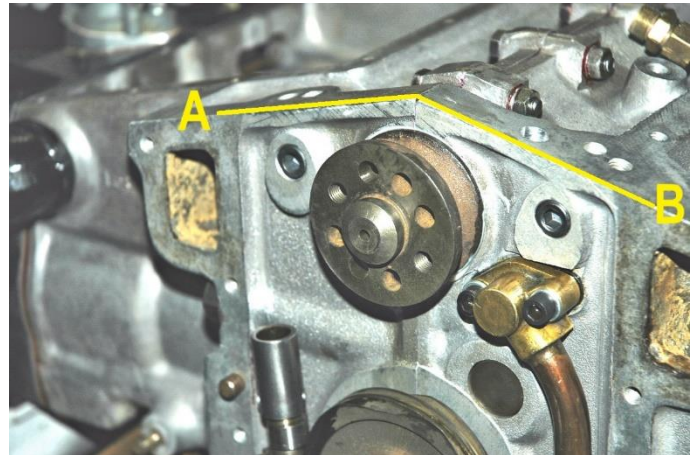
*Right: Figure 3. The yellow line 'A' to 'B' shows where the gasket must stick out 0.005-in. after the rear timing case cover has been bolted in its final position.*

5. The gasket, Part No. 50692 or J54688, should also be cleaned in the same manner as the other parts. It is well worth checking that the front edge of the gasket can protrude forward of the rear timing cover (refer to Figures 3 and 4) and the crankcase face by at least 0.005-in. with the hold down bolts easily passing through their holes in the gasket. This is necessary to ensure that there is an oil tight seal at the front timing cover gasket.

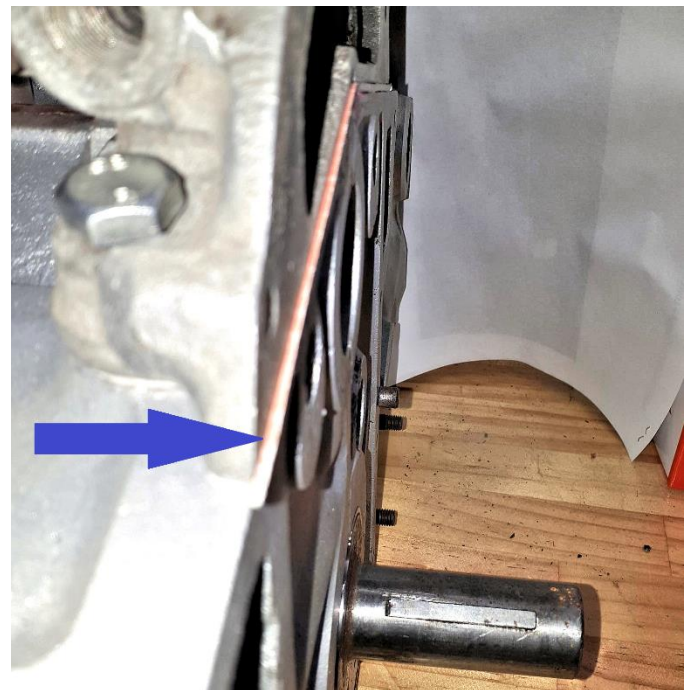
*Right: Figure 4. The pink portion indicated by the blue arrow is the gasket protruding forward of the front crankcase face.*

*Here it is exaggerated for illustrative purposes.*
