# TECHNICAL NOTES SERIES

## JOWETT JAVELIN – PA, PB, PC, PD & PE JOWETT JUPITER – SA & SC

## PART XXIV – GEARBOX OIL LEAKS

*Compiled by Mike Allfrey – January, 2007.  
Revised – February, 2024.*

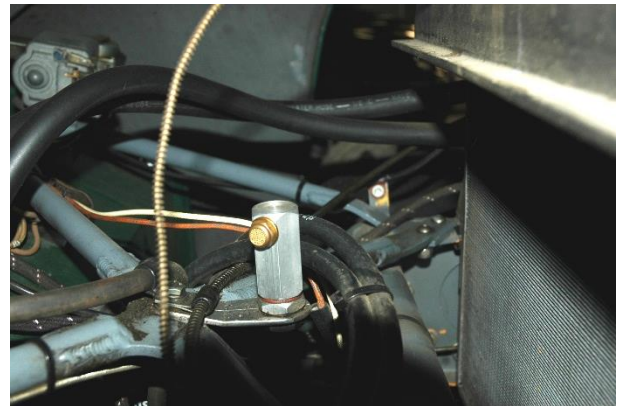
*Right: Figure 1. The breather is shown, located in tall oil filler cap.*

A capped fitting was machined from aluminium hexagon bar, with a brass barb for the oil bottle tube so that mess-free oil filling could take place. Into the side of the cap, a hydraulic breather filter was screwed in. The cap is sealed at the fitting with a fibre washer.

This system, due to the frequency of filling, works well and the breather filter is washed and dried once a year, to ensure there is no blockage due to oil vapour attracting dust.

The Jowett designed gearbox breathing system is rather tortuous and, if a home made gasket is installed, can easily be blocked-off completely. With old age having crept up on me, it was decided to install a remote oil filler. This took the form of a hose barb being inserted in the drilled and tapped original filler cap, a hose with an 8 mm bore was attached and routed up to the St. Andrew's cross firewall to chassis brace in the centre.

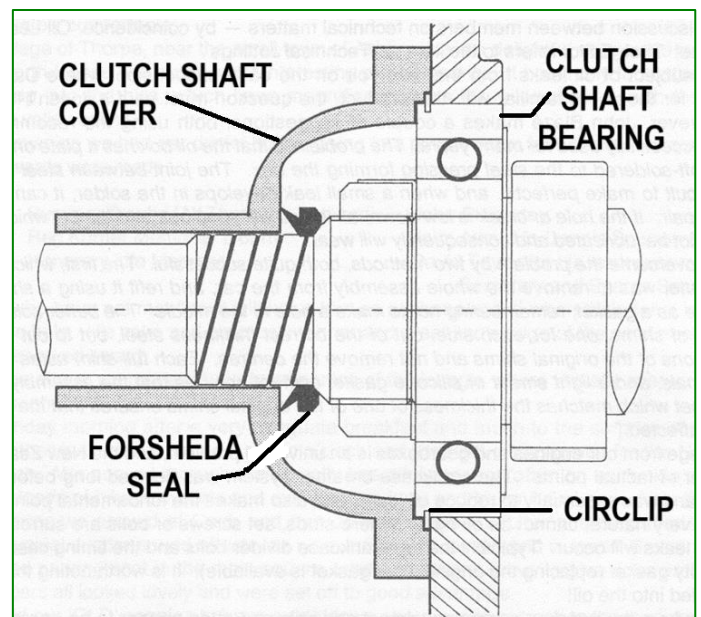
*Right: Figure 2. Sketch, not to scale, showing the position of the Forsheda type seal.*

This modification required a small amount of machining inside the bell of the brass clutch shaft cover, for the seal lip to run on. The depth of the machining was calculated to provide 2 mm 'crush' at the seal's flexible lip. This amount of crush was determined in discussion with the seal supplier.

Some time ago, I read about the late John Blazé's (JOAC member) modification to the clutch shaft (first motion shaft), using a flexible face lip seal of the Forsheda type, that forms a seal at the inside of the clutch shaft cover (50007). See Figure 2.

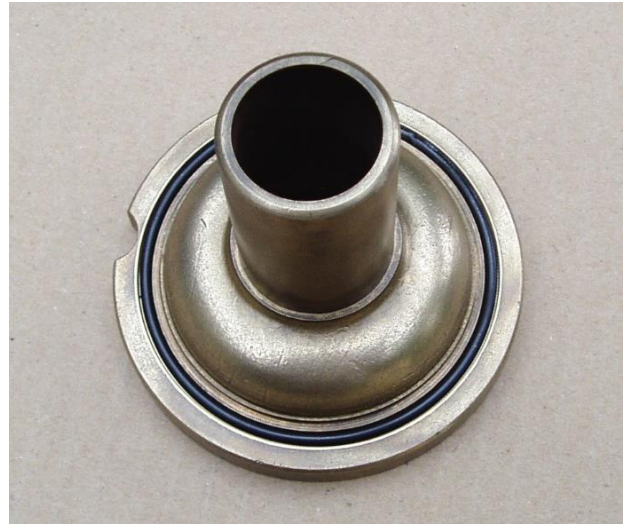
*Right: Figure 3. The clutch shaft cover with 'O' ring in place. The 'O' ring forms a compressible gasket.*

2. The machined diameter for the Forsheda seal to be in contact with is 1.60-in. (40.64 mm) and can be seen in *Figure 4*.
3. An 'O' ring groove, square bottomed, 2.94-in. (74.79 mm) diameter is machined into the front face of the clutch shaft cover. This dimension is the centre of the groove section.

The width of the groove is 0.110-in. (2.90 mm) wide and is 0.090-in. (2.20 mm) deep to accept an 'O' ring formed from 2.5 mm diameter 'O' ring cord, butt glued with Loctite 406 adhesive.

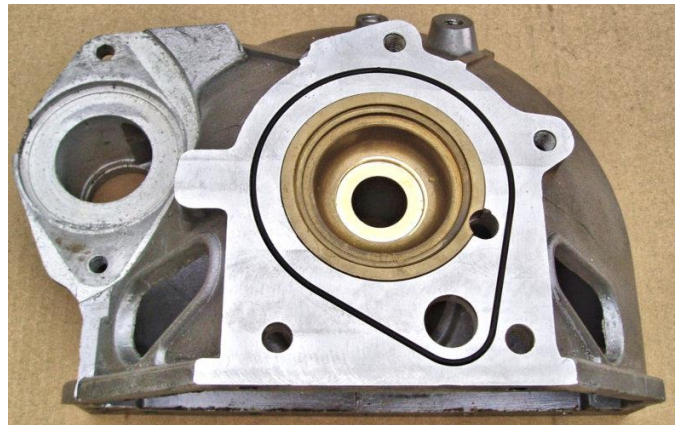
*Right: Figure 4. Modified clutch housing.*

4. At the clutch housing (50836), at the gearbox joint face, fill the breather hole with weld.
5. Referring to *Figure 4*, viewing the gearbox joint face on the clutch housing (50836), with clutch housing base cover (50861) edge at bottom of *Figure 4*, fill with weld metal the L.H.S. notch (provided for left-hand drive cars) that breaks into the clutch shaft cover recess.

6. Machine surplus weld material from the clutch shaft cover recess in the clutch housing (50836), maintaining the original diameter and depth of the recess.

7. Machine the entire gearbox face so that when clutch shaft cover is fully home, less the 'O' ring, its rear surface is absolutely flush with the gearbox face. This operation will also clean up the weld filled breather opening.

8. Machine into the joint surface an 'O' ring groove, as shown in *Figure 4*. The width of the groove is 0.110-in. (2.90 mm) wide and is 0.090-in. (2.20 mm) deep to accept an 'O' ring formed from 2.5 mm diameter 'O' ring cord, butt glued with Loctite 406 adhesive. The groove will be pear shaped to encompass the clutch shaft cover recess, the RHS throw-out bearing lever pivot and the gearbox layshaft spigot opening. Total length of the groove is free, because of the use of 2.50 mm 'O' ring cord.

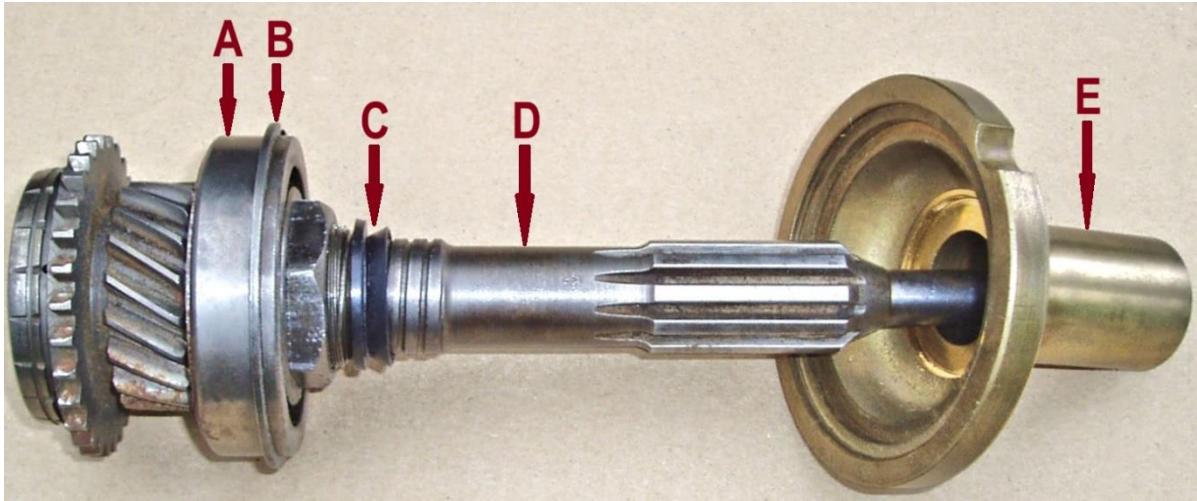
Above: Figure 5. Assembly of Forsheda type seal. Legend:

11. After making sure that the clutch shaft bearing securing nut is absolutely tight and locked, install the Forsheda seal with a bead of Loctite Blue RTV (Part Number 34248) to fill the oil scroll groove in the shaft. Allow to cure.
