TECHNICAL NOTES SERIES

**JOWETT JAVELIN – PA, PB, PC, PD & PE
JOWETT JUPITER – SA & SC**

PART XVII – REAR TIMING COVER GASKET

INSTALLING THE REAR TIMING COVER GASKET

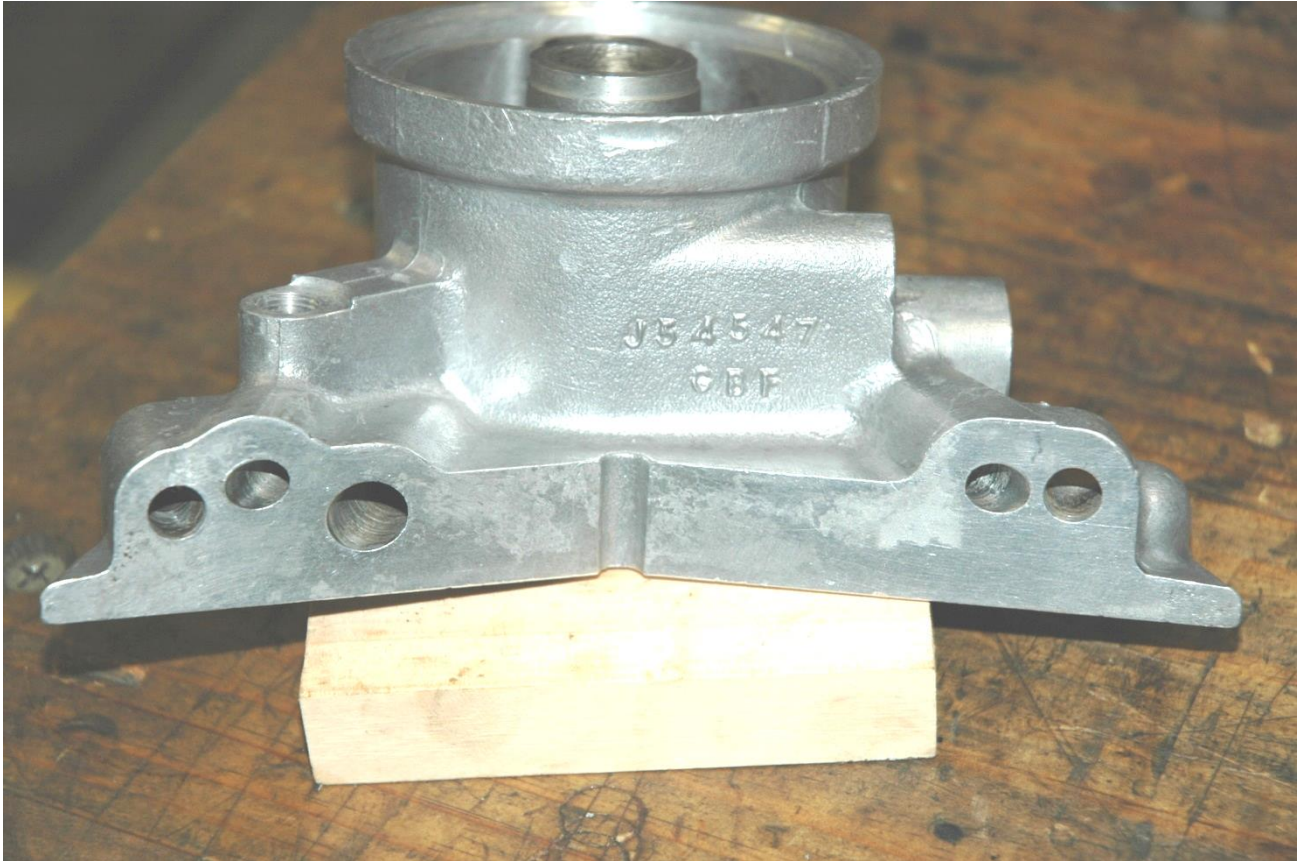
A Series III rear timing cover.
