# TECHNICAL NOTES SERIES

## JOWETT JAVELIN – PA, PB, PC, PD & PE JOWETT JUPITER – SA & SC

### – PART XXI –

## AVON WATER PUMP MECHANICAL SEALS

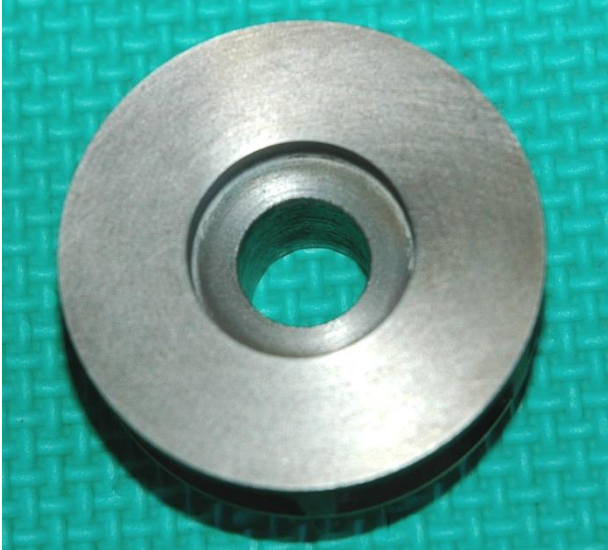
*Figure 1: Rear face of impeller with machined recess.*

The next delay was getting the two new impellers that had been ordered, machined to accept the ceramic rings for the Avon mechanical seals. Once I had a pair of the ceramic rings in my hand, the decision was readily made to use them. This entailed creating a cross section drawing of the machining required. The old impeller was cut through along its axis to verify that there was enough metal to cope with a recessed, flush-fitting ceramic ring.

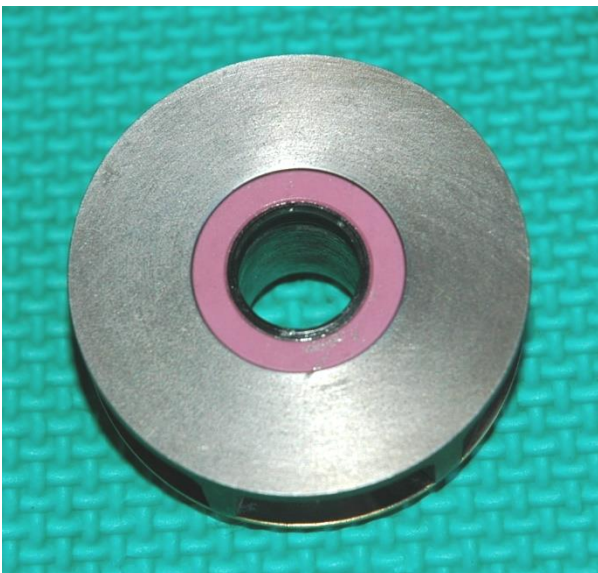
*Figure 2: Showing the ceramic ring and boot in place.*

The impeller was pulled forward until the dimension from the front face to the bearing shoulder was 34.45 mm. This, with the front ceramic ring in place, provides exactly 29 mm. This is a key dimension when working on a Jowett water pump! Once the impeller was set correctly, the grub screw was installed and tightened. A minimal smear of rubber grease was applied to the ceramic ring boot and the assembly was slid over the shaft and

pushed into the recess. Care needed to be taken to ensure that not too much grease was applied, otherwise a hydraulic lock could prevent the ceramic ring from being pushed fully home into the recess.

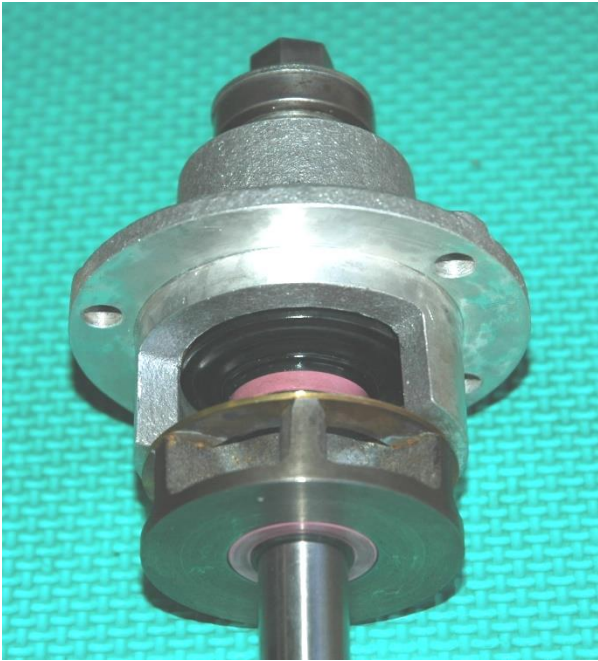
*Figure 4: The assembled front cover.*

*Figure 4* shows the relationship of the front ceramic ring and the mechanical seal after installation. The ceramic ring can be seen, in this illustration, just above the glint of the impeller's brass shroud. The mechanical seal can be seen just above the ceramic ring.
