TECHNICAL NOTES SERIES

JOWETT JAVELIN – PA, PB, PC, PD & PE JOWETT JUPITER – SA & SC

PART XXII – WATER PUMP SERVICE NOTES

Compiled by Mike Allfrey – Revised, April, 2017.

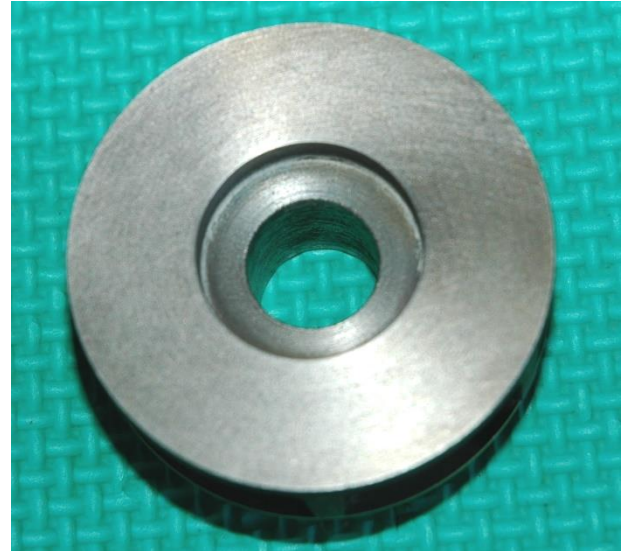
It was found that the task could be done successfully, and the recess was designed so that the ceramic ring and boot assembly fitted as a sliding fit into the recess and sat flush with the rear face of the impeller when pushed fully home. It was then a simple matter of removing sufficient metal from the impeller nose so that the front face of the ceramic ring would replace the existing cast iron. It has to be appreciated that machining the recess and the nose had, actually shortened the effective length of the impeller. The club supplied impellers have been bored to match the

Figure 1: Rear face of impeller with machined recess.

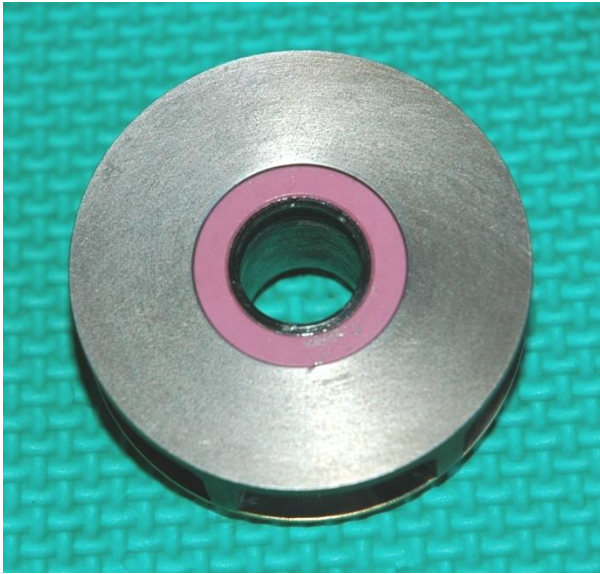
Figure 2. Ceramic ring in impeller.

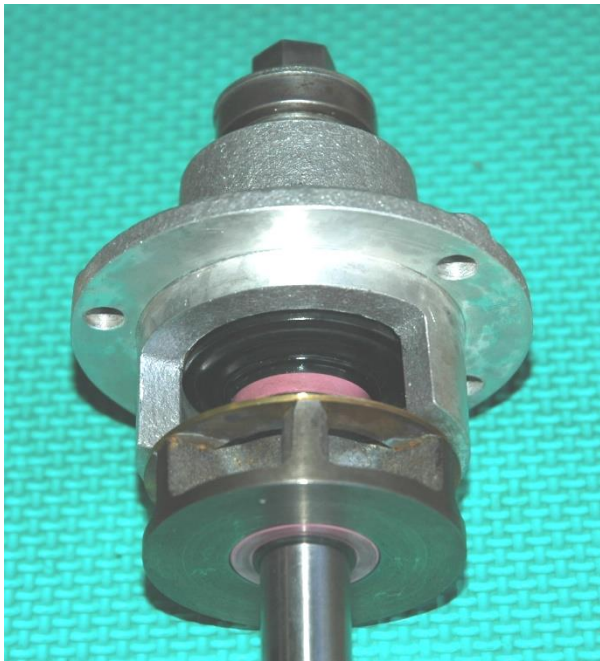
Figure 4 shows the relationship of the front ceramic ring and the mechanical seal after installation. The ceramic ring can be seen, in this illustration, just above the glint of the impeller's brass shroud. The mechanical seal can be seen just above the ceramic ring.

Figure 4: The assembled front cover.
