TECHNICAL NOTES SERIES

JOWETT JAVELIN – PA, PB, PC, PD & PE JOWETT JUPITER – SA & SC

PART XLIII – JOWETT JAVELIN AND JUPITER ENGINE REFURBISHMENT PRACTICES

Compiled by Mike Allfrey – April, 2022.

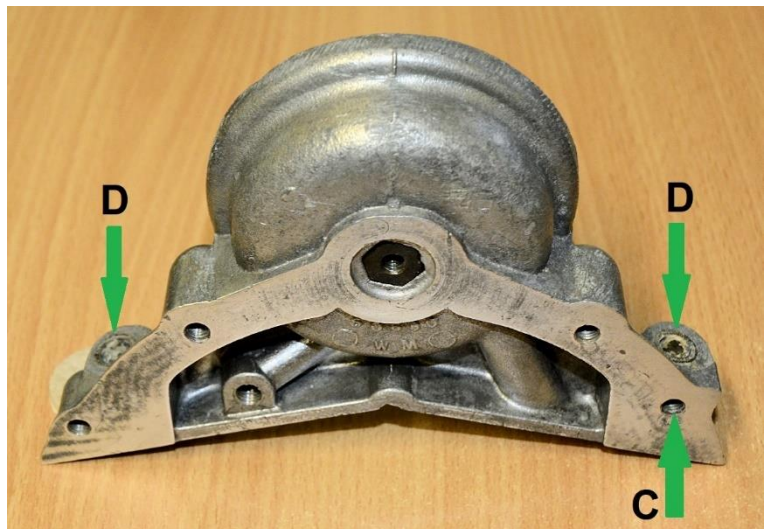
Right: Figure 4. Front face of the same rear timing cover. 'C' five threaded holes that need checking before installation, Items 'D' show securing bolt holes.

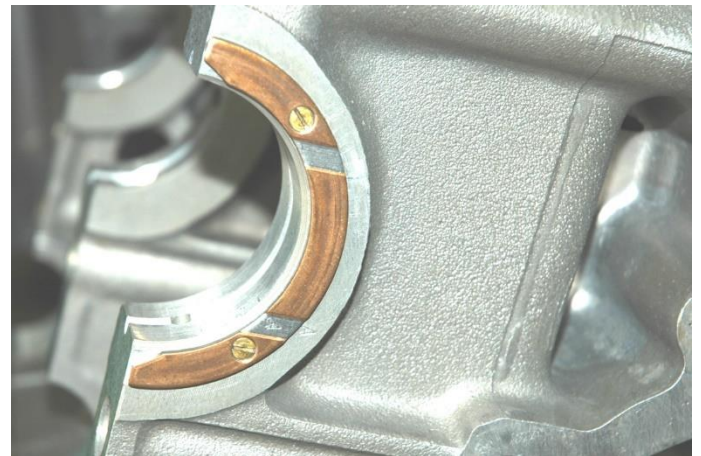
Right: Figure 14. Shows thrust bearing retained by two brass countersunk machine screws.

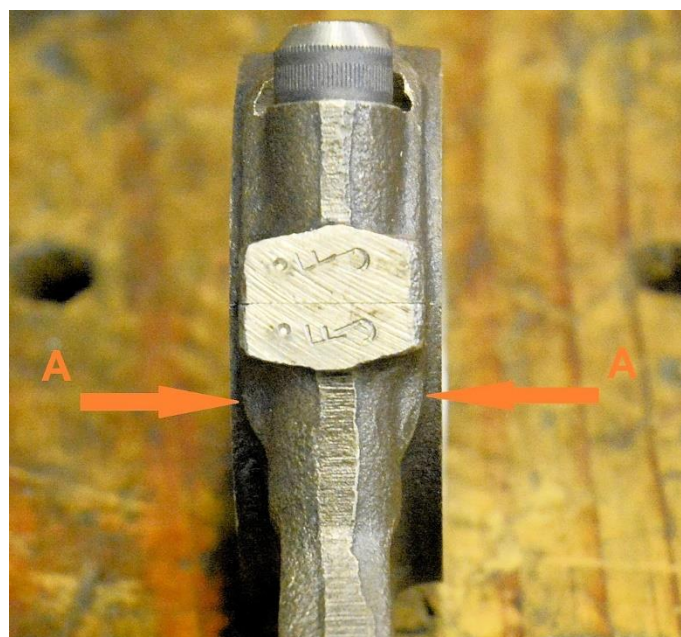
Very early connecting rod caps were fastened with ⅝-in. bolts, which were superseded by ⅜-in. BSF bolts. Next important change was from the plain ledge big end joints, which were replaced with serrated joint pads, each cap unique to its connecting rod assembly. After the serrated joints were introduced, there was another version with a 'beefed-up' forging at the short end of the rod, where

the cap bolt is threaded in. Connecting rods of this type should be selected, and early non-serrated connecting rods should, really, be cast aside.

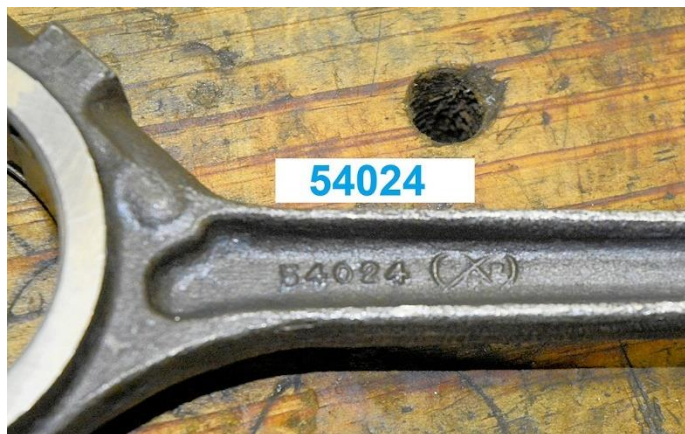
Above Left: Figure 18. Part number identification. Above: Figure 19. 'B' indicates strengthened area.

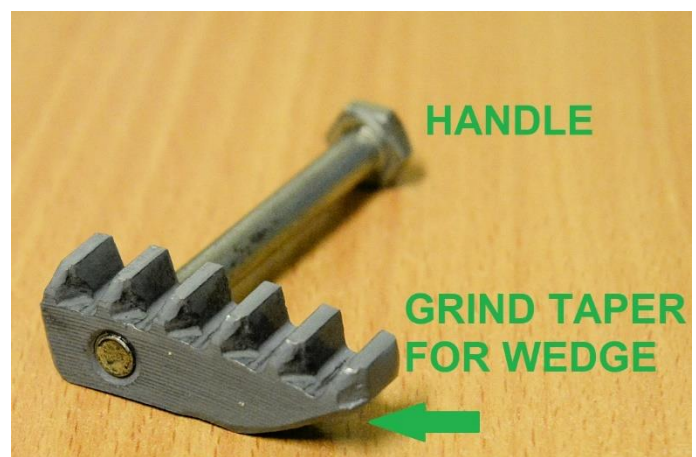
Right: Figure 21. Section cut from an old starter ring gear, with convenient handle that can be screwed in from either side for convenience.

8. Use a piece of old starter ring gear, cut to a taper at one end, so that it can wedge between the flywheel housing, at the right-hand side of the housing, to hold the ring gear on the flywheel firmly while the four flywheel securing bolts are loosened off.

Having ensured that the starter ring gear is secure on the flywheel, rotate the crankshaft so that the dowel (*Item 151*) is uppermost (engine still upside down in cradle) and carefully lower the flywheel into position on the crankshaft. The flywheel is heavy and is a tight fit in the housing. Once fully home on its crankshaft spigot, clean the bolt and crankshaft threads with Loctite 7471 Activator and, with good quality internal tooth lock washers, apply Loctite 263 and tighten the four bolts to 60 lb. ft. torque. Use the tool shown in *Figure 21*, to lock the flywheel while tightening the bolts.

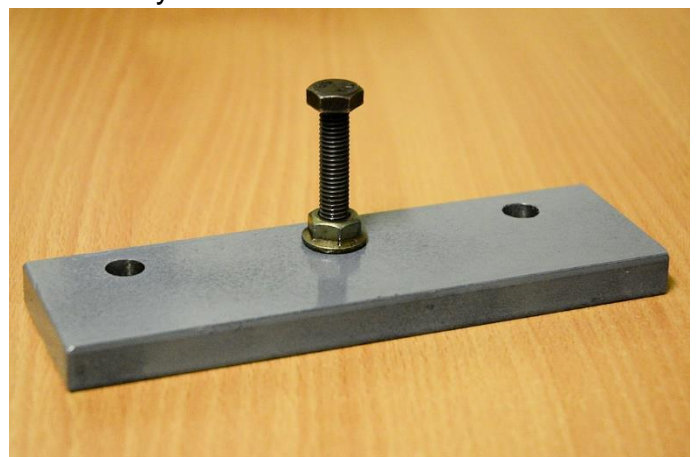
Right: Figure 23. Cylinder head removal tool.

Using a hammer to force a tapered lever between the cylinder head and the crankcase is not at all a recommended practice – too much damage can result at the gasket surfaces.

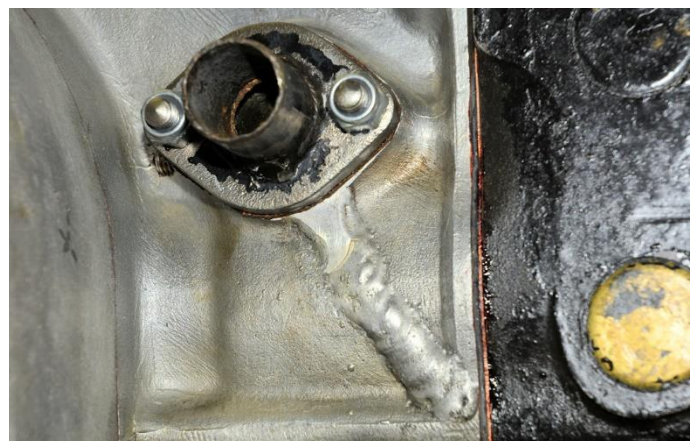
Right: Figure 24. A typical weld repair at rear face.

The most common weld repair on a crankcase can be found at the rear cylinder faces, just inboard of the cylinder head gasket surface. Correctly carried out repairs to such cracks (splits) can be good repairs, however, such repairs can cause some distortion along the gasket face.

Distortion in this area can be between 0.010 to 0.014-in., a dimension which a cylinder head gasket cannot cope with. Also, it needs to be taken into consideration, what did cause the crankcase to crack? Possibly, it was excessive

cylinder liner protrusion outboard of the head gasket surface, or, due to the coolant inlet elbows not being fitted prior to beginning the engine assembly procedure.

Attempts at adding weld to the distorted area and machining back to the original surface dimension may not be feasible due to further distortion 'walking' around the head gasket surface. The weld repair process does cause contraction towards the weld repair location, the head gasket surface is the weakest link to the repair area. There is an option whereby the entire head gasket surface be machined absolutely flat. This task requires the skill of a qualified machinist, who can determine the lowest point in the surface and machine to that point, but no further. This can be classed as a last resort type of repair, and it would be preferable to find a crankcase that may be in better condition. In addition, there are other concerns that need addressing:

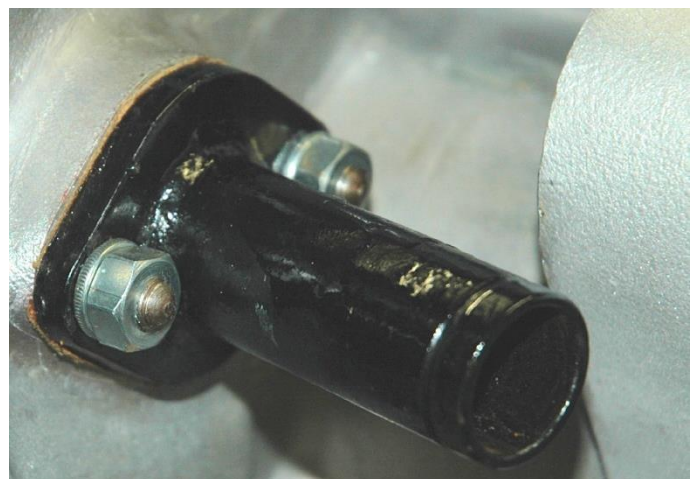
Right: Figure 31. The coolant inlet elbow has been fitted at both sides.

A successful balance pipe test provides the confidence to continue with the Jowett engine rebuild. After completing the balance pipe test, install both coolant inlet elbows. With these flanges properly mounted, the rear faces of the crankcase are reinforced. The elbows should be installed before the cylinder heads are tightened in place.

It is probably difficult to believe, but they do add a degree of strength to the crankcase set. The long elbow mounts on the left-hand side.

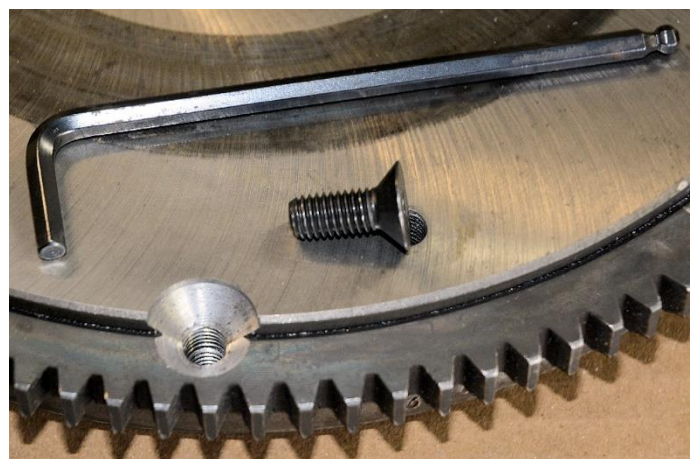
Right: Figure 37. Setscrew and Allen key prior to final installation.

The countersunk setscrews are 8 mm diameter and 20 mm long, metric screws have been used due to ease of sourcing. Refer to Part XIX of the Jowett Technical Notes Series.

With a white permanent marker pen, fill the stampings for T.D.C. 1 and 2 in the flywheel rim, then wipe away excess paint. Do the same for the 3 and 4 T.D.C. stamping. This makes identifying the points easier when setting the valve and ignition timing. Refer to *Figure 37*.

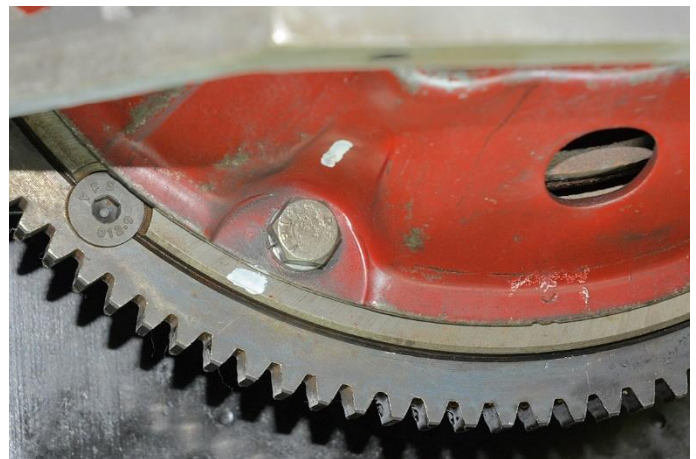
Right: Figure 39. Clutch and flywheel alignment marks confirm correct position.

The gearbox first motion shaft should be easy to slide in and out of position – if tight, investigate and resolve the concern. A spigot that is a good fit in the bush can, due to the lubricant, cause a slight vacuum as the shaft is withdrawn.

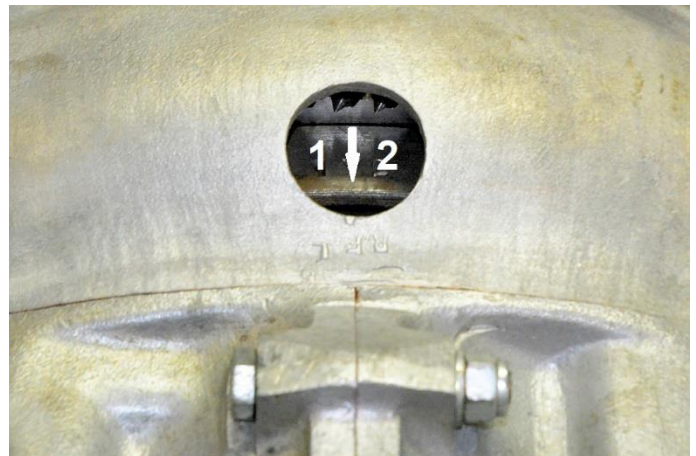
Right: Figure 40. T.D.C. 1 and 2 aligned.

Rotate the crankshaft so that the T.D.C. 1 and 2 arrow on the flywheel rim aligns with the crankcase upper joint line. A window in the top of the flywheel/clutch housing is provided for sighting the mark on the flywheel – there is also a similar mark for T.D.C. at 3 and 4 cylinders. Fit the crankshaft key (*Item 148*) into the nose of the crankshaft and slide the oil pump drive gear, with extended centre boss facing forward, onto the crankshaft.

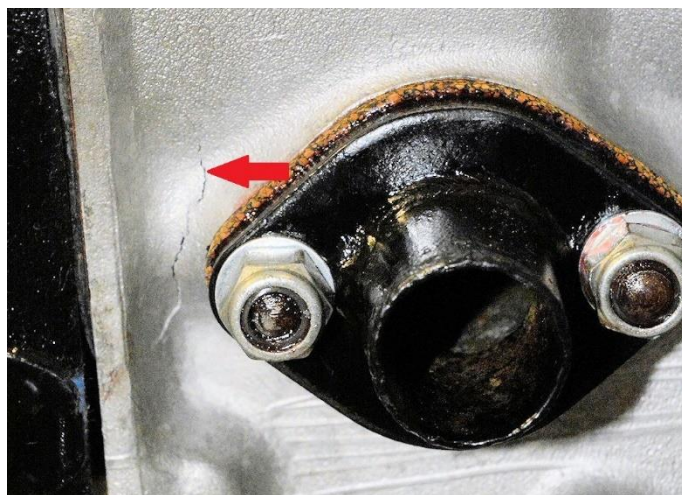
Right: Figure 43. The red arrow indicates a crack that appeared two days after installing a cylinder head. The crankcase had been seriously abused.

After installing the cylinder heads, it is advisable to let the assembly settle for a few days. The writer has recently experienced the devastating discovery of a crack appearing two days after the cylinder head was installed and left for the sealant to cure. This was a first time experience, it was found to be the result of previous abuse and improper repair methods – being cheaper in the short run. Possibly, no one knows if, in the past, a crank-case set has been abused due to incorrect cylinder liner protrusion or unskilfully repaired threads exist. It has to be understood that Jowett Engineering Limited introduced the extended cylinder head stud through the coolant inlet port for good reason. Indeed, an excellent modification and extremely cheap peace of mind for the Jowett engine builder.

It has to be understood that Jowett Engineering Limited introduced the extended cylinder head stud through the coolant inlet port for good reason. Indeed, an excellent modification and extremely cheap peace of mind for the Jowett engine builder.

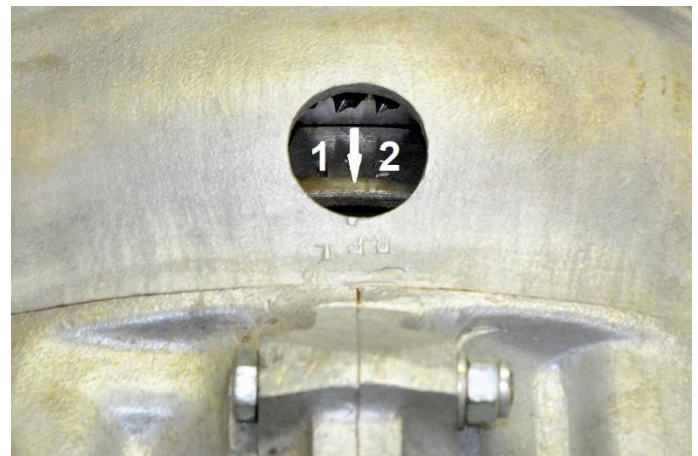
Right: Figure 44. Top Dead Centre for cylinders 1 and 2 in preparation for valve timing.

1. Lubricate the camshaft (*Item 119*) journals and cam lobes with Nulon L90 and insert the camshaft into the crankcase.
2. Lubricate the tappets (*Item 215*) with Nulon L90 and insert them in their bores.

3. Ensure that the oil pump drive spindle is located as shown in *Figure 41*, when the crankshaft is set to T.D.C. at 1 and 2, right. The oil pump spindle is driven at half crankshaft speed.
4. Fit a suitable pointer at one of the front timing cover bolt threads, mount the 360° timing wheel on the nose of the crankshaft and, with the crankshaft at T.D.C. on 1 and 2 cylinders, align the T.D.C. timing wheel 0° mark accurately with the pointer.

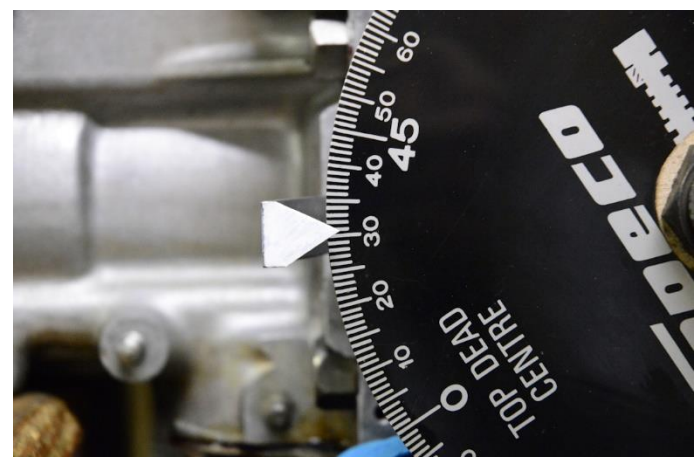
Right: Figure 46. Crankshaft set approximately 30° before T.D.C. at cylinders 1 & 2. Step 3.

5. Insert the push rod for Number 1 inlet valve and slide on the rocker shaft assembly.
6. Turn the crankshaft anti-clockwise until it is roughly 30° before T.D.C. mark, as shown in *Figure 43*, when viewed from the front of the engine. Tighten the rocker assembly nuts.
7. Turning the camshaft clockwise, as viewed from the front, find the full lift position at number 1 inlet valve, then turn the camshaft exactly half a turn. With the push rod set the inlet valve rocker at the valve stem to zero gap while on the heel of the cam lobe.

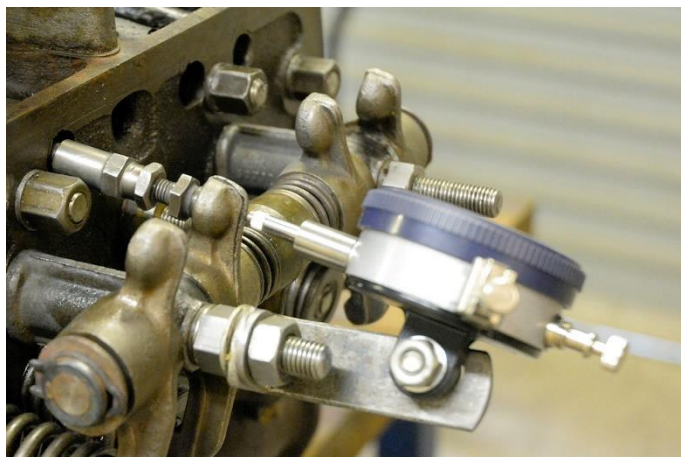
Right: Figure 47. Dial indicator mounted on the bracket at rocker gear pedestal stud.

8. Mount a dial indicator, which displays 0.001-in. increments, with its plunger directly in line with the push rod centre, to bear on the push rod end of number 1 inlet valve rocker arm. The plunger should be set to have some travel in both directions, to prevent it from bottoming in the indicator body. Rotate the indicator rim so that the indicator needle aligns with zero (0) on the dial. This is the 'home' position.

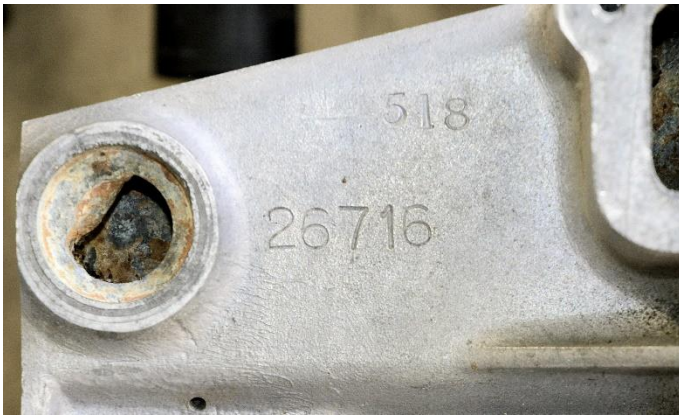
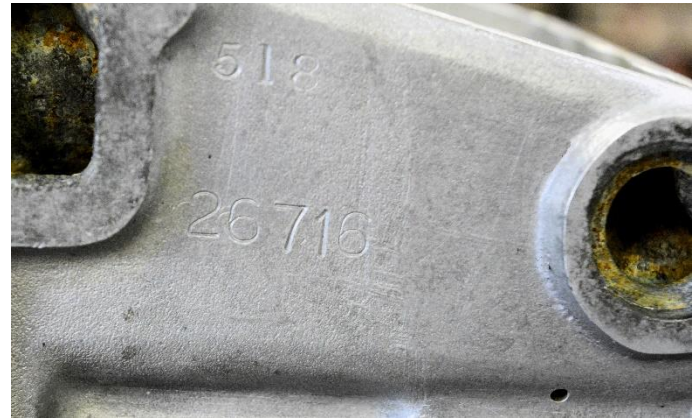
Above: Figures 54 and 55. From a Series III crankcase set, matching production reference numbers, in this case the matching numbers are 26716.
