# TECHNICAL NOTES SERIES

## JOWETT JAVELIN – PA, PB, PC, PD & PE JOWETT JUPITER – SA & SC

## PART XIX – COOLANT PUMP OVERHAUL

*Compiled by Mike Allfrey – August, 2021.*

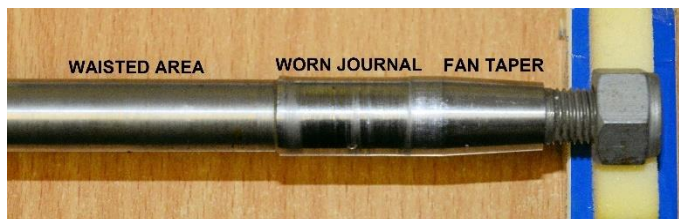
*Right: Figure 4. An example of a worn journal.*

Note that *Figure 4* shows the rear end of a late production run spindle with less steep taper and  $\frac{7}{16}$ -in. BSF thread for securing the cooling fan.

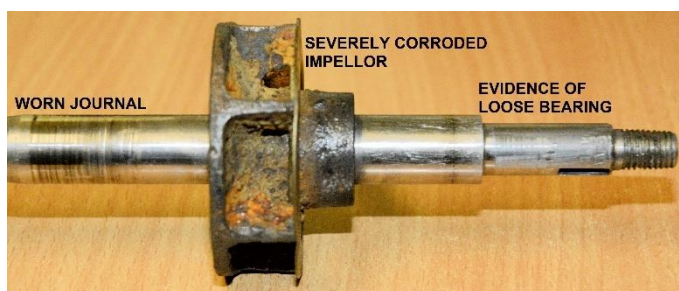
*Right: Figure 5. Abnormal wear at bearing journal, wear at ball bearing and drive pulley shank. The impellor is severely corroded.*

8. The impellor (*Item 387*) should be checked for looseness on the shaft. If corroded as shown in *Figure 5*, build up of rust and scale can be carefully cleaned up for re-use. The overall length of the impellor should be measured accurately to establish if wear has taken place at the contact surfaces for the mechanical seals (*Item 386*). The dimension should be 1.216 to 1.233-in. (30.89 to 31.32 mm). See Appendix III on Page 20.

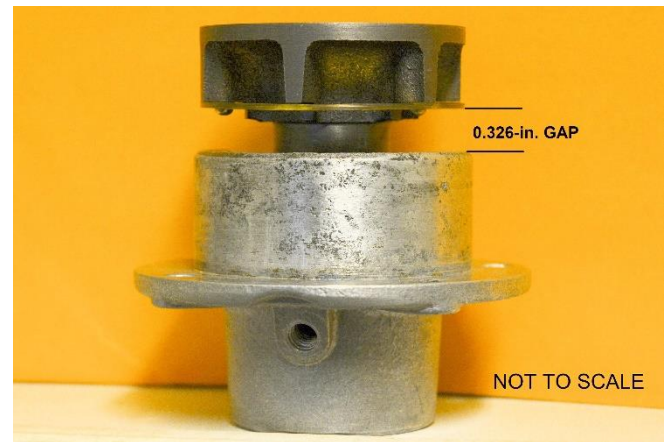
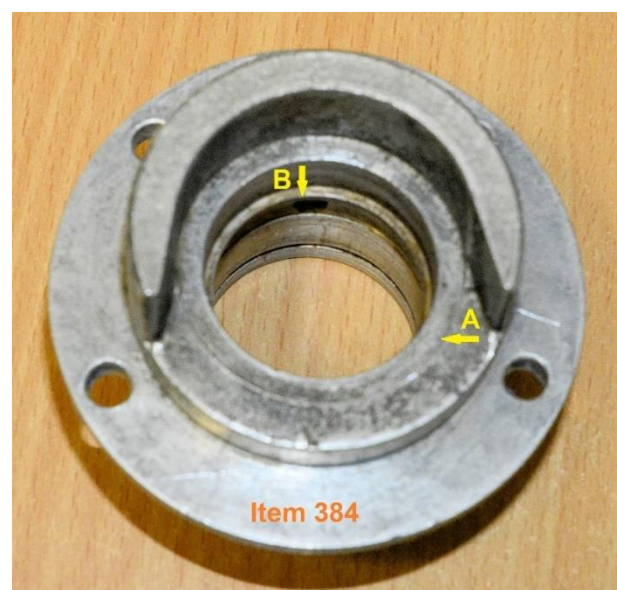
*Right: Figure 9. Front cover housing, viewed from rear.*

Item 'B' shows the bore in the housing that should also be continued in depth, by the same amount, to accommodate the mechanical seal's spring cup. On original front cover housings, this bore can break through into the ball bearing

cavity. With a sealed-for-life bearing, the breakthrough does not cause any inconvenience. Record the calculation result so that it can be given to a machinist.

**Note:** All dimensions shown in Figures 7-8-10 are for reference purposes only – they are not to scale. To repeat, ideal crush should be 0.138 to 0.157-in. (3.5 to 4 mm) maximum, which will provide a reserve of spring movement in the compressed mechanical seal (Item 386), which will reduce wear at the impellor (Item 387).

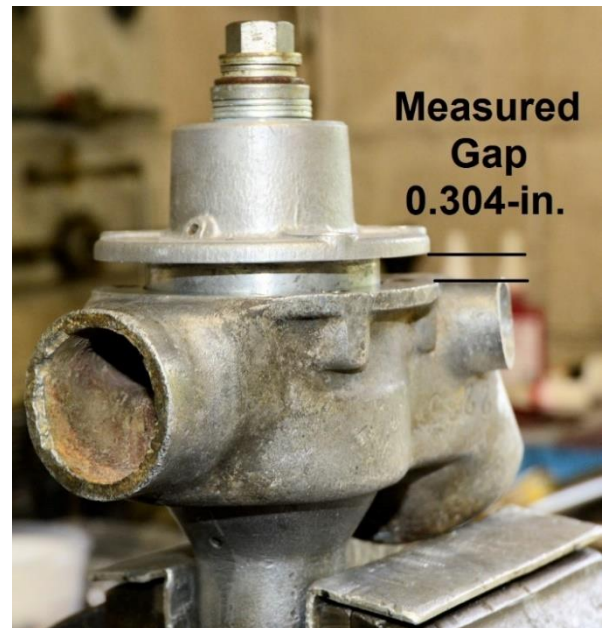
*Right: Figure 10. Showing how to check the gap between the rear housing and front cover at the gasket surfaces. The impellor is resting on the Avon NB020A mechanical seal. The illustration is not to scale.*

- a) The same technique as for the front cover housing (Item 384), can be applied to the rear housing (Item 392), so that the amount of material to be removed can be established. Assemble the front cover housing, ball bearing, circlips and spindle assembly as shown at Figure 6, on Page 10.

A new gasket (Item 332) should be placed on the rear pump housing while the dimension for the calculation is measured. The gap between front cover housing (Item 384) should be 0.138 to 0.157-in. (3.5 to 4.0 mm) after the rear housing has been machined, with the gasket located on the rear housing surface (e.g. 0.026-in. thick).

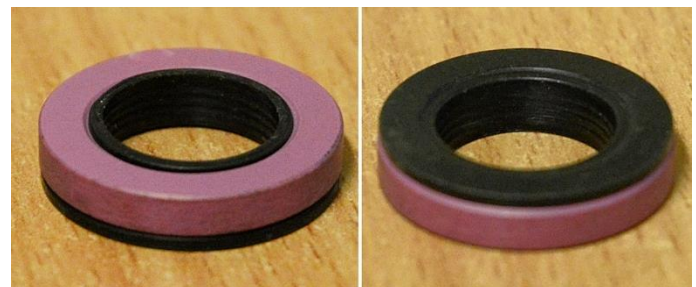
To install the ceramic boot assemblies onto a spindle (Item 390) and impellor (Item 387) that have been assembled as at Step '1', Page 13, apply a liquid soap solution at the inside diameter of the rubber boot, and on the spindle at both sides of the impellor. Then apply a light smear of Vaseline to the ceramic faces that contact the carbon ring on the mechanical seals.

Next, slide the first ceramic boot assembly, with the rubber towards the front face of the impellor and push it firmly home. From the rear end of the spindle, slide the ceramic boot assembly onto the spindle and push it home into the recess so that it is flush with the rear face. The ceramic boot assemblies can be a tight fit on the spindle journals, but once in position, they will be held in place by the spring force of the mechanical seals.

It should be noted that the ceramic boot assemblies are of the colours shown below. In all cases, the rubber boot will be black. The Avon Part Number is V16278. The illustrations are not to any scale, they are shown here purely for descriptive purposes. The ceramic portion can also be of white colour, but has identical properties.

When the spindle (Item 390) impellor and ceramic boot assembly are installed the mechanical seals (Item 386) will exert sufficient pressure to hold the ceramic boot assemblies against the impellor, thus providing a completely leak proof coolant pump.

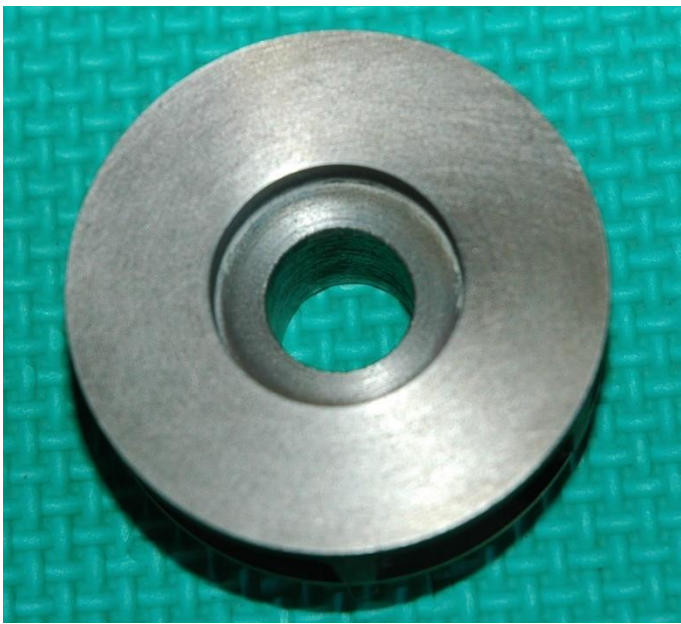
Above: Figure 18. Recess in rear of impellor.

The coolant pump impellor (Item 387) requires machining at both ends prior to the installation of two ceramic boot assemblies. A recess needs to be machined in the rear face of the impellor and a similar amount needs to be machined from the front end.

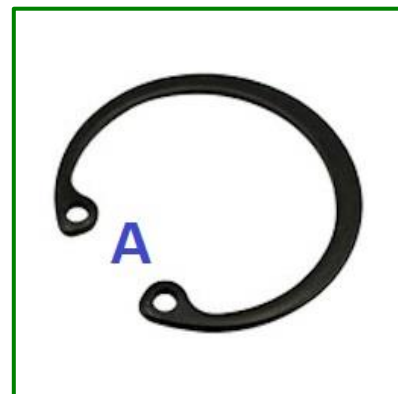
*Right: Figure 23. A typical internal circlip. At 'A' are the opening and two circlip plier holes.*

There is a technique that should be employed for circlip installation. Prior to inserting the pliers, careful examination of the clip will reveal that the holes provided in the clip are tapered, i.e. on one face the holes are of smaller diameter than they are on the other face. This is a useful result of the way the circlip is punched, in one operation from a steel strip. By installing the plier points into the small (sharp edged) face of the clip, a secure grip can be maintained while the pliers are being squeezed to compress the ends of the

circlip prior to insertion in the bearing bore. As well as the plier holes having a sharp edge, the outer diameter of the circlip is also sharp edged – this feature will help lock the clip in position.

Inserting the pliers from the sharp edged face of the circlip will make its removal at a later time much easier, thus saving workshop time. Good quality circlip pliers feature a number of circular grooves along the points that enter the circlip holes. These grooves work in conjunction with the sharp edged face of the circlip.
