# TECHNICAL NOTES SERIES

## JOWETT JAVELIN – PA, PB, PC, PD & PE JOWETT JUPITER – SA & SC

## – PART XII –

### ENGINE CRANKCASE REPAIR TECHNIQUES

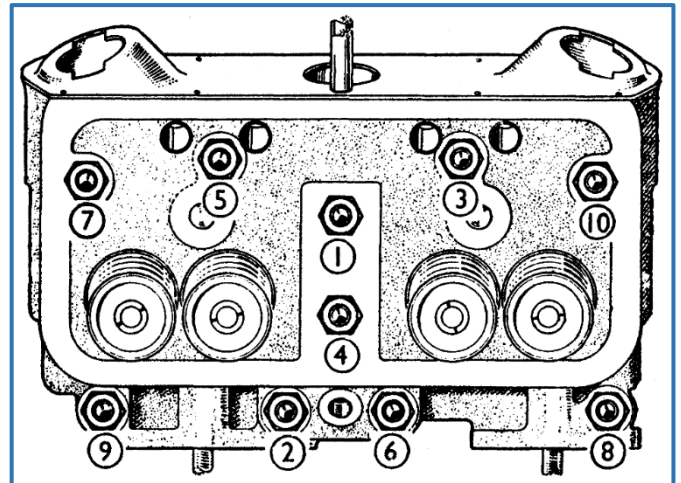
Figure 3.

1. Making use of the cylinder head nuts' tightening sequence, see *Figure 3*, commence by carefully measuring the overall depth of Number 2's threaded hole from the gasket surface to the inner end of the hole. Write this dimension into the top table box for stud number 2.

**Note:** 'Stud – Sequence No.' heading refers to the stud location in the crankcase set, as per the cylinder head nuts' tightening arrangement as shown in the *Maintenance Manual*, see *Figure 3*. The dimensions shown in blue, below, are those calculated on the subject crankcase. It is suggested that they are deleted and then the pages printed for personal use while carrying out this exercise. 'Left Hand Side' and 'Right Hand Side' headings refer to which crankcase half. With engine viewed from the driver's seat.

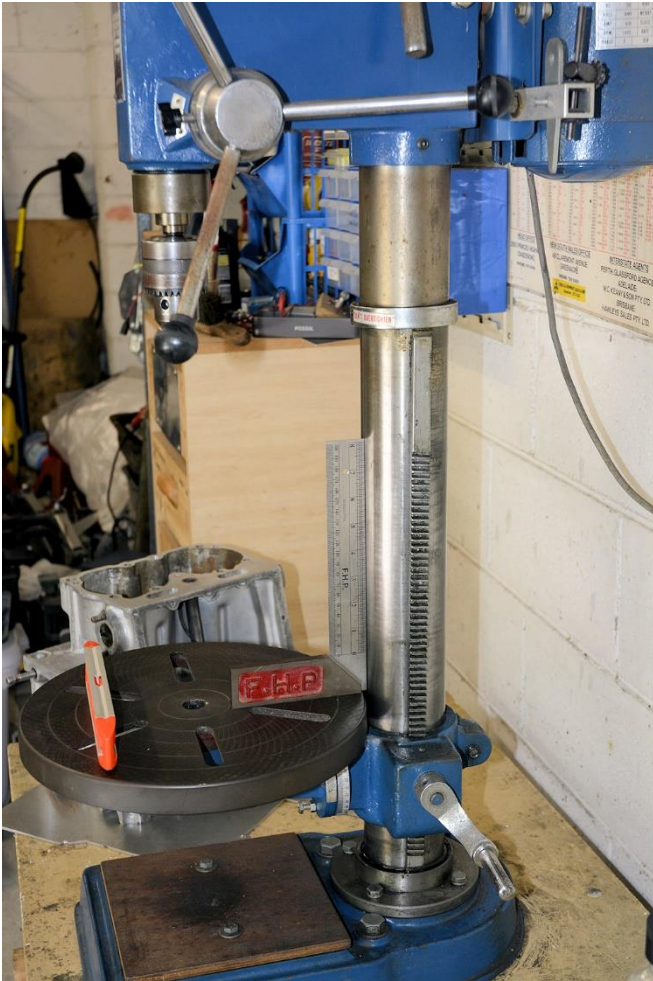
*Figure 8.*

setscrew that facilitates the adjustment for true square, i.e. a try square sitting on the table and positioned on the table, so the drill's pedestal pillar is at exact right angles to the table – in both planes. See *Figure 8*. The set-up involves a fair amount of trial and error at the radial clamping bolt and the adjuster setscrew, while

maintaining the table is a level position. A very small adjustment for final fine tuning. After initial set up, it is best to leave and come back later for a final check and, maybe, further adjustment.

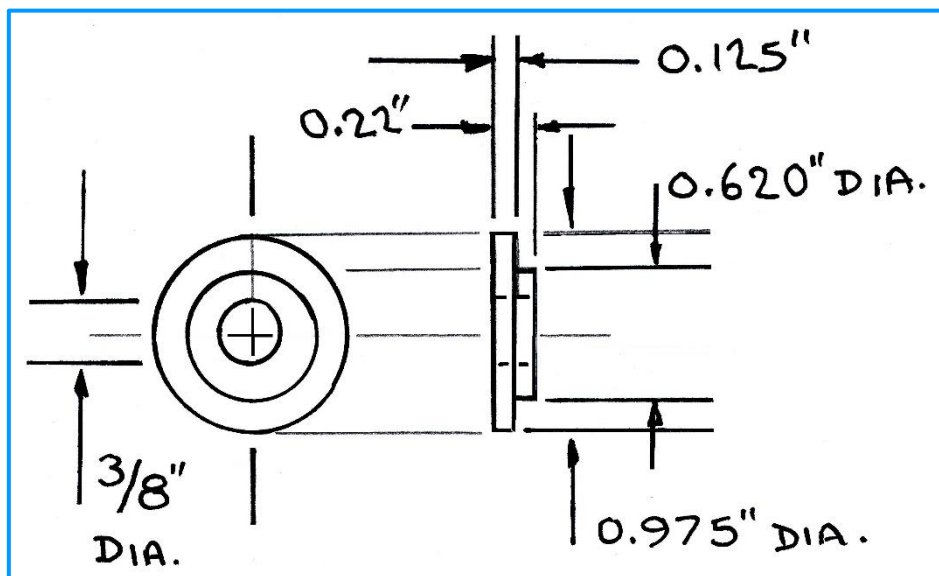
*Stepped 'O' Ring Collar*

The Number 4 cylinder head stud hole in the cylinder head has a counter bore for a rubber seal ring ('O' ring). The sketch below shows the dimensions for a collar that will squeeze the 'O' ring so that it forms a coolant-tight seal. Two collars per engine are required.

This sketch is not to scale. Material – Mild Steel, please machine six off.
