# TECHNICAL NOTES SERIES

## JOWETT JAVELIN – PA, PB, PC, PD & PE

## JOWETT JUPITER – SA & SC

## PART III – SERVICE BULLETINS – JAVELIN AND JUPITER

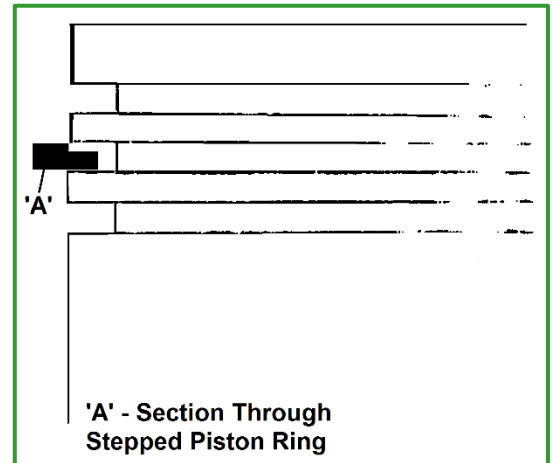
*Right: Figure 1. Showing the stepped second compression ring.*

From Engine Number E0 PB 8345 a new type of cylinder liner, Part Number 54019, has been fitted. This liner can be identified by the fact that the flange which locates with the crankcase set (50522/3) is larger than on the original type, Part Number 50642. A new type piston, Part Number 50656BG, and second compression ring, Part Number 54021, have also been introduced for use with this liner. The piston has the letters 'BG' stamped on the crown and the second compression ring has an internal step which should be fitted as shown in the illustration at right.

As a result of these changes, the length of the locating plate distance tube which fits on the centre cylinder head stud has been reduced by  $\frac{1}{16}$ " (1.587 mm) to  $2\frac{7}{32}$ " (56.355 mm). Should the shorter distance tube be used with the old type cylinder liners, a  $\frac{1}{16}$ " (1.587 mm) brass washer should be fitted between the tube and the locating plate to ensure the tube is nipped by the cylinder head.

Liners and pistons are fully interchangeable in sets, but stocks of the old type liners and pistons will be maintained.

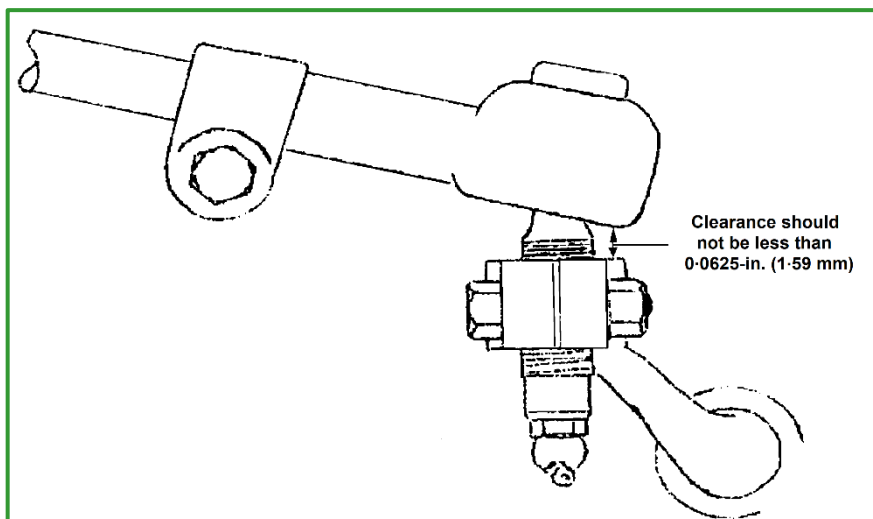
ball housing and the steering arm, which must not under any circumstances be less than  $\frac{1}{16}$ -in. (0.0625-in.) as shown in the sketch below.

It should be noted that steering arms, Part Numbers 52667 (RHS) and 52666 (LHS), are fitted to Right Hand Drive cars and steering arms, Part Nos. 52678 (LHS) and 52679 (RHS), are fitted to Left Hand drive cars. The difference in the right and left hand drive models is in the height of the forward end of the steering arm in relation to the stub axle, and therefore it will be readily understood that the fitting of the incorrect arm will seriously affect the steering geometry.

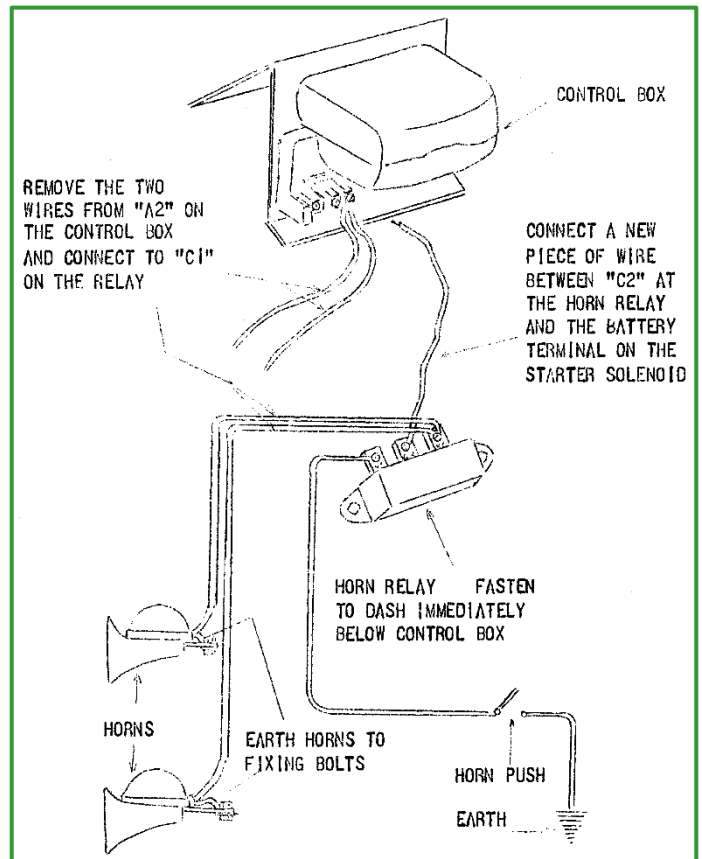
Please refer to the wiring diagram at right.

3. Disconnect the two wires (identification colours – purple with black) from the 'push-in' connector behind the instrument panel, and from the terminals inside the horns.
4. Extend the horn push lead (identification colours – purple and black) from the connector to the W terminal on the relay.
5. Fit a new lead from the main battery lead on the starter solenoid to the C2 terminal on the relay.
6. Fit a short earth lead from each horn terminal (which was originally fitted with a purple and black lead) to one of the horn securing bolts

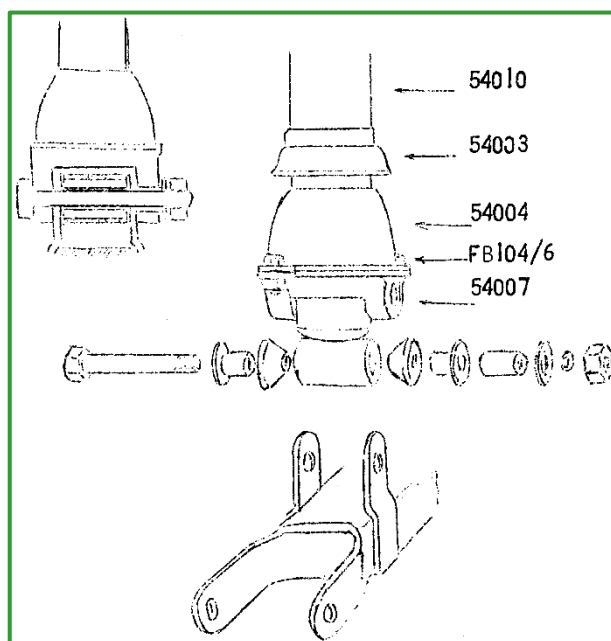
*Right: Figure 1.*

It will be noted that the buffer assembly is cut away to provide clearance for the stub axle in the rebound suspension position.

*Front shock absorber lower mounting.*

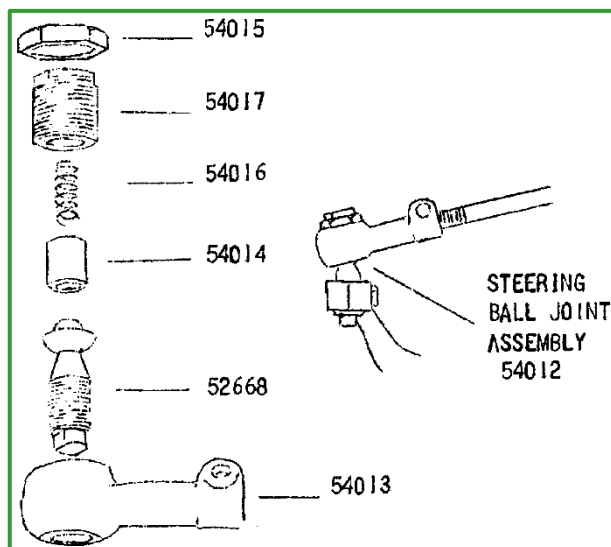
The new type ball joint assembly allows an increased range of travel for the ball, and the steering socket is positioned in such a manner as to allow an increased clearance between the housing and the steering arm. Where difficulty is experienced in obtaining the correct clearance on cars fitted with the ball joint assembly, Part Number 52668, the new type steering ball joint assembly, Part Number 54012, should be fitted. The full track and camber check as detailed in Bulletin Item Number 16, should be carried out when fitting the new assembly.

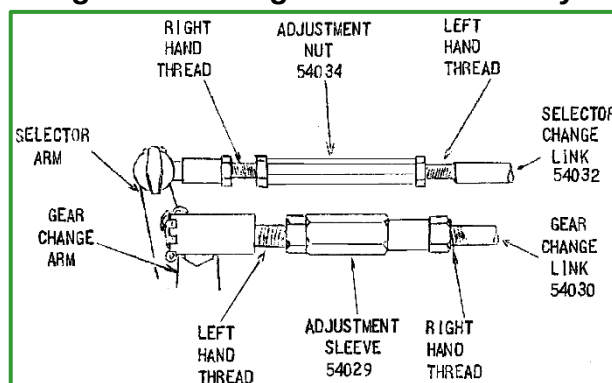
which allow the link to be lengthened or shortened by turning the nut or sleeve after the locknuts have been released. Please refer to the illustration above. The direction of rotation for adjustment works in opposite directions on each link i.e. to lengthen the selector change link the top of the adjustment nut should be turned away from the operator, whereas to lengthen the gear change link the top of the adjustment sleeve should be turned towards the operator.

The new type selector and gear change link assemblies are fully interchangeable with the original assemblies on R.H.D vehicles. Please refer to Spares Note Number 63 for parts change information.

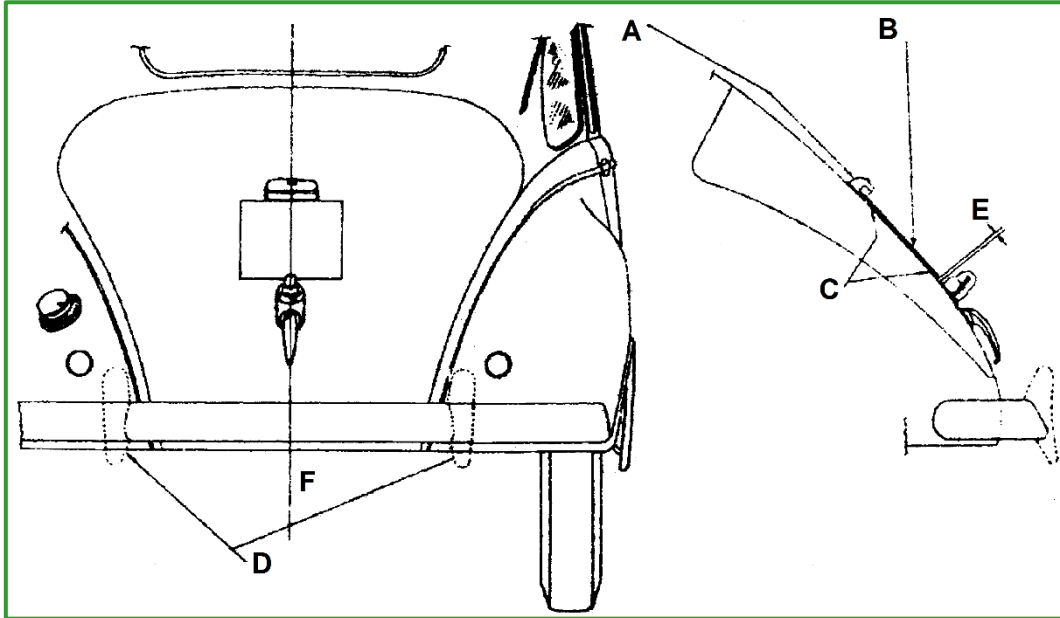
*Above: Figure 1. Sketch showing position of rear number plate and light when fitting tow bar to 1951 De Luxe models.*

These towing attachments are the same type as those which have been fitted previously, and fitting instructions given on Javelin Technical Circular Number 11 still apply.

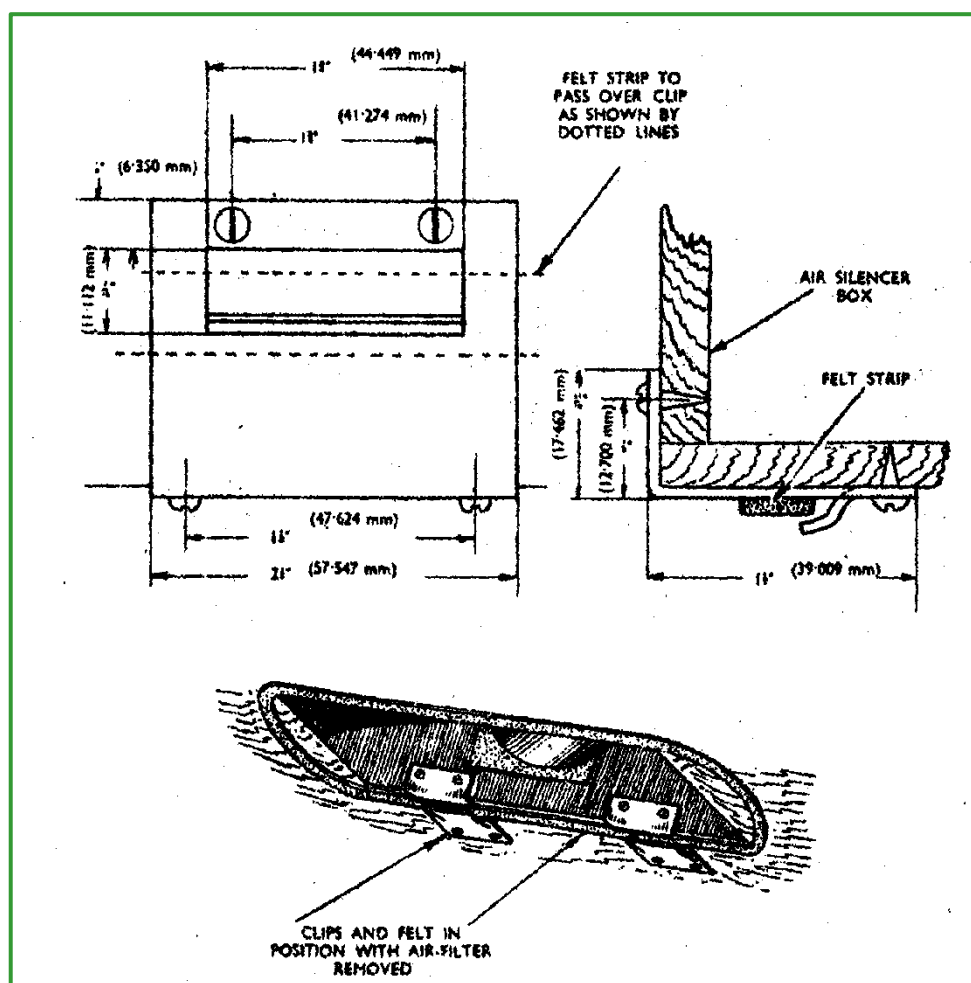
With effect from Engine Number E0 PB 8950 the woodscrews which secure the air filter brackets to the air silencer base, have been replaced by threaded screws and rivet nuts. On cars prior to the above Engine Number where difficulty is experienced with the original filter mounting, modified securing brackets may be fitted. This type of bracket, Part Number 54237, is held firmly in position by four wood screws set at right angles to each other, as shown in Figure 1.

Figure 1. Modified air cleaner bracket arrangement.

Arrangements have been made for the modified brackets to be supplied from our Spares Department.

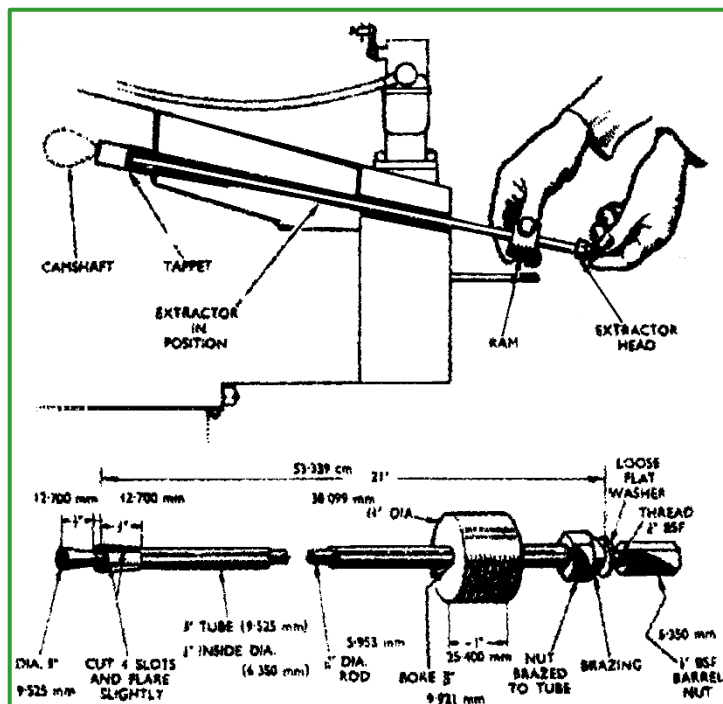
*Right: Figure 1. Hydraulic tappet extractor.*

In cases where difficulty is experienced in withdrawing the solid type tappet from the tappet bore a firm hold can be obtained on the conical end of the tappet insert. A special puller is therefore not necessary in this case.

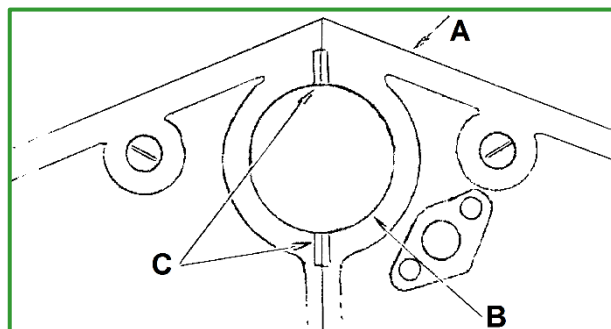
Instances of heavy intermittent engine knock, particularly at slow running speeds, have been traced to camshaft end float. Investigation has indicated that this is due to oil pressure building up between the camshaft boss and the crankcase, thereby causing a 'hydraulic' action. We have recently introduced a modification in the form of a groove in the crankcase bearing boss to relieve excess pressure at the point as illustrated in *Figure 1*.

*Right: Figure 1. Showing position of oil release grooves.*

Camshaft end float is normally controlled by the thrust spring, Part Number 50681, but when any knocking of the nature referred to is experienced, the following action should be taken:

1. Increase the tension of the thrust spring. A simple check may be effected by tapping the camshaft thrust peg, Part Number 54002, into the timing case which will increase the spring loading. If the knock is eliminated the front timing case must be removed and washers of suitable thickness inserted between the thrust pad end and the timing case to re-position the thrust pad.

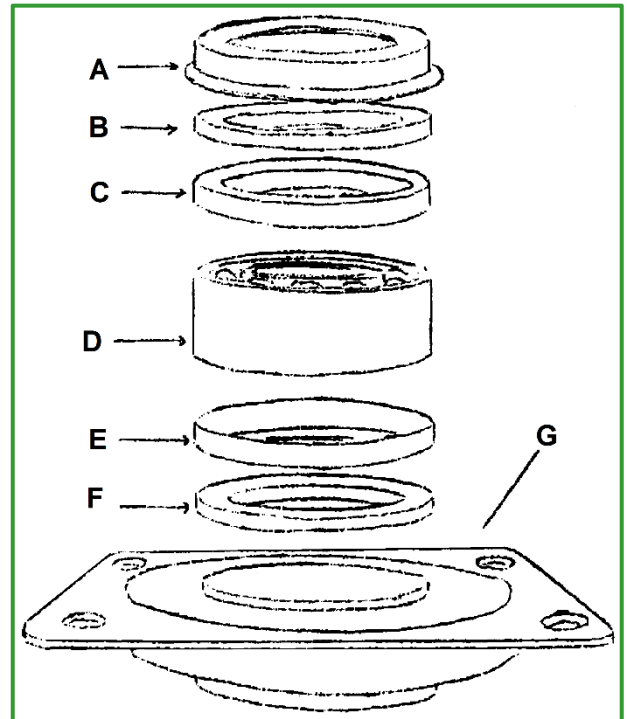
5. Place seal retainer on top of the bearing with the face side uppermost. Rest the felt seal on the retainer flat face and fit the seal housing, Part Number 50925, in position over the felt seal and seal retainer, with the rim of the retainer housing below the rim of the bearing housing.

6. The bearing and seal assembly should now be secured in position by turning over the protruding edge of the bearing housing. This can be done with the use of a lathe and a rolling tool, or in the absence of this equipment, the edge can be peened over using hammer and punch method. If the latter course is adopted, care must be taken to ensure that the rim is peened over evenly round the full perimeter of the rim.

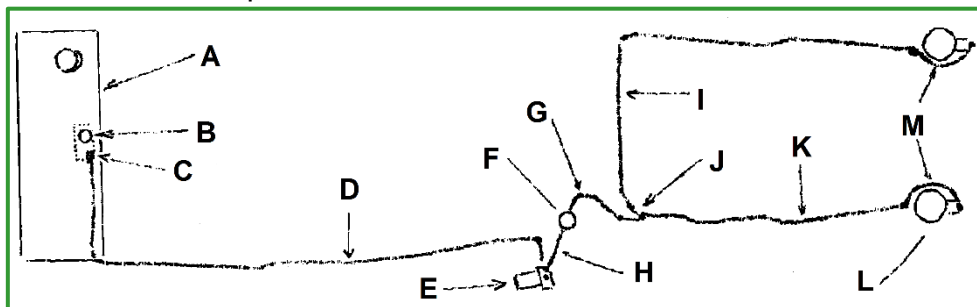
The Jupiter petrol system has been modified to incorporate a new type petrol pump and petrol filter as follows. From Engine Number E1 SA 439 a new type petrol pump (type SU. PP 36L), Part Number 1.53814, which gives an increased petrol flow was fitted and the position of the petrol pump was changed from the front of the dash panel to the R.H.S. of the chassis.

From Engine Number E1 SA 520, a rubber cover was fitted to the pump to prevent ingress of water and it should be carefully noted when removing and replacing the cover that the  $\frac{1}{16}$ " (1.5873 mm) breather hole should be positioned to the underside of the pump. From Engine Number E1 SA 504 the three-way petrol tap and reserve supply system was dispensed with and replaced by a single pipe from the petrol tank direct to the petrol pump. At the same engine number a new type petrol filter, Part Number J54436, was introduced and the position of the petrol filter was changed from the front dash panel to the RHS of the chassis.

Above: Figure 1. Fuel system showing component part numbers.

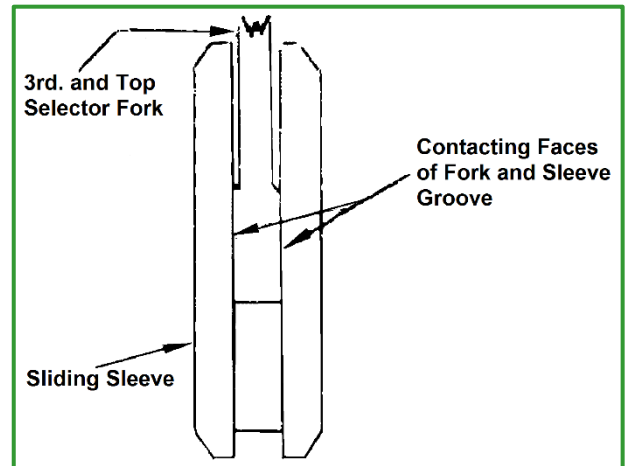
To prevent gear lever vibration the width of the third and top selector fork has been increased for a distance of approximately  $\frac{5}{8}$ -in. (15.875 mm) from the ends of the fork by 0.020-in. (0.508 mm) as shown below. With this modification the  $\frac{5}{8}$ -in. (15.875 mm) increased width portion of the fork only contacts the sliding groove when the sliding sleeve is being moved axially on the driving dog, thereby eliminating any tendency for the sliding sleeve to be incorrectly aligned when in full engagement with the gear dog teeth.

*Right: Figure 1. Third and top sliding sleeve and selector fork.*

The increased width of the selector fork necessitates an increase in the width of the sliding sleeve groove, and the fork and sleeve are only interchangeable with the previous type in pairs.

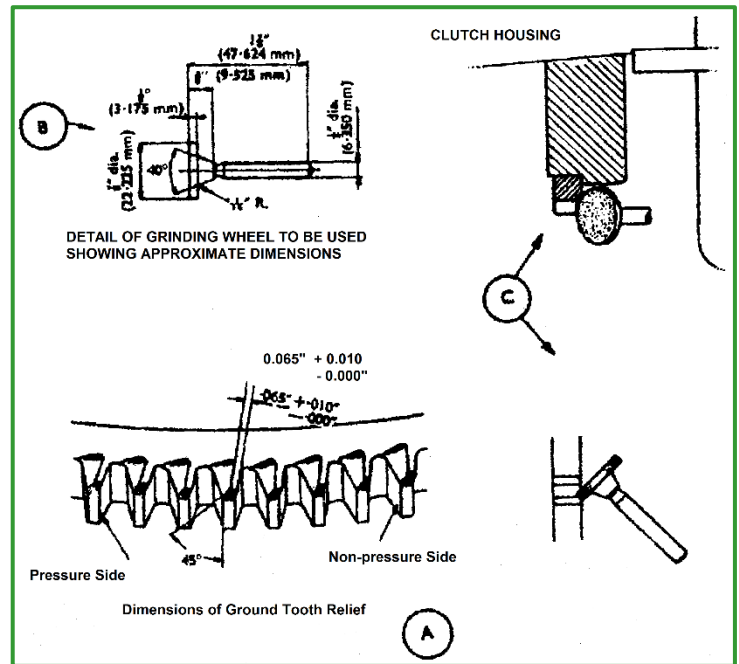
engine in position using a grinding wheel of the dimensions shown at (B). The new type ring gear is fully inter-changeable with the previous type and the fitting instructions remain the same.

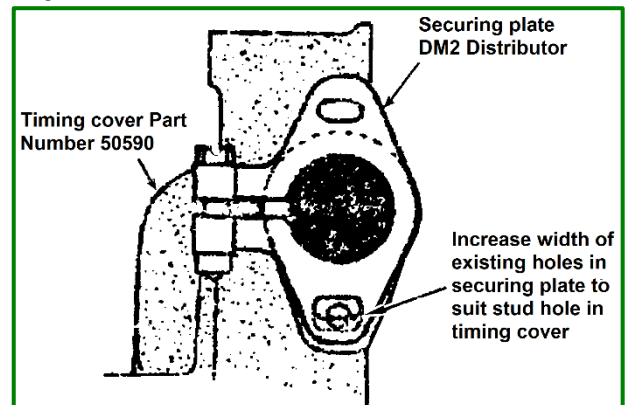
*Right: Figure 1. Installation of securing plate on early type timing cover.*

The mounting flange on the timing cover is modified to suit the new type distributor securing plate and the new type timing cover, Part Number 54662, has also been changed. The DM2 distributor may be fitted to the old type timing cover by increasing the width of the elongated hole in the securing plate as shown in *Figure 1*.

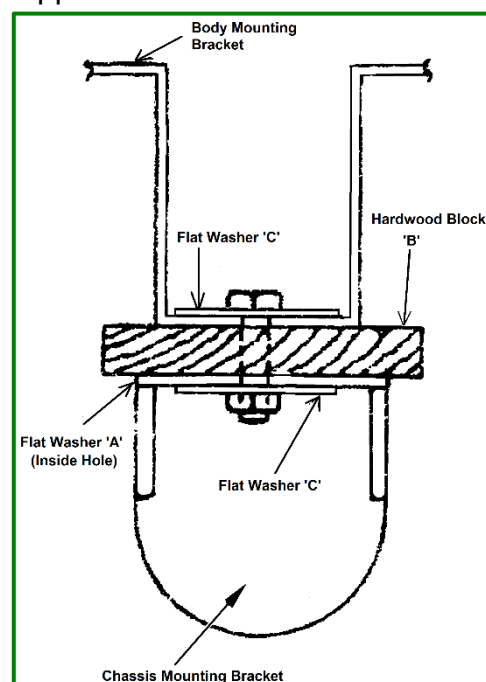
3. Cut four hardwood blocks 'B', *Figure 1*, 3 x 3 x ⅞-in. (76·2 x 76·2 x 22·23 mm) and drill a ½-in. (12·7 mm) hole in the centre of each. Fit the blocks in place of the Silentbloc bushes, ensuring that the grain of the wood is at right angles to the chassis frame, refer to *Figure 1*.
4. Fit ½ x 2-in. body mounting bolts with ½-in. flat washers of 2-in. outside diameter by ⅜-in. thick beneath the head of each bolt and fit ½-in. Oddie (Nyloc) nuts together with washers of the previous dimensions, refer to 'C' *Figure 1*.

Note: The nuts must not be tightened at this stage.

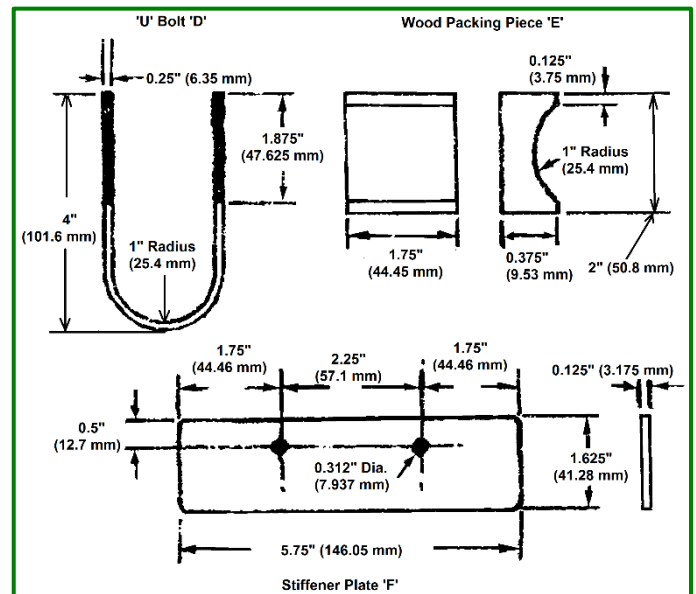
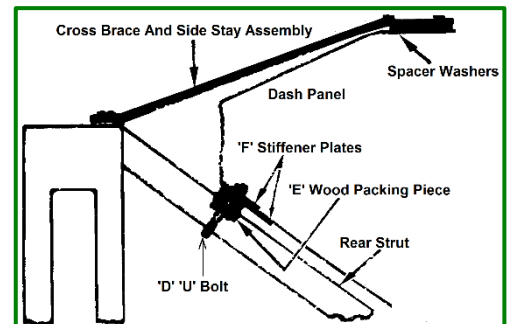
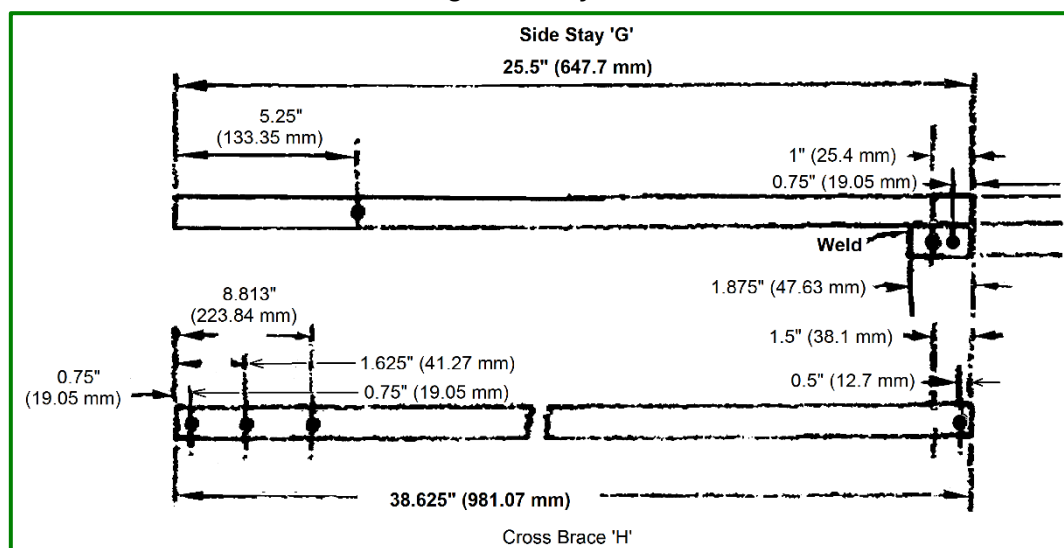
*Right: Figure 3. Installation of front bulkhead brace.*

**IMPORTANT NOTE:** Use of only the works scuttle bracing without the wooden body mounting blocks renders the car rigid at the scuttle but flexible throughout the body. This can seriously impair its stability, and may in time weaken the aluminium panels by causing excessive flexing. If the scuttle bracing is used, the recommended hardwood blocks should be used instead of rubber for mounting the body.

*Above: Figure 4. Sketch of side and diagonal stays.*

7. Fabricate from 1 x ¼-in. strip mild steel bar two (2) side stays ('G', *Figure 4*), and weld on two strips of the same material. Fabricate two cross braces ('H', *Figure 4*). Bend the side stays to the required shape (see *Figure 3*) and fit together with the cross braces as shown in *Figure 5*, using ⅝-in. bolts. Fit ¾-in. spacing washers 'J' of 2-in. (50.8 mm) outside diameter by ¼-in. (6.35 mm) thick between the side stays and the dash panel assembly (refer to *Figures 3* and *5*) and a ⅜-in. flat washer with 2-in. outside diameter by ⅛-in. (3.175 mm) thick under the nuts beneath the dash panel.

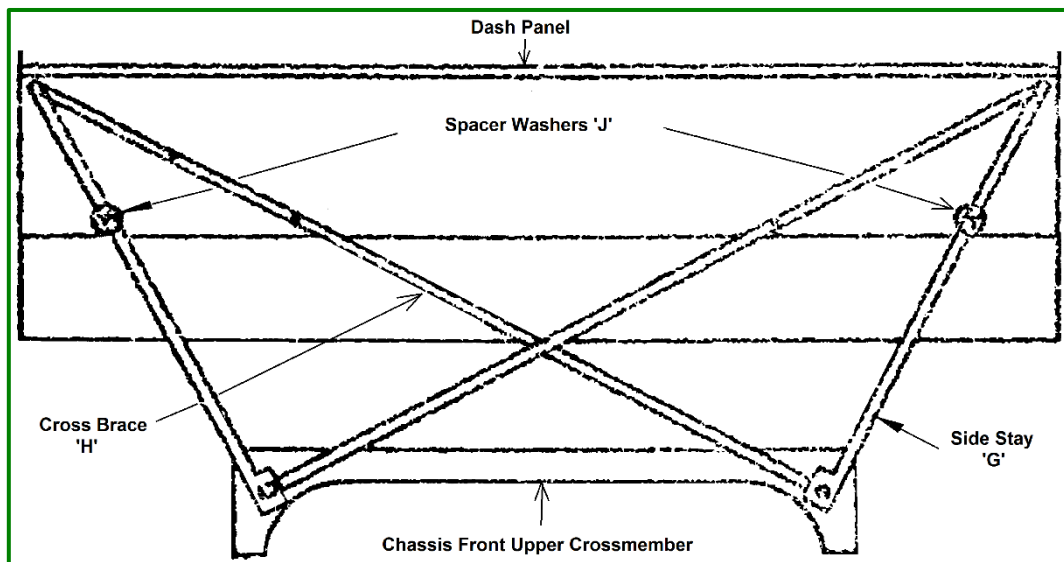
Above: Figure 5. Installation of side and diagonal stays.

*The dash (scuttle) side and diagonal bracing can be fabricated from aluminium tube and plate to form a lightweight welded structure.*

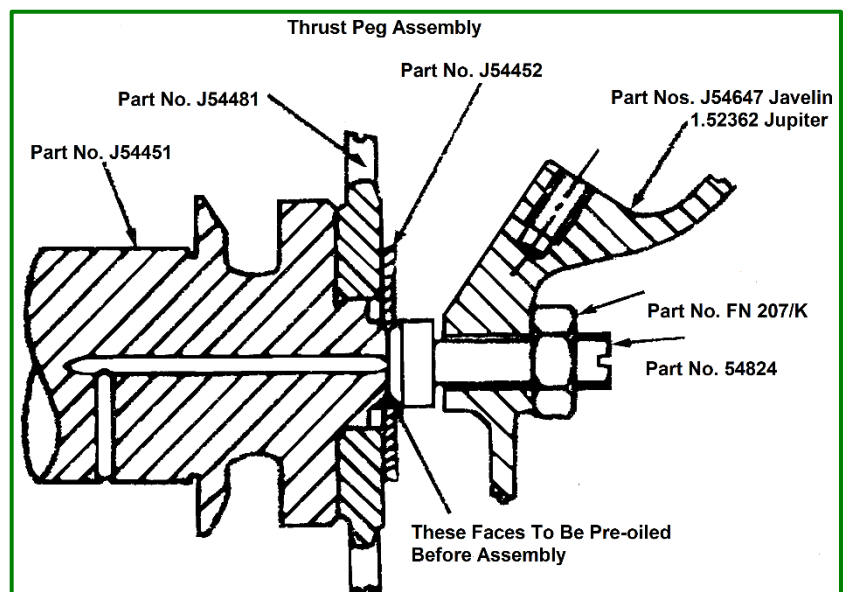
*Right: Figure 1. (This is Section AA)*

The camshaft now incorporates an integral extension to provide a bearing surface for the adjustable thrust peg. Oil is fed to grooves on this surface via a drilling in the camshaft front journal. To eliminate end float on cars fitted with the foregoing adjustment, release the locknut, Part Number FN 207/K, on the thrust peg and screw in the thrust peg, Part Number J54644, to make light contact with the camshaft, and turn back not more than  $\frac{1}{8}$ <sup>th</sup> of a turn and tighten the locknut.

During assembly the bearing faces of the thrust plug, Part Number J54824, and the thrust peg, Part Number J54644, must be pre-lubricated.

**NOTE:** It is most essential that the adjustment is **NOT** carried out with the engine running.

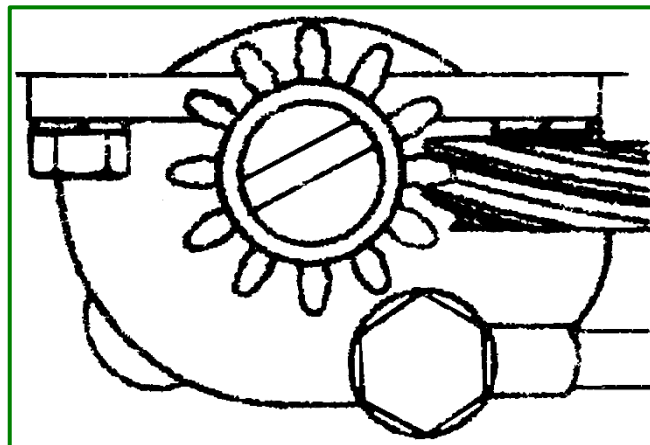
*Right: Figure 1. Showing alignment of distributor drive key.*

**Note:** The position of the off-set keyway with number one piston on T.D.C firing stroke shown in *Figure 31* on Page 30 of the Javelin and Jupiter Maintenance Manual shows the position when the **DKY H4A** type distributor only is fitted.

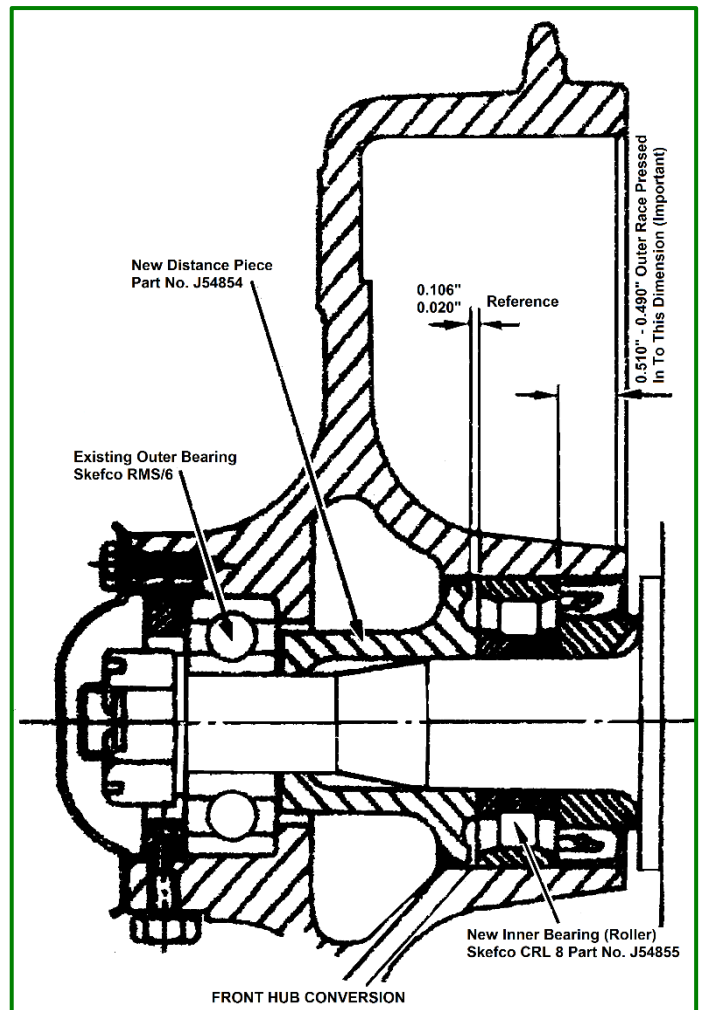
*Arrangement of roller bearing conversion.*

The roller type bearings and distance piece can be fitted to all hubs after Engine Number E0 PB 10594 (Javelin) and Engine Number E0 SA 56 (Jupiter), the new type distance piece must be used.

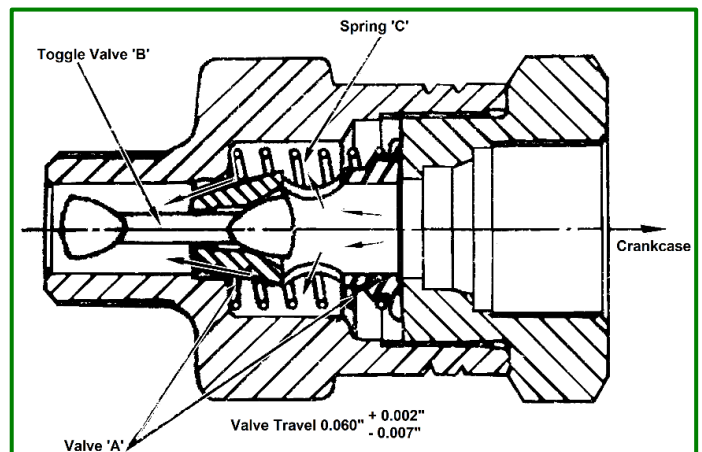
*Right: Figure 1. Section through breather valve.*

The crankcases of both the Javelin and the Jupiter are designed to operate at a pressure slightly below atmospheric pressure (14.7 psi), the normal running pressure in the crankcase being between 14 – 14.6 psi. To ensure even running of the twin carburettors a balance pipe was fitted from which runs a connecting pipe to the oil filler tube where the breather valve is located. To further assist the circulation of the air, breather vents are fitted one

in each push rod cover, inside which, is tucked a small felt to act as an air filter. (Refer to Bulletin Item 9)

**Note:** Valve must be closed when breather threaded end (connected to balance pipe) is subjected to 9½-in. of mercury and start to open between 5½ and 3½-in. of mercury.
