# TECHNICAL NOTES SERIES

JOWETT JAVELIN – PA, PB, PC, PD & PE  
JOWETT JUPITER – SA & SC

## – PART XIII – CRANKCASE STUDS CYLINDER LINER INSTALLATION CYLINDER HEAD GASKET INSTALLATION ENGINE COOLANT MAINTENANCE CYLINDER HEAD GASKET EXPERIENCES

*Compiled by Mike Allfrey – 29<sup>th</sup> January, 2006.  
With assistance from Neil Moore, JCC (NZ).  
Revised – February, 2024.*

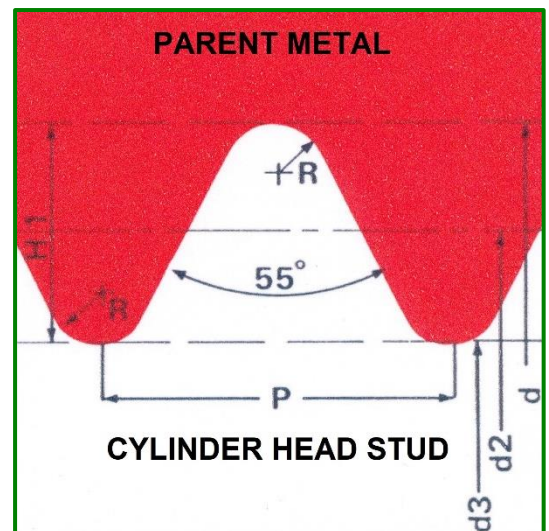
The foregoing means that if a cylinder head stud has been over-tightened into a crankcase, and/or the cylinder head nuts over-tightened, and metal (aluminium) shearing, or stud pulling out, has commenced, no matter by how little an amount, the nature of the metal working with a high tensile steel stud can, having started, continue to yield. The parent metal's structure has been abused. The stud may not feel loose in the crankcase thread, but the cylinder head stud pull-out process can continue. Try cutting a piece of aluminium sheet with a pair of tin snips and note that when the shear commences, the force required to operate the snip handles reduces somewhat – the same is happening in a crankcase thread. Several Jowett engine crankcases have had very tight cylinder head studs removed by me, those in a clean state have shown that they have been over-tightened into their crankcase threads. Also, those that have been tight (difficult) to remove due to corrosion, have exhibited crumbly pieces of corrosion residue when the stud has been finally unscrewed. This can also be checked by inserting a cotton bud soaked in light machine oil into the crankcase's threaded hole and the stuck on residue examined.

Therefore, if a crankcase being prepared for an engine rebuild, is not of known condition or a stud feels loose in the thread, action should be taken to ensure that *all* crankcase threads are in top condition – if there are any doubts, get into action with the Recoil kits.

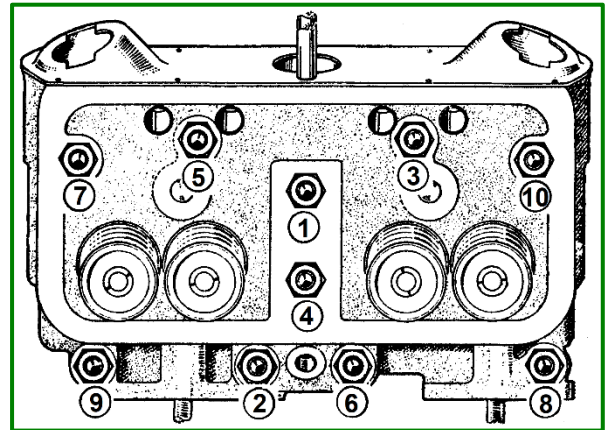
Looking back at the engine’s original crankcase, with the problems at numbers one/three cylinder head, the cylinder head nuts adjacent to number one cylinder, Nos. 7, 5, 2 and 9 in the Jowett specified torque sequence (refer to *Figure 15*), were too easy to unscrew when the cylinder head was being removed for repair. Why were they so loose?

*Right: Figure 15. Jowett Javelin/Jupiter cylinder head nut tightening sequence.*
