TECHNICAL NOTES SERIES

JOWETT JAVELIN – PA, PB, PC, PD & PE JOWETT JUPITER – SA & SC

– PART XII –

ENGINE CRANKCASE REPAIR TECHNIQUES

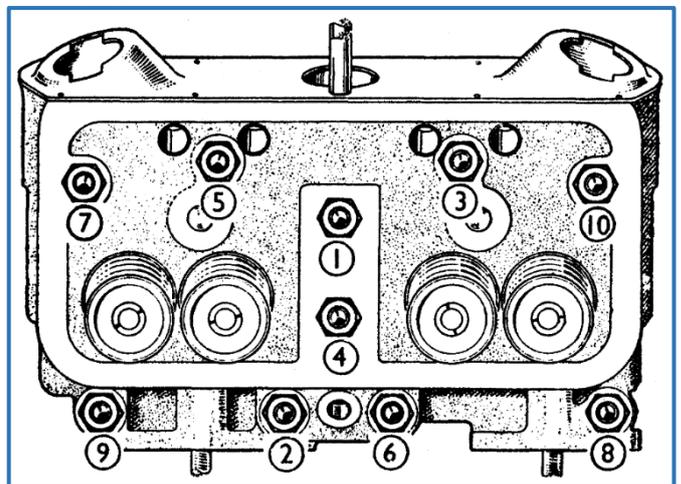
Figure 3.

1. Making use of the cylinder head nuts' tightening sequence, see *Figure 3*, commence by carefully measuring the overall depth of Number 2's threaded hole from the gasket surface to the inner end of the hole. Write this dimension into the top table box for stud number 2.

Note: 'Stud – Sequence No.' heading refers to the stud location in the crankcase set, as per the cylinder head nuts' tightening arrangement as shown in the *Maintenance Manual*, see *Figure 3*. The dimensions shown in blue, below, are those calculated on the subject crankcase. It is suggested that they are deleted and then the pages printed for personal use while carrying out this exercise. 'Left Hand Side' and 'Right Hand Side' headings refer to which crankcase half. With engine viewed from the driver's seat.
