# TECHNICAL NOTES SERIES

## JOWETT JAVELIN – PA, PB, PC, PD & PE JOWETT JUPITER – SA & SC

## PART XXV – GEARBOX OVERHAUL

*Originally written by Ed Wolf, for The Javelin Magazine.*

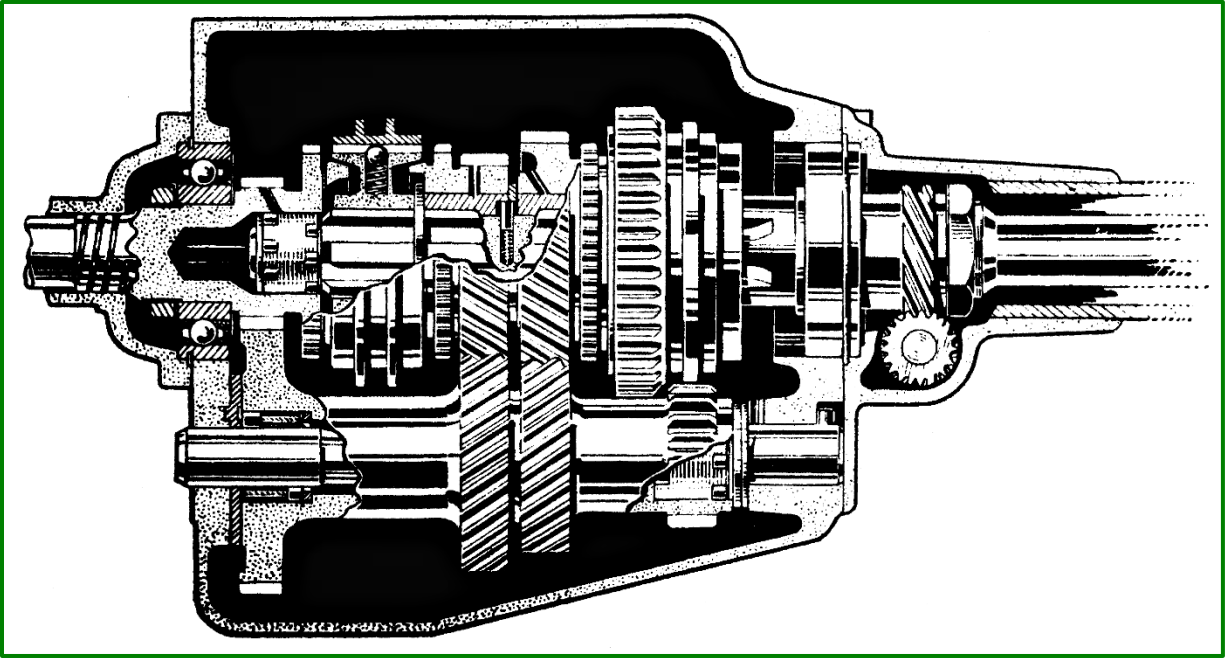
*Above: A cross section through the Jowett Javelin and Jupiter gearbox.*
