# TECHNICAL NOTES SERIES

## JOWETT JAVELIN – PA, PB, PC, PD & PE JOWETT JUPITER – SA & SC

## PART XXXIX – JOWETT JAVELIN AND JUPITER ENGINE REFURBISHMENT PRACTICES

*Compiled by Mike Allfrey – April, 2022.*

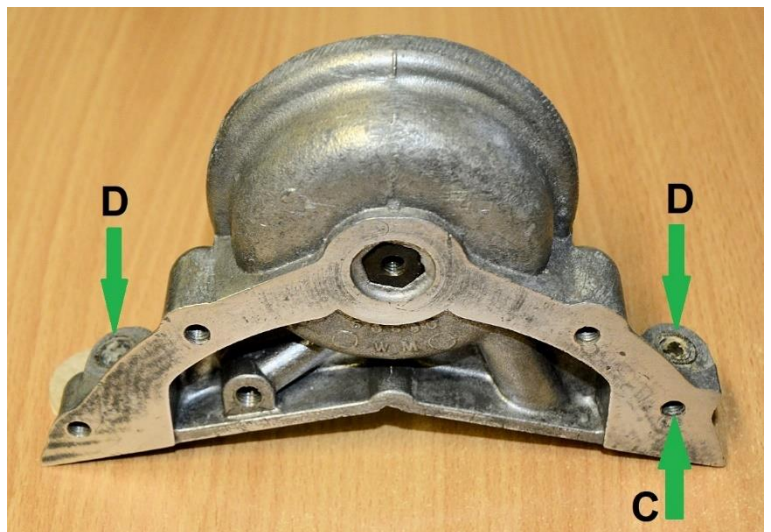
Right: Figure 4. Front face of the same rear timing cover. 'C' five threaded holes that need checking before installation, Items 'D' show securing bolt holes.

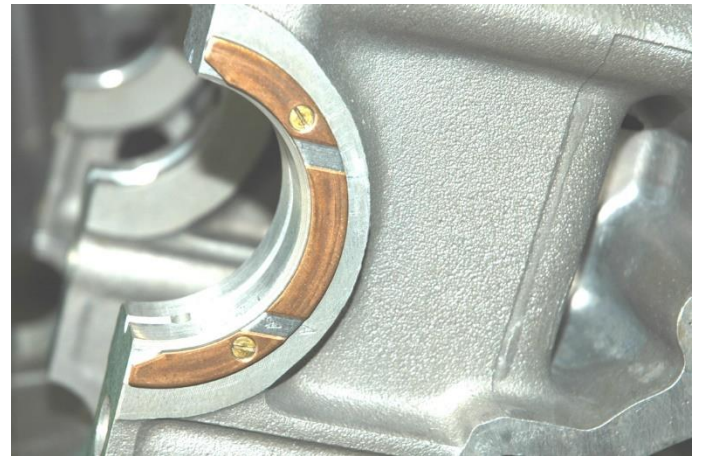
*Right: Figure 14. Shows thrust bearing retained by two brass countersunk machine screws.*

Another proven method for holding the thrust plates is to drill 1/8-in. clearance holes through clamped thrust plates and the crankcase web for floating brass anchor pins.

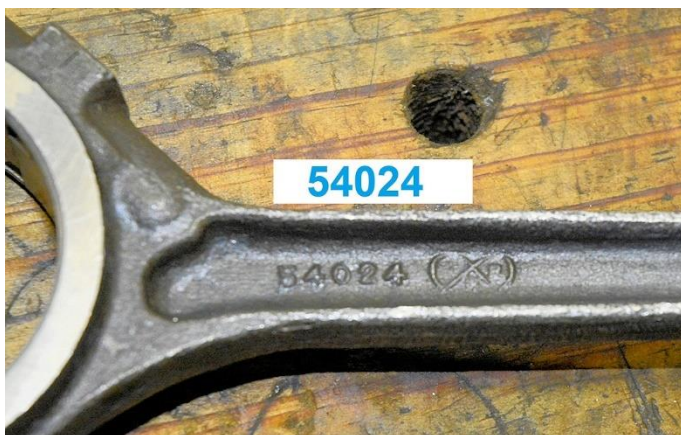
*Above Left: Figure 18. Part number identification. Above: Figure 19. 'B' indicates strengthened area.*

Very early connecting rod caps were fastened with  $\frac{5}{16}$ -in. bolts, which were superseded by  $\frac{3}{8}$ -in. BSF bolts. Next important change was from the plain ledge big end joints, which were replaced with serrated joint pads, each cap unique to its connecting rod assembly. After the serrated joints were introduced, there was another version with a 'beefed-up' forging at the short end of the rod, where the cap bolt is threaded in. Connecting rods of this type should be selected, and early non-serrated connecting rods should, really, be cast aside.

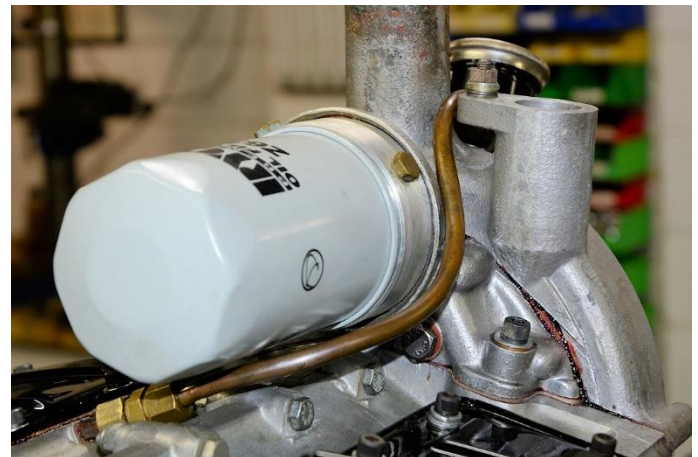
*Right: Figure 20. A Ryco Z63 spin-on cannister fitted to a Vokes oil filter adaptor. The two plugs in the drillings that facilitate the reverse flow through the aluminium adaptor can be seen.*

Currently, the JCCA can provide conversion kits to enable the use of modern-style 'spin-on' type cannister oil filters. The Tecalemit adaptor is common to other makes of engines that used the same style Tecalemit oil filter, however, it should be noted that the adaptor for converting the Vokes filter features drillings and plugs in its body to ensure that the oil follows the same path for cleaning as that for the Tecalemit unit. Modern filter cannisters also have an anti-drain valve built in, which can make filter changing less messy. Even with the anti-drain valve, it is still necessary to release the filter drain setscrew (*Item 19*) to let the warmed oil drain to sump for about half an hour, prior to unscrewing the cannister.

**NOTE:** When installing the Vokes type adaptor kit, the anchor bolt that secures the adaptor to the rear timing cover, should be installed with Loctite 263 Thread Locker and the adaptor face that contacts the 'O' ring should have a smear of Loctite 518 Master Gasket applied, as well as the same sealant being applied at the 'O' ring groove in the rear timing cover. This will assist preventing the adaptor from loosening off as the cannister is unscrewed during replacement. **DO NOT OVERTIGHTEN THE SPIN-ON CANNISTER!**

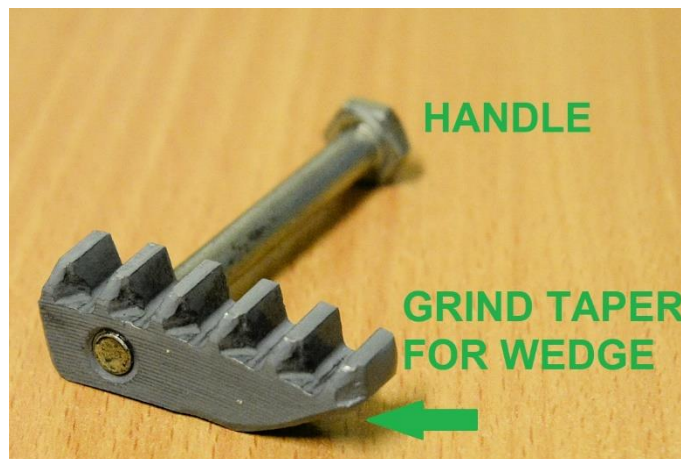
*Right: Figure 21. Section cut from an old starter ring gear, with convenient handle that can be screwed in from either side for convenience.*

9. Move the jamming section of ring gear to the left-hand side, so that the front crankshaft dog can be loosened-off. Withdraw the front pulley and place in the bin marked 'Front'.

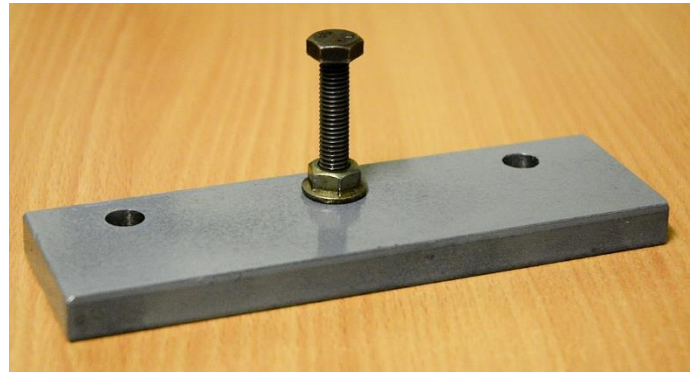
*Right: Figure 23. Cylinder head removal tool.*

21. The cylinder heads can be successfully pushed off the crankcase by using a device that can be easily constructed from a piece of flat steel bar, drilled to slide over the two rocker gear studs. Aligned with the number one cylinder head stud, the bar should be drilled and tapped with an 8 mm thread for a 50 mm long setscrew that can be adjusted to push on the oil feed stud.  $\frac{1}{2}$ -in. nuts can be used as spacers on the rocker gear studs, to ensure purchase for the pusher to function. The two studs have sufficient thread to facilitate the removal of each

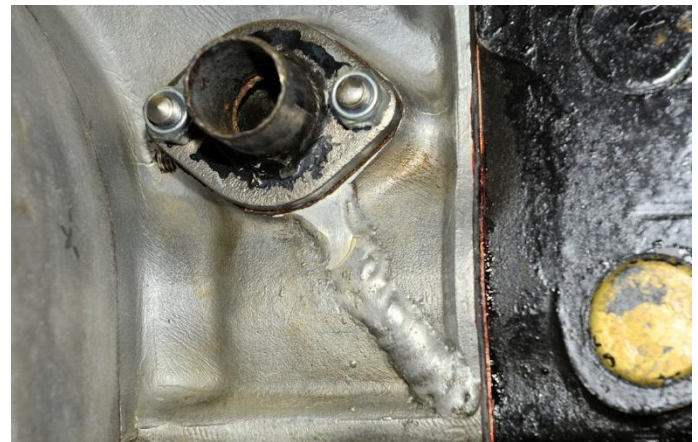
*Right: Figure 24. A typical weld repair at rear face.*

Distortion in this area can be between 0.010 to 0.014-in., a dimension which a cylinder head gasket cannot cope with. Also, it needs to be taken into consideration, what did cause the crankcase to crack? Possibly, it was excessive cylinder liner protrusion outboard of the head gasket surface, or, due to the coolant inlet elbows not being fitted prior to beginning the engine assembly procedure.

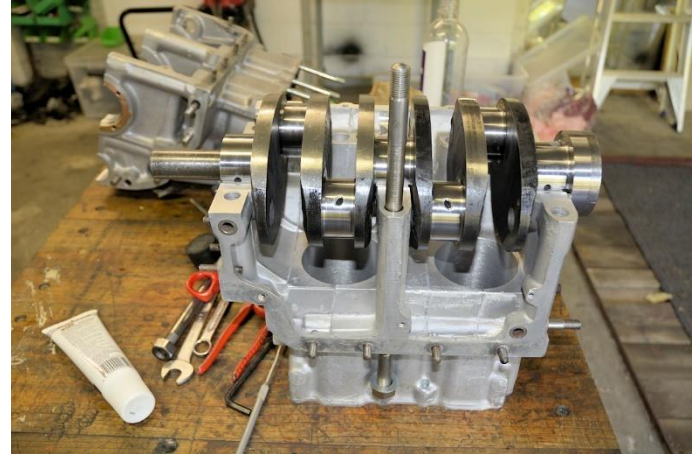
*Right: Figure 27. Crankcase half mounted on free standing bench for assembly work.*

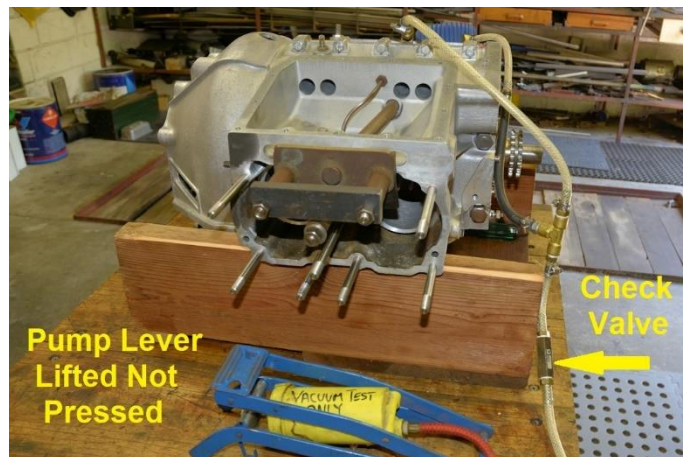
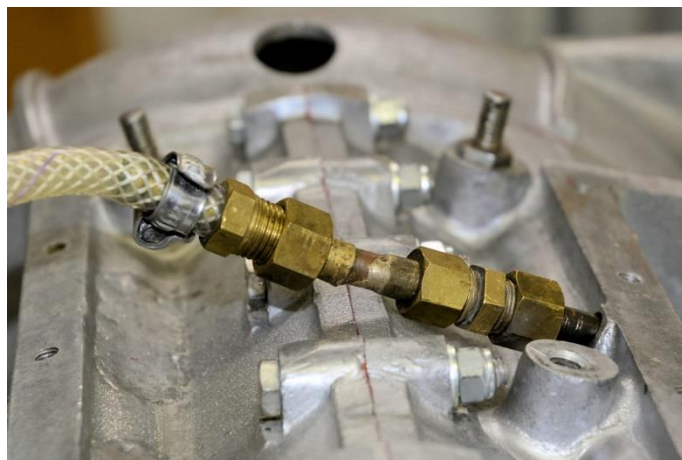
- Install the blanking plates and tighten firmly with 3/8-in. washers and BSF nuts.
- Attach a vacuum gauge to the breather pipe union fitting (*Item 14*) at the crankcase.
- With a tyre pump that has a reversed piston washer, pull a vacuum of 20-in. mercury. The gauge should hold position for 10 minutes.
- This test relies on a few conditions:
  - The check valve in the test kit seats with tight effect.
  - The union fitting at the pipe exiting the crankcase balance pipe makes a tight connection. Should the olive be loose on the copper pipe, the test will fail.
  - That the rubber pads make an effective end seal.

*Right: Figure 30. Reading the vacuum value.*

- Should the drawn vacuum disappear immediately, one of the 'O' rings has been inadvertently cut during assembly. The only effective repair is to split the crankcase and start all over again.

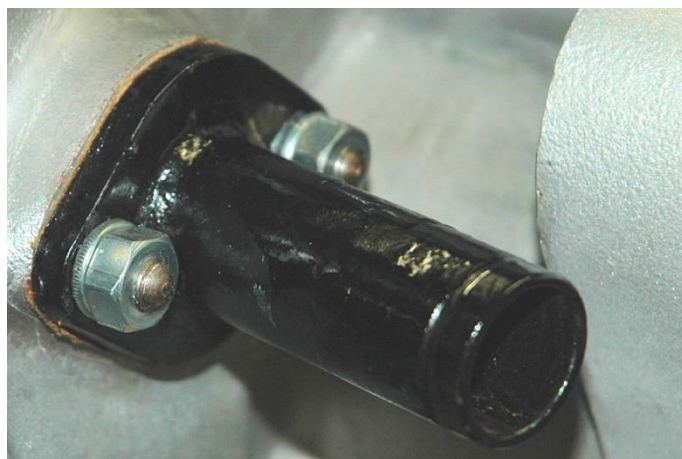
*Right: Figure 31. The coolant inlet elbow has been fitted at both sides.*

A successful balance pipe test provides the confidence to continue with the Jowett engine rebuild. After completing the balance pipe test, install both coolant inlet elbows. With these flanges properly

mounted, the rear faces of the crankcase are reinforced. The elbows should be installed before the cylinder heads are tightened in place.

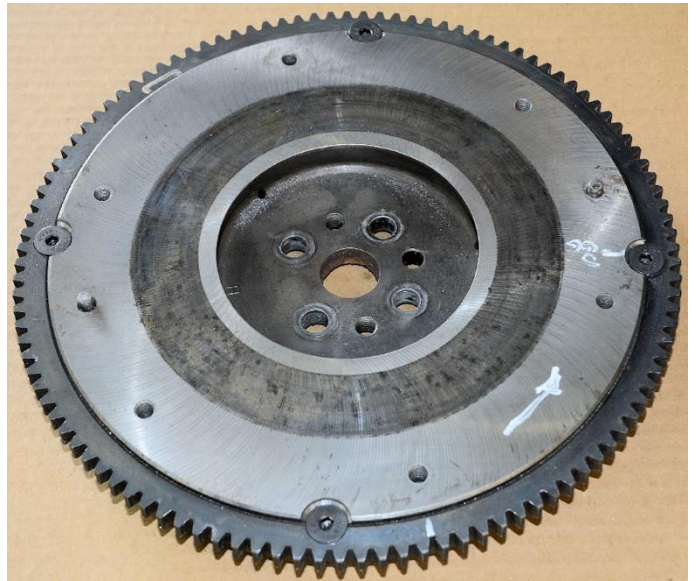
The countersunk setscrews are 8 mm diameter and 20 mm long, metric screws have been used due to ease of sourcing. Refer to Part XIX of the Jowett Technical Notes Series.

*Right: Figure 37. Setscrew and Allen key prior to final installation.*

With a white permanent marker pen, fill the stampings for T.D.C. 1 and 2 in the flywheel rim, then wipe away excess paint. Do the same for the 3 and 4 T.D.C. stamping. This makes identifying the points easier when setting the valve and ignition timing. Refer to *Figure 37*.

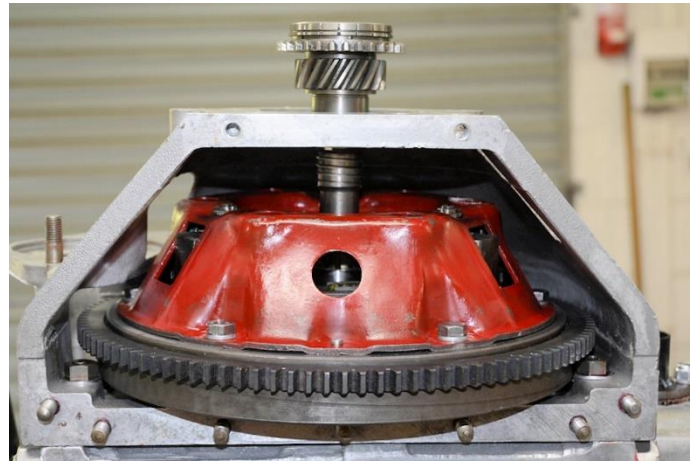
*Right: Figure 38. Installing the clutch assembly.*

Place a smear of Nulon L90 assembly paste in the spigot bush at the rear of the crankshaft. Install the clutch disc and then locate the clutch pressure plate onto the two dowels in the flywheel making sure that the white identifying marks are aligned. Insert a spare gearbox first motion shaft so that the loose friction disc is aligned with the spigot bush (*Item 152*) in the crankshaft. The six clutch pressure plate setscrews (with new spring washers) should be installed progressively as the flywheel is rotated. With all setscrews fitted, make a final check for equal tightness – 20 lb. ft. torque.

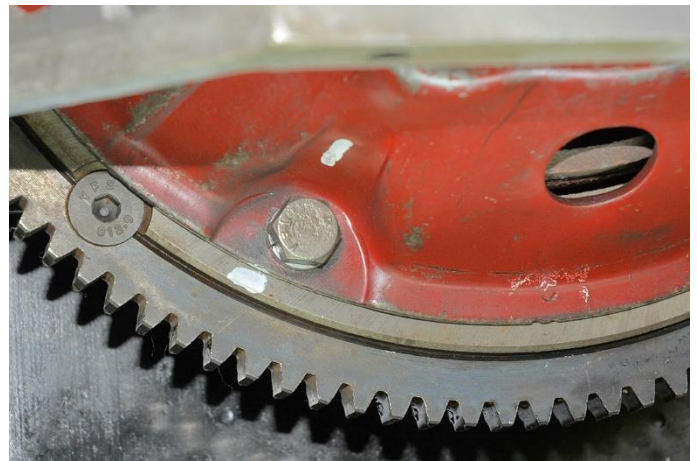
*Right: Figure 39. Clutch and flywheel alignment marks confirm correct position.*

The gearbox first motion shaft should be easy to slide in and out of position – if tight, investigate and resolve the concern. A spigot that is a good fit in the bush can, due to the lubricant, cause a slight vacuum as the shaft is withdrawn.

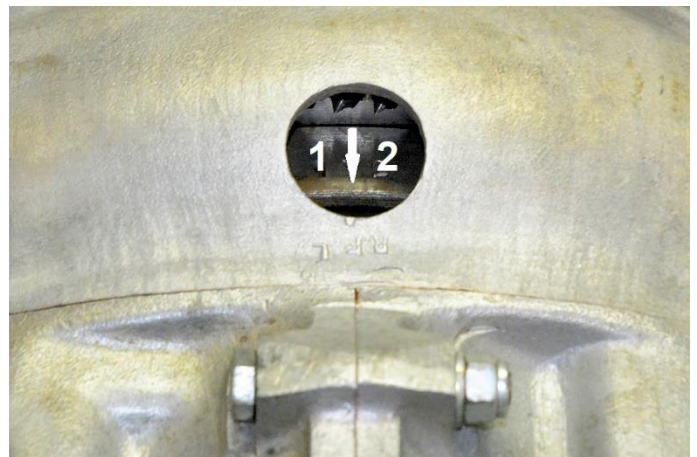
Fit the oil pump assembly, with the oil strainer below the baffle plate, locating it onto the hollow dowels, and ensuring the drive spindle is positioned so that the offset slot into which the distributor drive is fitted, as shown in *Figure 38*. This action is very important, if the tongue slot is out of position, the ignition timing at the distributor cannot be set, due to the proximity of the coolant pump. Tighten the three oil pump securing nuts.

*Right: Figure 41. The oil pump drive spindle viewed from above, when in position with T.D.C. 1 and 2 is set. This view is from directly above the drive spindle.*

Note that *Figure 41* shows the drive coupling position for the Lucas DKY-H4A and *Figure 41a*, the DM-2 distributor with the crankshaft at T.D.C. Nos. 1 and 2 cylinders. Note the slot angle difference.

3. Ensure that the oil pump drive spindle is located as shown in *Figure 41*, when the crankshaft is set to T.D.C. at 1 and 2. The oil pump spindle is driven at half crankshaft speed. The slot for the distributor drive is offset as shown in *Figure 41*.
4. Fit a suitable pointer at one of the front timing cover bolt threads, mount the 360° timing wheel on the nose of the crankshaft and, with the crankshaft at T.D.C. on 1 and 2 cylinders, align the T.D.C. timing wheel 0° mark accurately with the pointer.

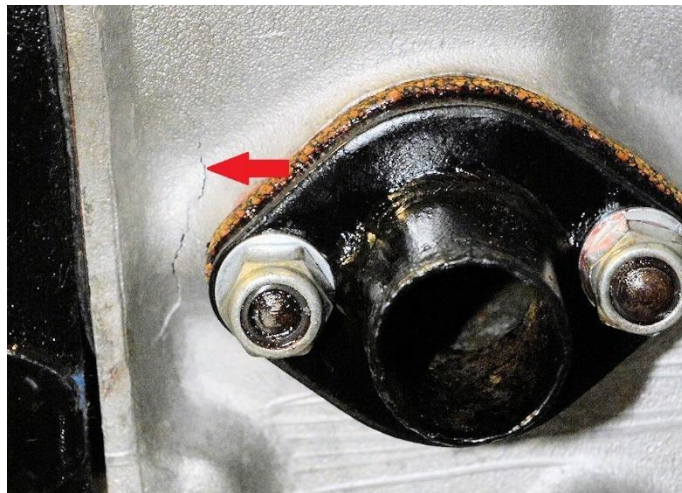
*Right: Figure 43. The red arrow indicates a crack that appeared two days after installing a cylinder head. The crankcase had been seriously abused.*

After installing the cylinder heads, it is advisable to let the assembly settle for a few days. The writer has recently experienced the devastating discovery of a crack appearing two days after the cylinder head was installed and left for the sealant to cure. This was a first time experience, it was found to be the result of previous abuse and improper repair methods – being cheaper in the short run. Possibly, no one knows if, in the past, a crank-case set has been abused due to incorrect cylinder liner protrusion or unskilfully repaired threads exist. It has to be understood that Jowett Engineering Limited introduced the extended cylinder head stud through the coolant inlet port for good reason. Indeed, an excellent modification and extremely cheap peace of mind for the Jowett engine builder. Failing to include this modification borders on sheer stupidity.

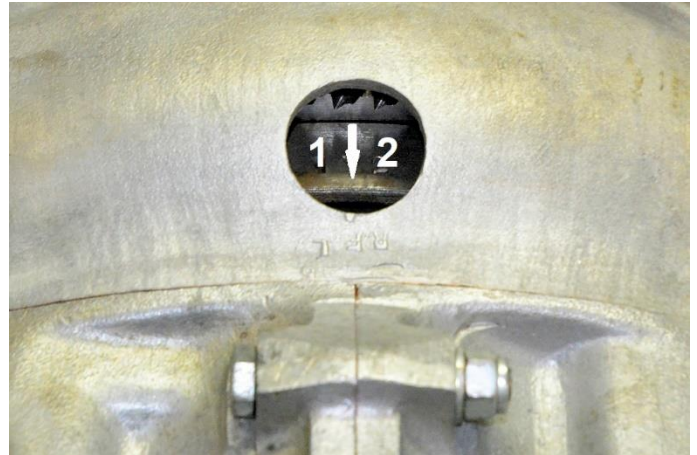
*Right: Figure 44. Top Dead Centre for cylinders 1 and 2 in preparation for valve timing.*

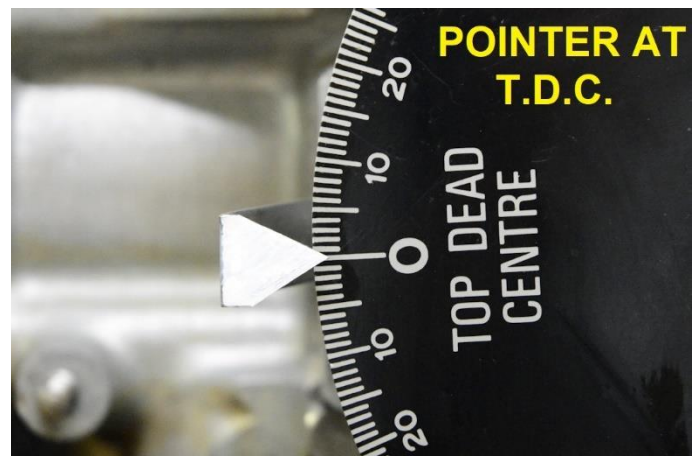
*Right: Figure 45. Showing the pointer set at T.D.C.*

It is advisable to fit the timing wheel between two fibre washers that grip the wheel in a manner that it can be rotated without moving the crankshaft, but still holds its set position on the crankshaft.

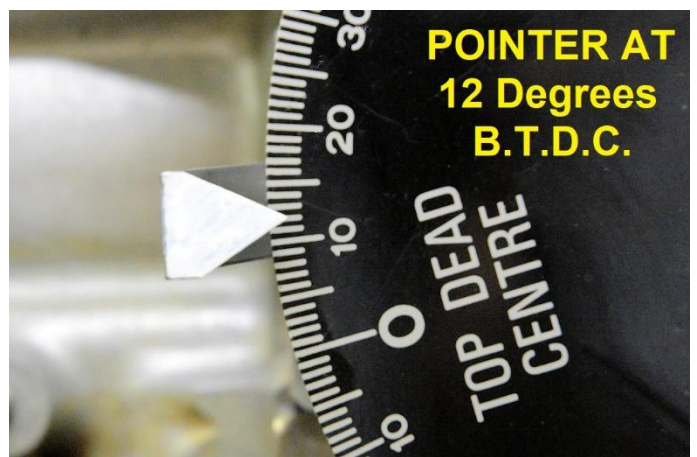
10. Rotate the crankshaft clockwise until it is at 12° before T.D.C. position. At this point, hold the timing chain onto the crankshaft sprocket, and work the camshaft chainwheel to a position in the upper arc of the chain so that the chainwheel can be pushed over the spigot and dowel on the camshaft. For camshaft and chainwheel with Vernier timing adjustment, proceed as at this stage, however, the chainwheel should be rotated inside the chain until a position is found where the floating dowel can be freely pushed into the chainwheel and the cam-shaft mounting boss, and the bolts can be threaded into the camshaft boss. The small diameter arbour on the dowel prevents it from moving rearwards after installation – the locking plate prevents the dowel from moving forward. The Vernier camshaft timing is thus correctly set – it is accurate.

*Right: Figure 49. The crankshaft has been set at 12° before T.D.C.*

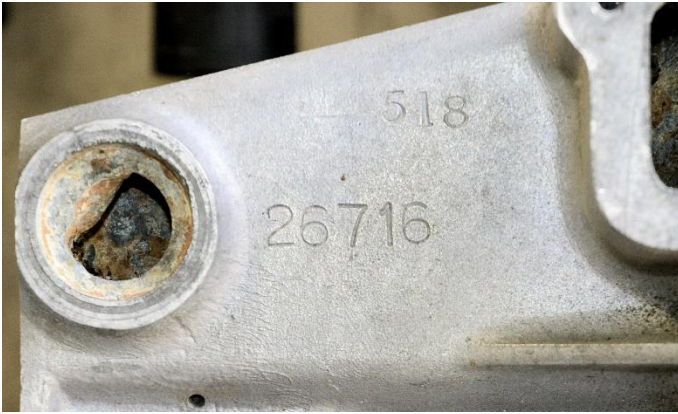
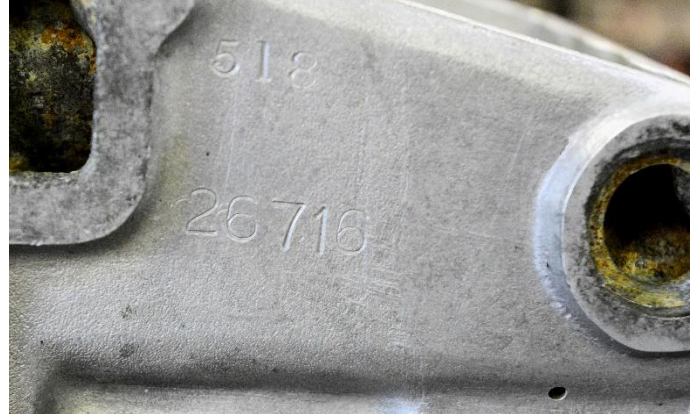
Above: Figures 54 and 55. From a Series III crankcase set, matching production reference numbers, in this case the matching numbers are 26716.

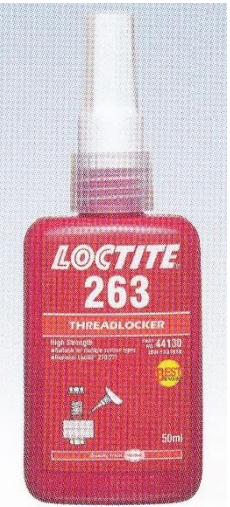
| Item | Description | Applications | Jowett Usage |
|---|---|---|---|
| | <p><b>Loctite 263</b><br/>Thread Locking –<br/>Works by filling the spaces between threads.<br/>Provides an assembly that will not loosen under stress and vibration.</p> | <p>Red liquid, high strength, can be used on threads up to 1-in. diameter. Copes with temperatures from minus 55 °C to 180 °C</p> | <p>Connecting rod bolts, flywheel bolts, studs in crankcase, starter dog, stud in rear timing cover, setscrews in flywheel ring gear, early oil filter adaptor anchor bolt.</p> |

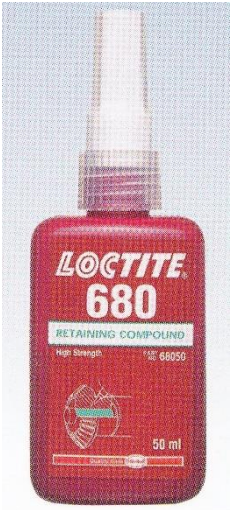
| Item | Description | Applications | Jowett Usage |
|---|---|---|---|
| | <p><b>Loctite 680</b><br/>Component Locking.<br/>Extreme strength for loose parts on shafts.</p> | <p>Green liquid fills gaps up to 0.020-in. Will require heat for dismantling. Very high strength. Copes with temperatures from minus 55 °C -150 °C.</p> | <p>Fixing loose starter ring gear.<br/>Useful for permanent locking tasks.</p> |

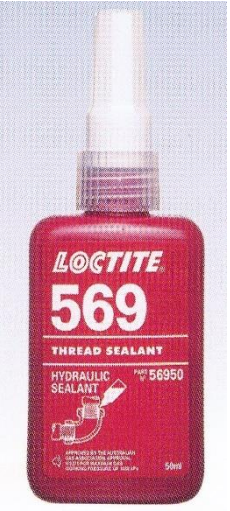
| Item | Description | Applications | Jowett Usage |
|---|---|---|---|
| | <p><b>Loctite 569</b><br/>Seals threaded fluid fittings – stays flexible. Works by filling the spaces between threads. Provides an assembly that seals but will not loosen under stress and vibration.</p> | <p>Brown liquid, of medium strength, can be used on threads up to ¾-in. diameter. Copes with temperatures from minus 55 °C to 150 °C</p> | <p>Oil pressure union, breather pipe fittings, extended cylinder head stud, oil filter drain fibre washer, advance/retard union on carburettor.</p> |

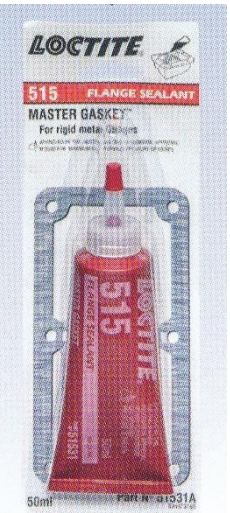
| Item | Description | Applications | Jowett Usage |
|---|---|---|---|
| | <p><b>Loctite 515</b><br/>Master Gasket Sealant.<br/>Flexes with gaskets as temperature changes</p> | <p>Purple liquid in a tube. Can seal gaps up to 0.008-in. Has excellent oil sealing properties. Excellent sealing against engine coolants, glycol etc. Copes with temperatures from minus 55 °C to 150 °C</p> | <p>All gasketed joints, head gaskets, timing cover, tappet covers, sump and petrol pump.</p> |

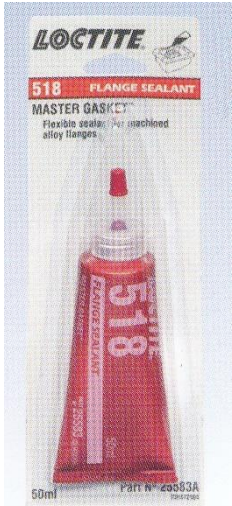
| Item | Description | Applications | Jowett Usage |
|---|---|---|---|
| | <p><b>Loctite 518</b><br/>Master Gasket Sealant for metal to metal joints.<br/>Flexes in joint as temperature changes.</p> | <p>Red gel in a tube.<br/>Can seal gaps up to 0.020-in. Has excellent oil sealing properties.<br/>Good sealing against engine coolants, glycol etc.<br/>Copes with temperatures from minus 55 °C to 150 °C<br/>Non-dripping gel.</p> | <p>Centre head stud seal.<br/>Internal balance pipe.<br/>Joint between flywheel housing and crankcase.<br/>Joint between gearbox and clutch housing.<br/>Joint between rear timing cover and crankcase if aluminium plate is used in place of gasket.</p> |
